MINERALS PROGRAM INSPECTION REPORT
PHONE: (303) 866-3567

MINE NAME: Agnus Dei Lode Claim	MINE/PROSPECTING ID#: M-2013-052	MINERAL: Gemstones & quartz (quartzite/quartzose sandstone)	COUNTY: El Paso
INSPECTION TYPE: Monitoring	INSPECTOR(S): Timothy A. Cazier	INSP. DATE: September 21, 2017	INSP. TIME: 11:15
OPERATOR: Jean Marie Cowman	OPERATOR REPRESENTATIVE: Jean Cowman & Rich Fretterd	TYPE OF OPERATION: 110(2) - Hard Rock Limited Impact	
REASON FOR INSPECTION: Normal I&E Program	BOND CALCULATION TYPE: Partial Bond	BOND AMOUNT: \$6,553.53	
DATE OF COMPLAINT: NA	POST INSP. CONTACTS: U.S.Forest Service	JOINT INSP. AGENCY: U.S.Forest Service	
WEATHER: Clear	INSPECTOR'S SIGNATURE:

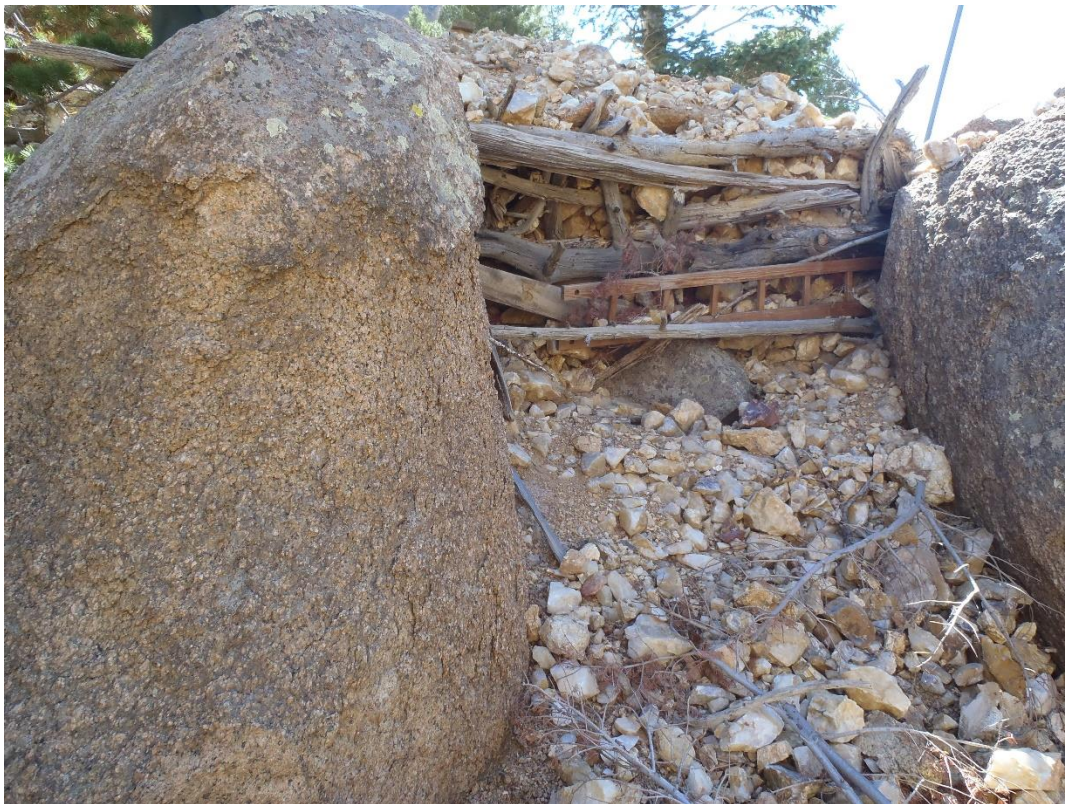
Excess Spoil and Dev. Waste: The natural slope is very steep for this site. The Permittee has constructed a crib wall (see **Photo 1**) that is holding for now. However, the DRMS has concerns about the rigidity of this structure as it was not engineered. In addition, site representatives indicated claim jumpers have added to the spoil pile. Continued similar activity may overload the crib wall. The resulting failure, given the steep terrain, it is very likely to have an offsite impact. The DRMS highly recommends reinforcing the crib wall and/or reducing the volume of material it contains.

Photo 1. Crib wall (from below).

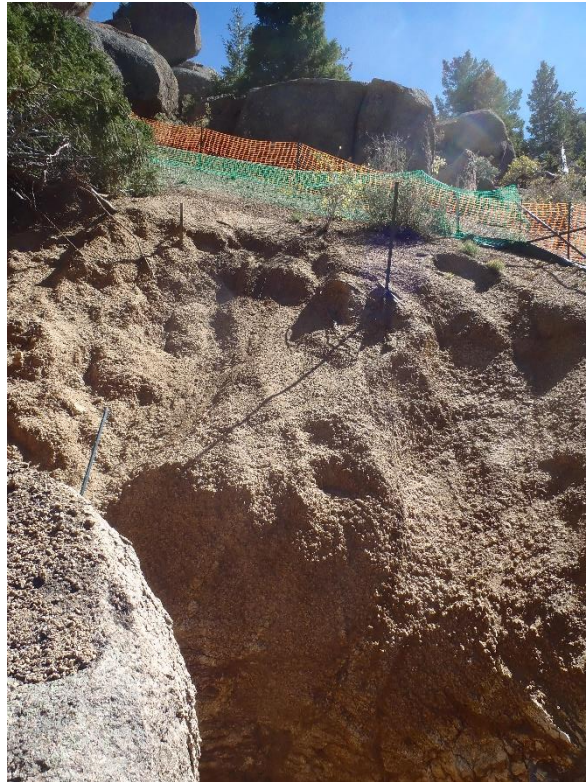
Gen. Compliance with Mine Plan: The operation appeared to be in compliance with the approved mine plan. The disturbed area was estimated to be less than 0.1 acres. Highwalls were estimated to vary between 12 and 15 feet in depth (which is the permit limit) and appeared stable below the weathered Pikes Peak Granite (see **Photo 2**). The configuration of the dig at the time of the inspection ensures any weathered material that slides, will end up in the dig and should not result in any impact outside the permit boundary (see enclosed **Post Inspection Map**).

Photo 2. Weathered Pikes Peak Granite.

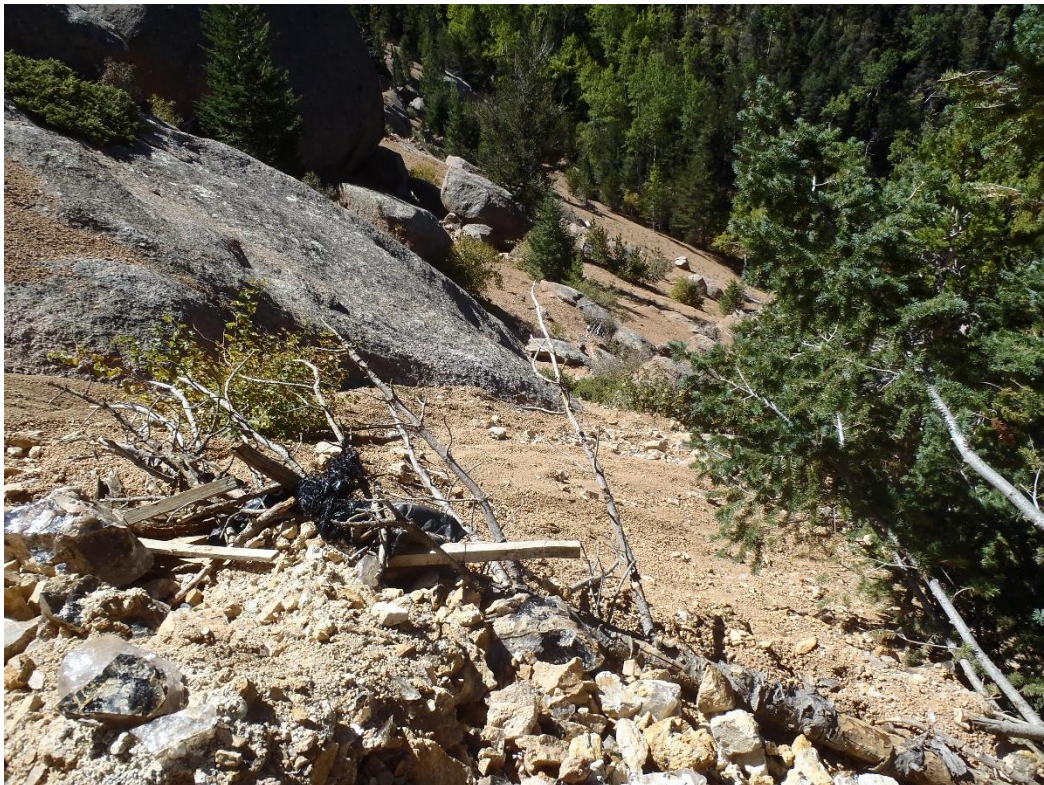
Processing Waste: The spoil pile downslope of the dig site consists of overburden and discarded quartz (see **Photo 3**). The quartz has a unique hazard in that much of it contains carbon dioxide "bubbles" which when heated by exposure to the sun can cause these crystals to explode. The Operators use safety glasses on hot days.

Photo 3. Overburden and discarded quartz (foreground).

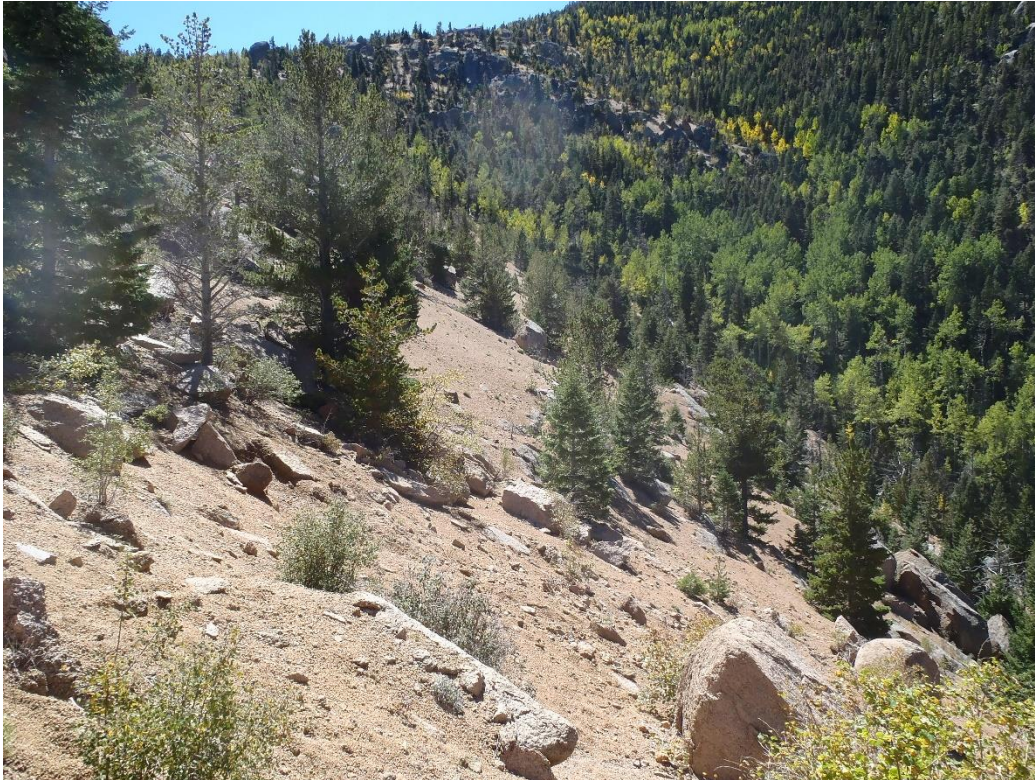
Revegetation: No noxious weeds were observed. Ms. Cowman asked about revising the seed mix. Given the very sparse natural vegetation (see **Photo 4**), the approved seed mix is not likely to be very successful. Mr.

Photo 4. Very sparse natural vegetation (undisturbed area, looking south).

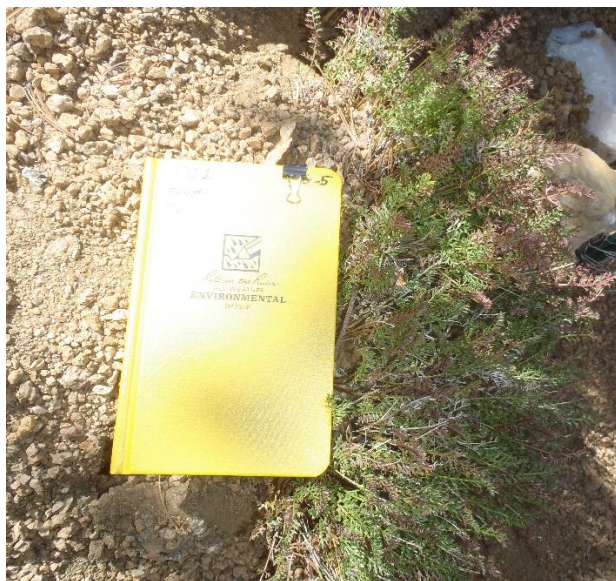
Hovermale agreed and the DRMS will coordinate with the USFS on reviewing and approving a change to the seed mix. Ms. Cowman pointed out what she called "Mountain Parsley" (see **Photo 5a**) that seemed in her experience to grow well on this steep slope. The DRMS could not confirm the species based on **Photo 5b** (from <https://www.swcoloradowildflowers.com/Yellow%20Enlarged%20Photo%20Pages/cymopterus%20lemmonii.htm>) and encourages the Permittee to have an expert confirm the species before including it in any seed mix change. The DRMS will require a technical revision (TR) be submitted to change the seed mix. There is no required fee for 110(2) permit TRs.

Photo 5a. "Mountain Parsley" on site.

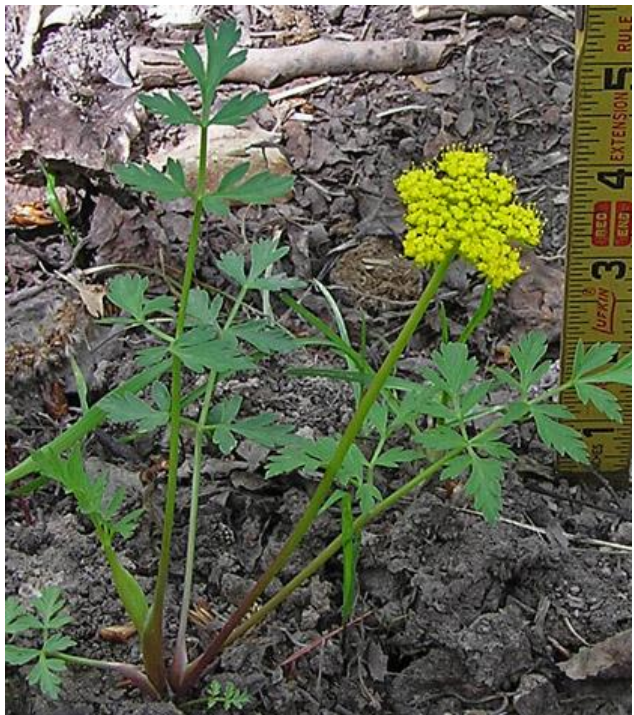
Photo 5b. Mountain Parsley from swcoloradowildflowers.com.

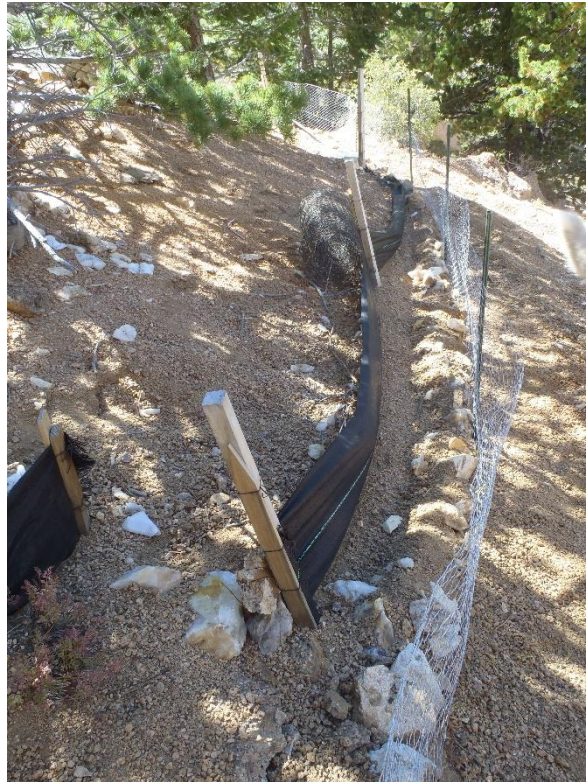
Sediment Control: No erosion problems were observed and no best management practices (BMPs) beyond those installed (see **Photo 6**) were needed at the time of the inspection.

Photo 6. BMPs (silt fence) with chicken wire to catch rockfall.

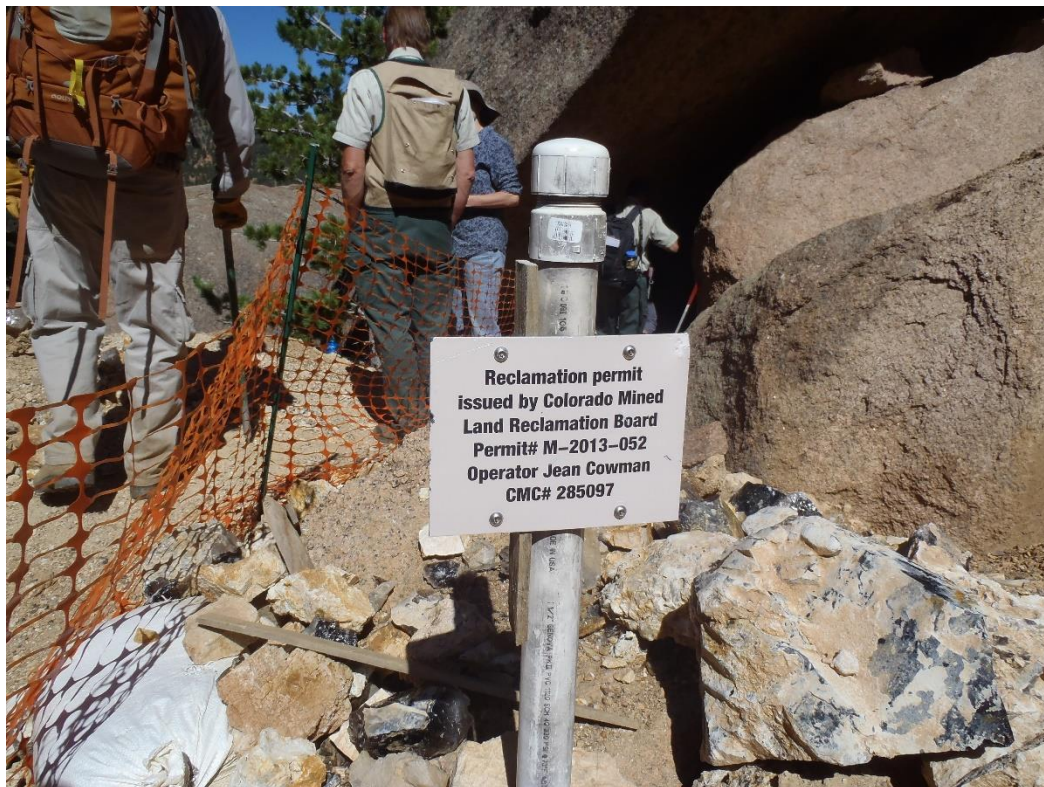
Signs and Markers: The permit sign was properly posted (see **Photo 7**) and boundary markers were observed to delineate the permit boundary (see **Photo 8**).

Photo 7. Permit sign.

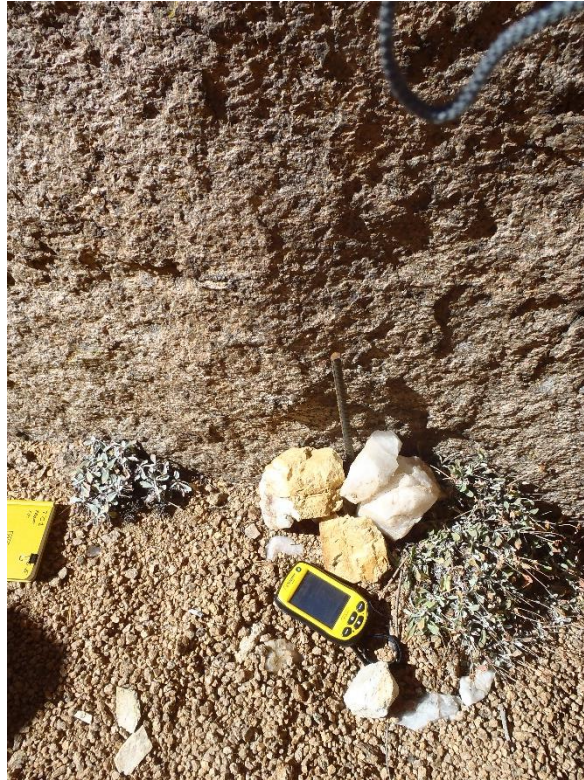
Photo 8. Typical permit boundary marker.
