**Locatable Minerals Site Inspection**  
**U.S. Department of the Interior**  
**Bureau of Land Management**  
**Royal Gorge Field Office**

| Date: 09/13/2016<br>Time: 12:50 - 1:10 p.m.<br>Weather: Cloudy<br>Inspection Purpose: General | Project Name: First Bentonite<br>Case Number: COC 051303<br>Operator: Pam Wedige<br>Location: Coaldale, CO |

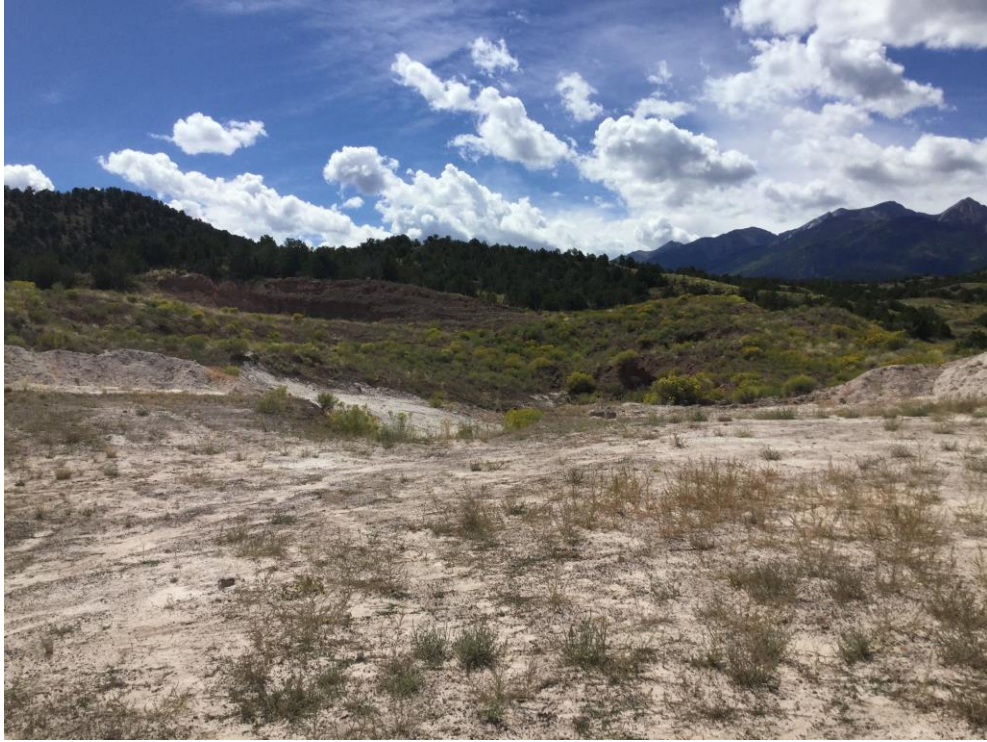
Photo 1: A view towards the highwall from the parking/staging area

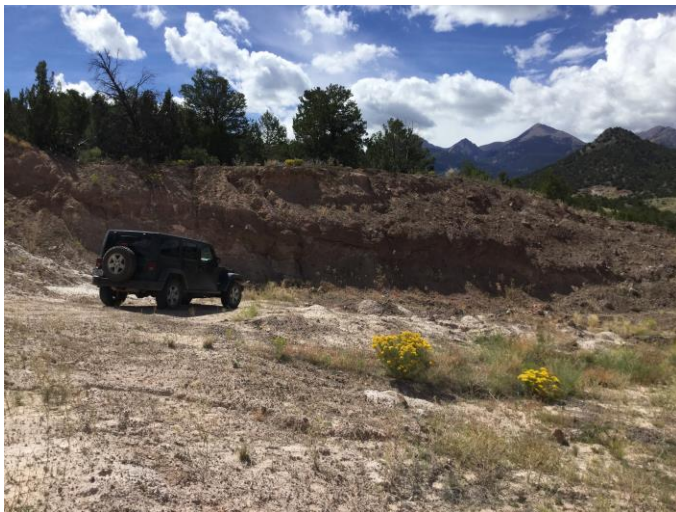
| <p style="text-align: center;"><u>Highwall/Working Face Conditions</u></p> <p style="text-align: center;"> x Working                      <input type="checkbox"/> Reclaimed </p> <p> -Ravelling or rock fall present<br/> -Tension cracks<br/> -Benches (are they clean?)<br/> -Adequate ingress/egress<br/> -Measurements (concurrent with ops - height, depth, slope) </p> | <p><input type="checkbox"/> N/A</p> <p>There was no evidence of highwall tension cracks, ravelling, or rock fall observed during the inspection. There appears to be adequate ingress/egress at the base of the highwall. The highwall is currently about 18 feet tall and near vertical.</p> |

Photo 2: The clay mine highwall to be reclaimed to a 3:1 slope (Jeep for scale).

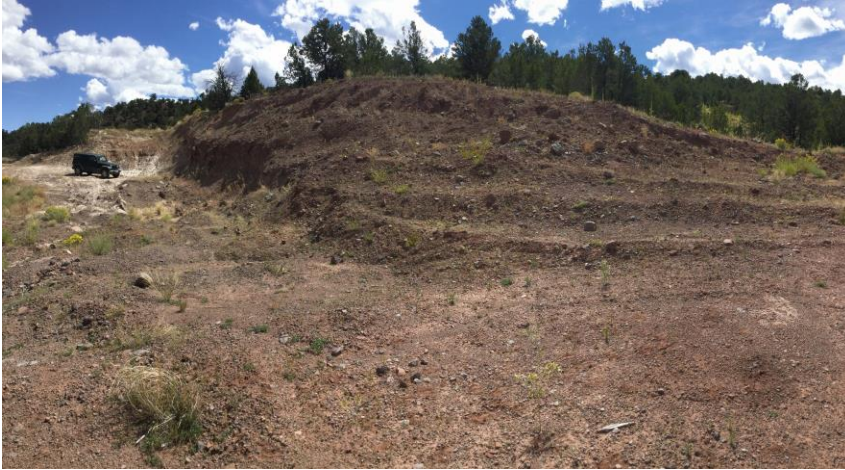
Photo 3: A panoramic view of the highwall.

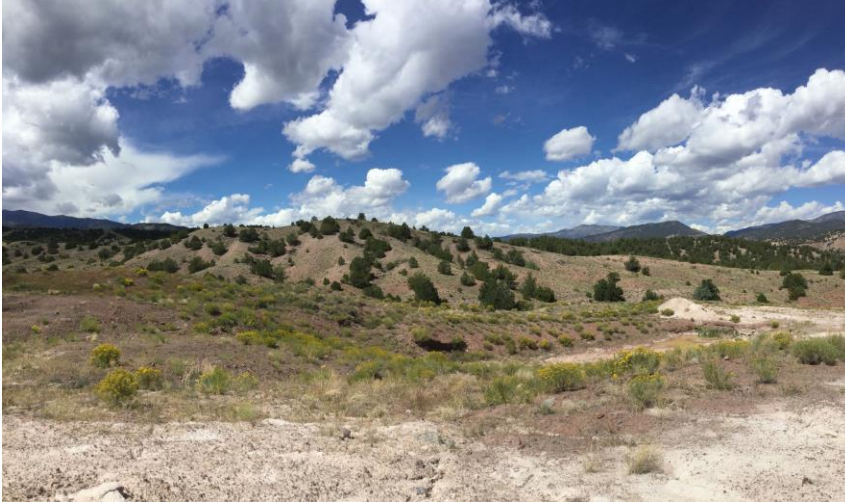
Photo 4: The view to the North from the southern boundary of the pit.

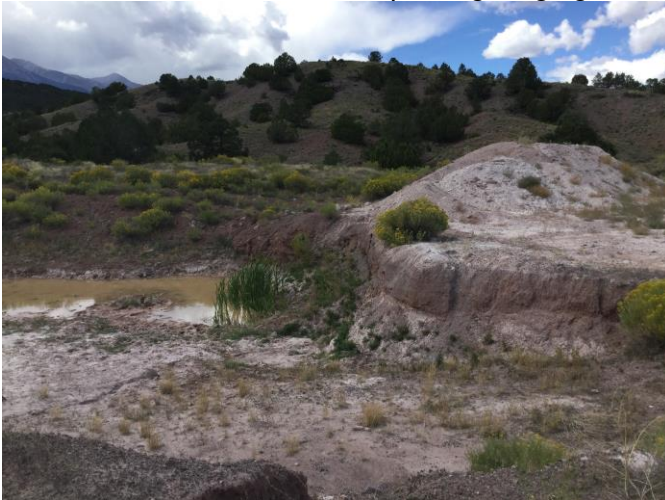
Photo 5: The basin below the parking/staging area.

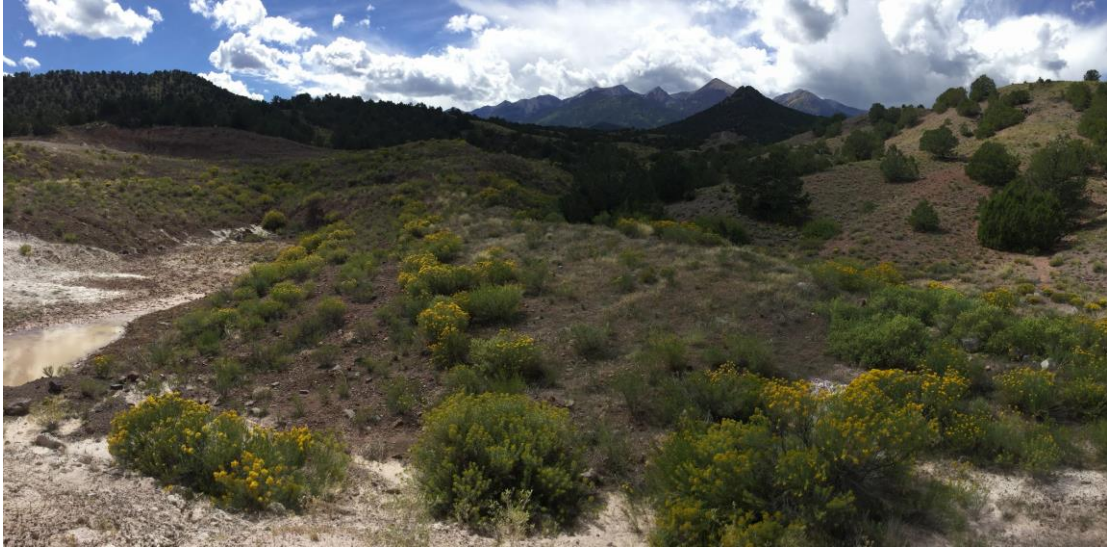
Photo 6: The topographic boundary between the mine area and the natural drainage.
