Locatable Minerals Site Inspection
U.S. Department of the Interior
Bureau of Land Management
Royal Gorge Field Office

Date: 11/29/2016 Time: 11:50 a.m. - 12:50 p.m. Weather: Cloudy Inspection Purpose: General	Project Name: First Bentonite Case Number: COC 051303 Operator: Pam Wedige Location: Coaldale, CO
Attendees BLM: William Jenkins Operator(s): Not onsite Other(s): N/A	Project Status: Active (reclamation phase) Project Type: Plan of Operations Occupancy: None
General Compliance Compliance with the filed Plan of Operations, and 43 CFR 3809 (in particular the performance standards outlined in 3809.420).	In general, the operation is in compliance with the Plan on file with BLM. x Yes <input type="checkbox"/> No <input type="checkbox"/> N/A In general, the operation and disturbances on site coincide with the method of prospecting, mining, and access described in the Plan of Operations. x Yes <input type="checkbox"/> No <input type="checkbox"/> N/A

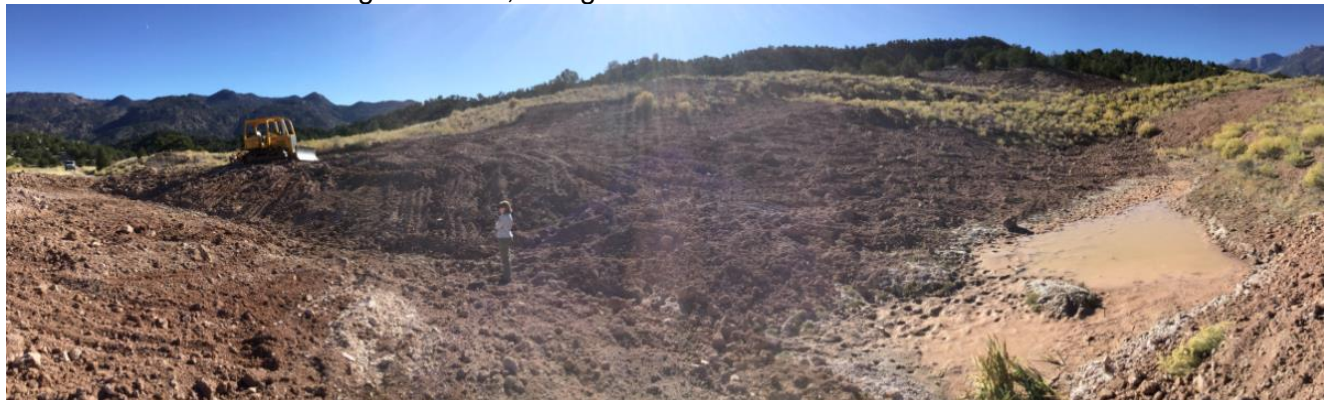
Photo 1: Panorama showing the swale, and grader.

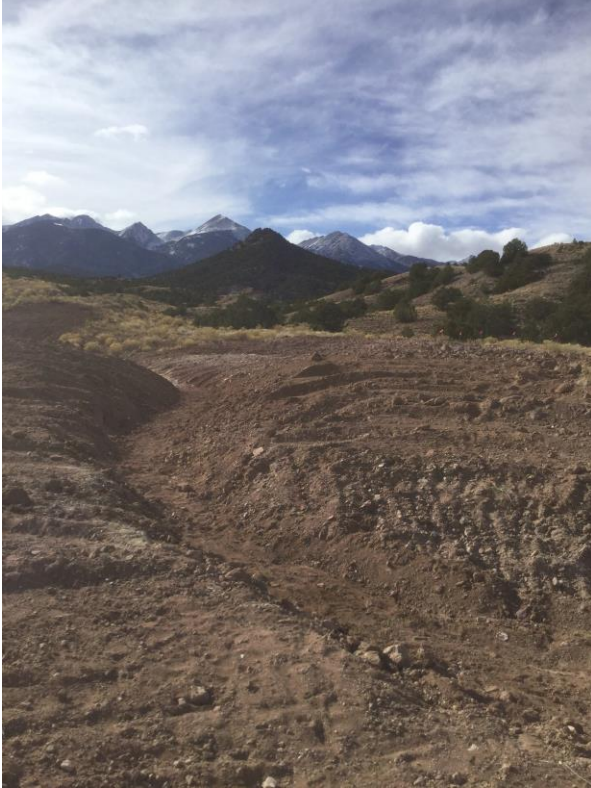
Photo 2: Photo of the swale, facing the pit.

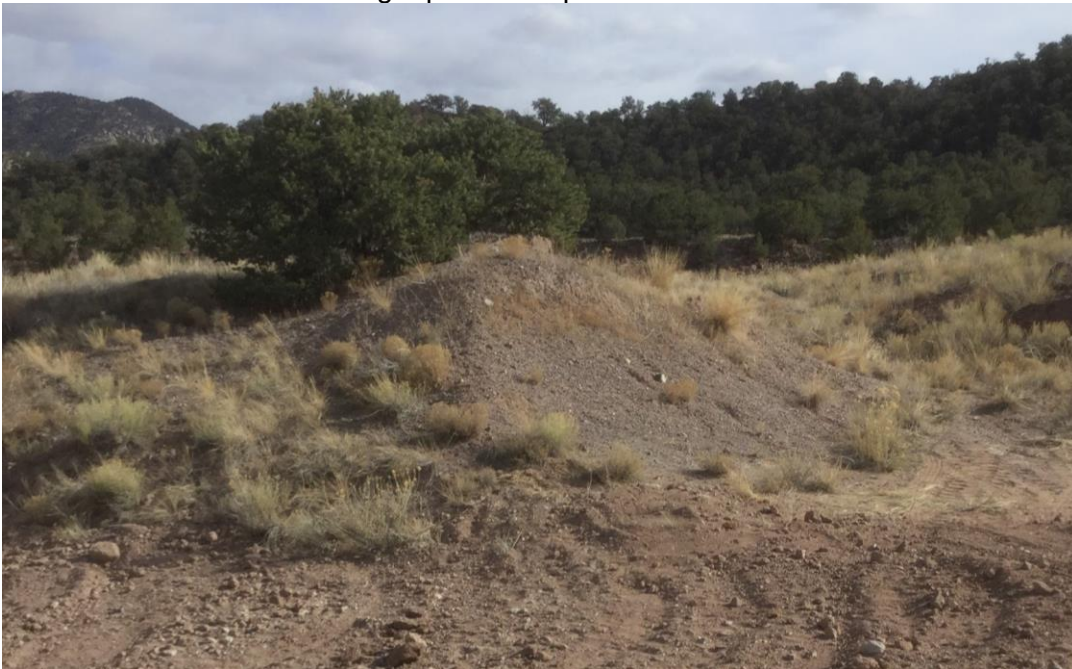
Photo 3: One of the remaining topsoil stockpiles on site.

<input type="checkbox"/> Impoundment Structures (Water, tailings ponds, etc.) - adequate freeboard - dimensions, stability - leaking at base?	through the existing impoundment structures.
<p style="text-align: center;">Ore Processing</p> <input type="checkbox"/> Non-Chemical Processing (crushing, screening, washing) - methods, equipment condition, water source <input type="checkbox"/> Chemical Processing (leaching, milling) - methods, chemicals involved (Xanthates, Cyanide, etc.), spill contingency	<input type="checkbox"/> N/A The operator does not process the bentonite clay they produce (it is used in its existing condition).
<p style="text-align: center;">Actions to be taken by the Operator</p> Operators should read this report carefully because it may require corrective action and/or response to the BLM in order to avoid consideration of possible enforcement action.	The lower staging area and remaining road need to be ripped and seeded for final reclamation. Once the remaining product material has been removed from the site, the remaining stockpiled topsoil should be used to reclaim the lower staging area.

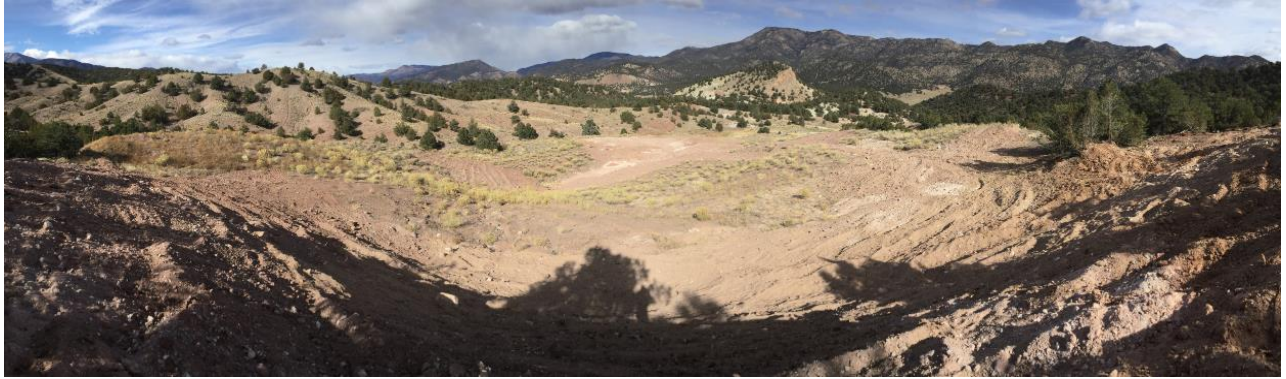
Photo 4: Panorama taken from the top of the reclaimed highwall.

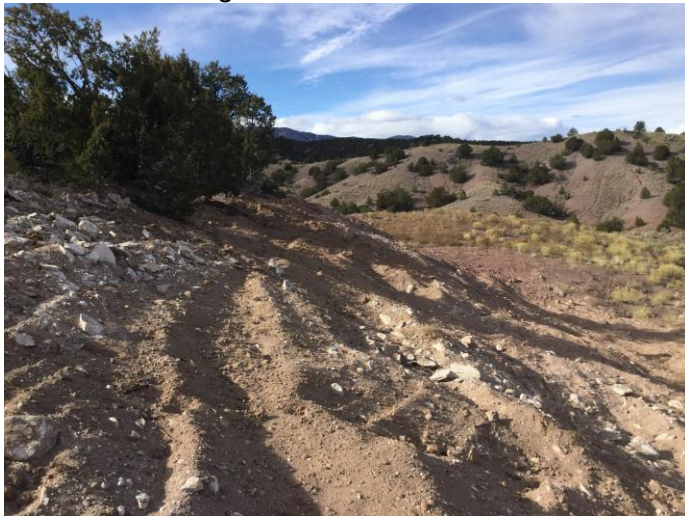
Photo 5: Showing the loose material used to backfill the highwall.

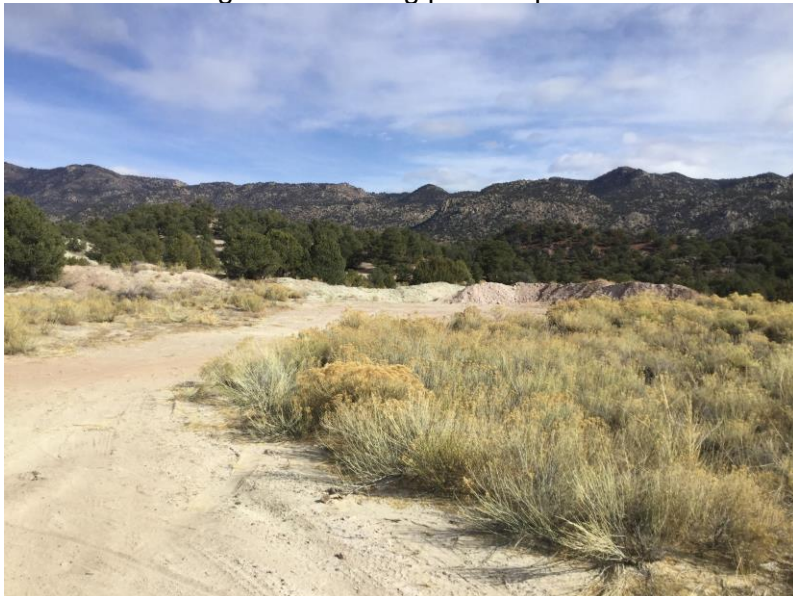
Photo 6: Showing the remaining product piles on the lower staging area.
