Mineral Materials Site Inspection
U.S. Department of the Interior
Bureau of Land Management
Royal Gorge Field Office

Date: 04/27/2017 Time: 9:10 - 10:45 a.m. Weather: Clear Inspection Purpose: General	Project Name: Mica White Operator: Colorado Quarries Location: Howard, CO BLM COC #: 078191 CDRMS Permit #: M-1992-058
Attendees BLM: William Jenkins Operator(s): Greg Cleaves Other(s): Tim Cazier (CDRMS)	Project Status: Active Commodity: Quartzite (aquarium rock) Type of Operation: 112 Contract Acres/Amount: 10 acres/30,000 tons Contract Expiration Date: 04/2018
General Compliance Compliance with the approved Mine and Reclamation Plan per the requirements outlined in 43 CFR §3601.40-42.	In general, the operation is in compliance with the Mine and Reclamation Plan on file with BLM. x Yes <input type="checkbox"/> No <input type="checkbox"/> N/A In general, the operation and disturbances on site coincide with the method of mining, reclamation, and access described in the Mine and Reclamation Plan. x Yes <input type="checkbox"/> No <input type="checkbox"/> N/A

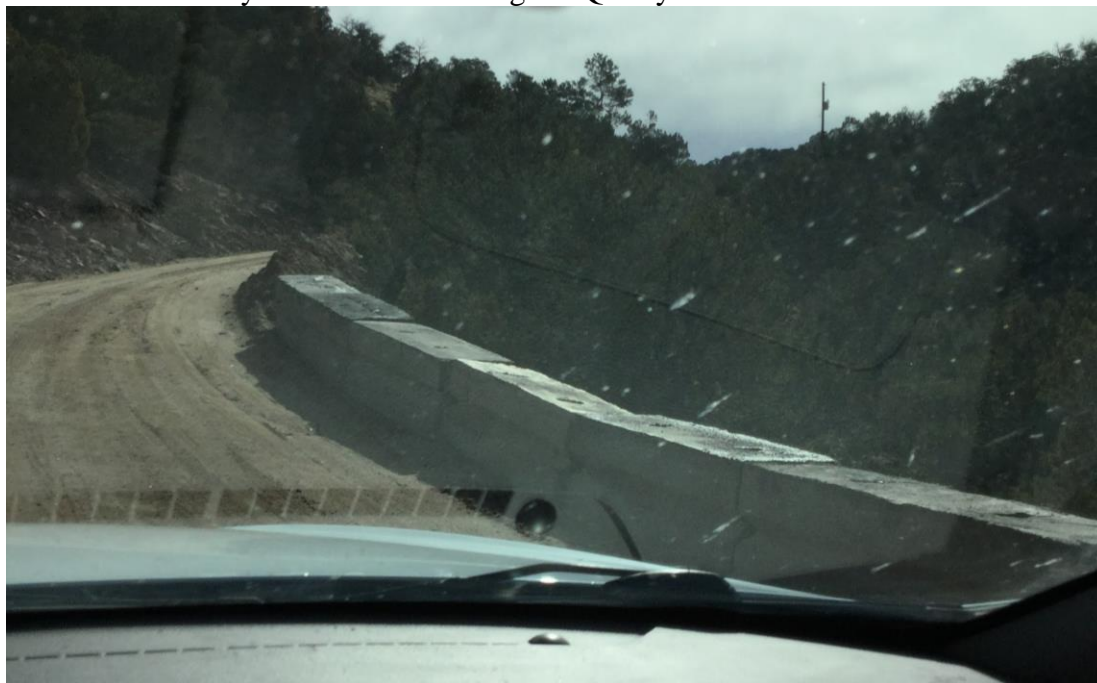
Photo 1. The newly installed berm along the Quarry access road.

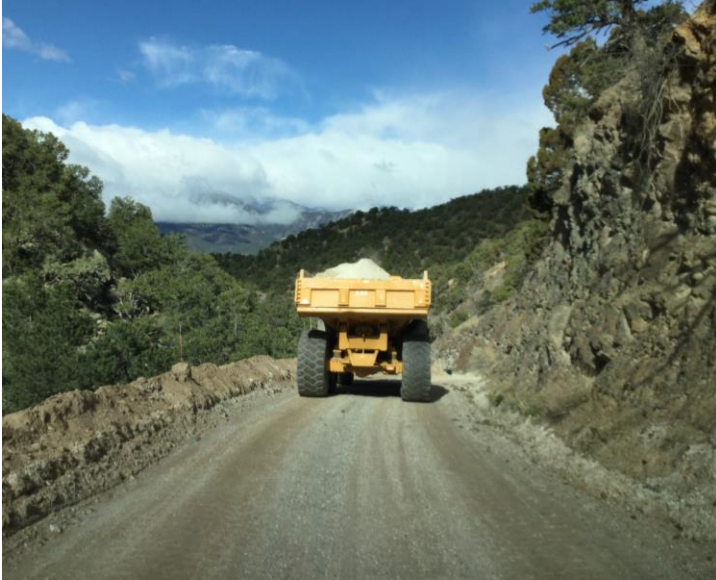
Photo 2. Showing the operator's haul truck (w/ fines). Note that the berm is axle height for this vehicle.

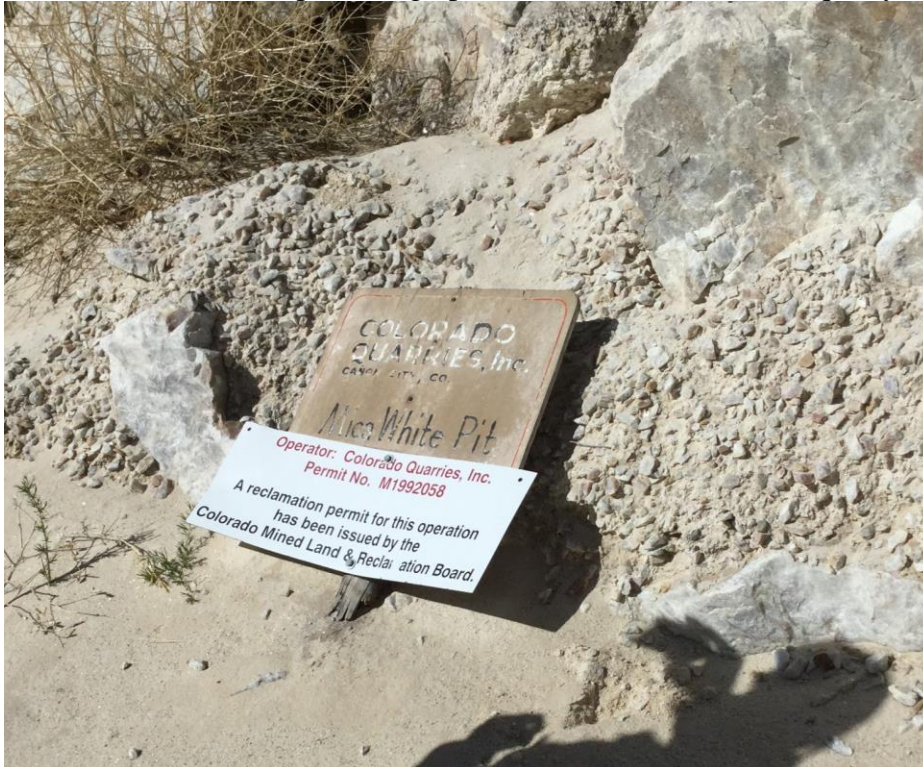
Photo 3. The CDRMS permit sign posted at the entrance to the quarry site.

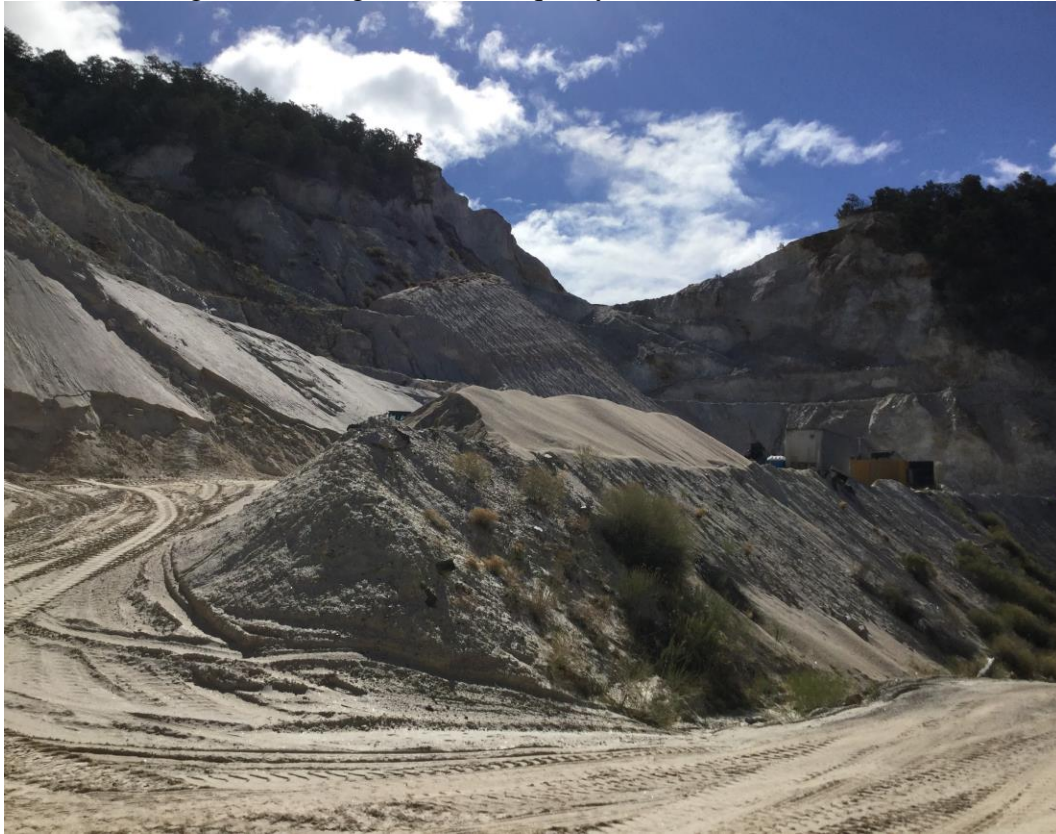
Photo 4. Facing the working floor of the quarry from the access road.

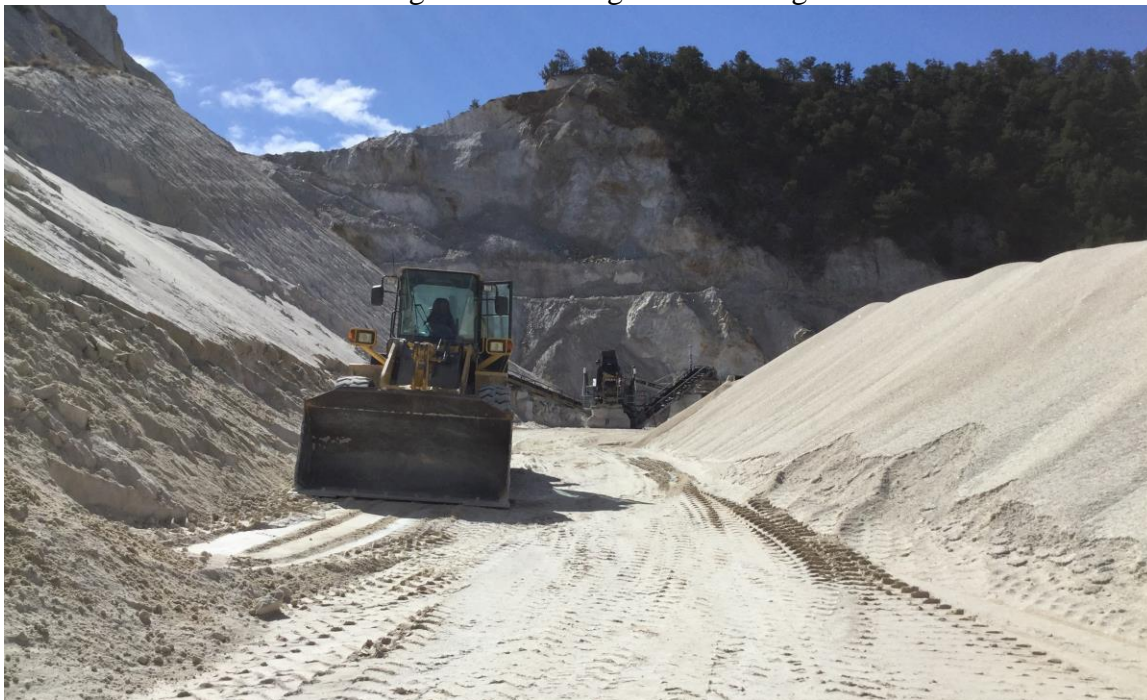
Photo 5. The access road leading to the crushing and screening unit.

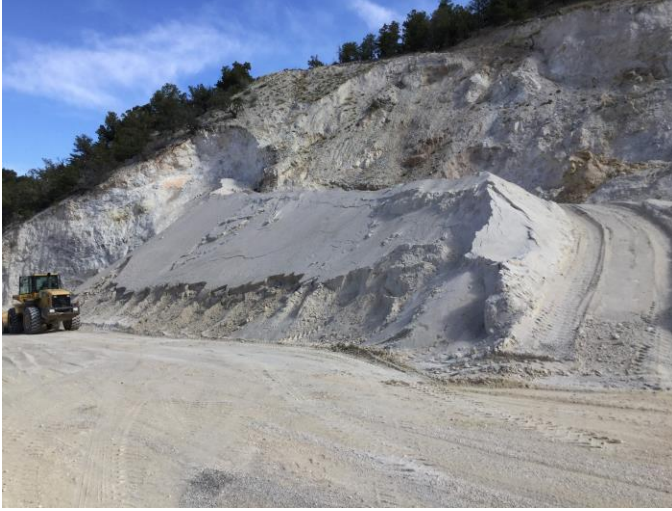
Photo 6. The operator's fines pile on the quarry floor.

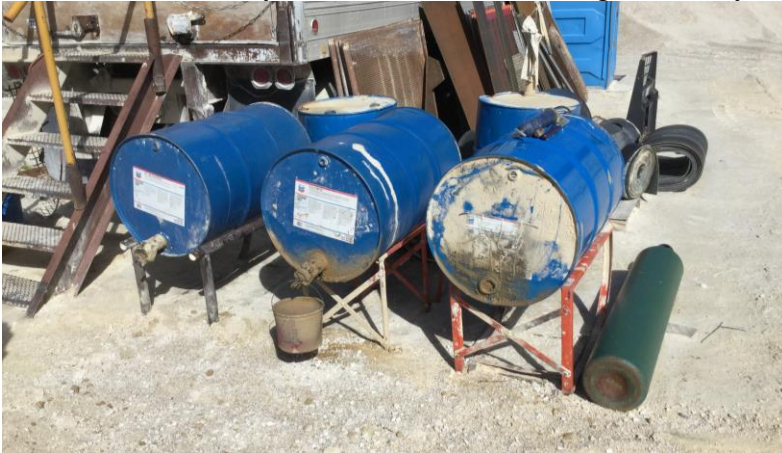
Photo 7. The three hydrocarbon barrels needing secondary containment.

<p style="text-align: center;">Actions to be taken by the Operator</p> <p>Operators should read this report carefully because it may require corrective action and/or response to the BLM in order to avoid consideration of possible enforcement action.</p>	<p>Install an adequate secondary containment structure for the 3 hydrocarbon barrels on the quarry working floor.</p>
<p style="text-align: center;">General Comments</p> <p>Other observations and notes from the inspection</p>	<p>During the inspection, several boundary posts were located for the lower staging area.</p>

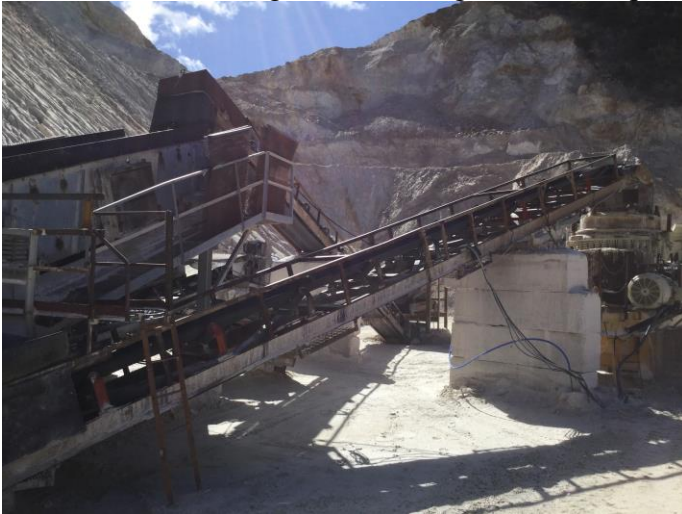
Photo 8. The crushing and screening unit on the quarry floor.

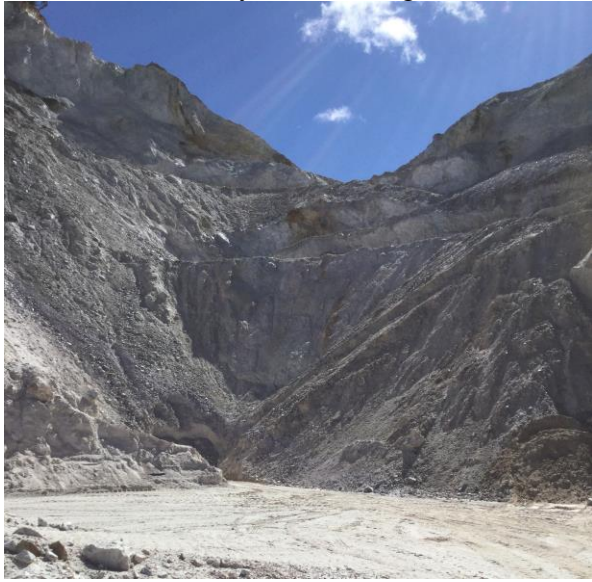
Photo 9. The newly benched highwall.

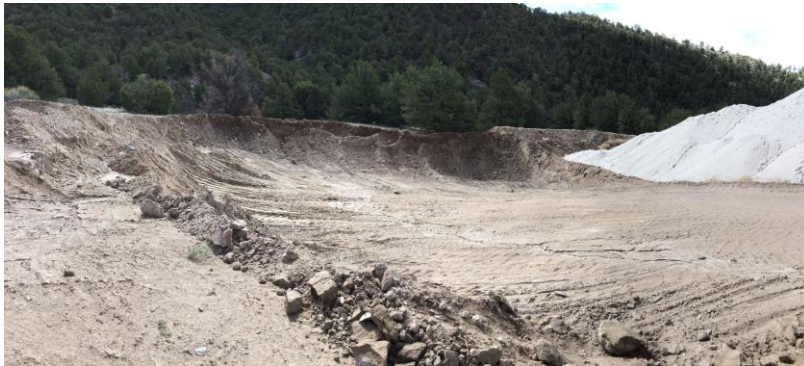
Photo 10. Material that was removed from the lower staging area for use in the construction of the access road berms.

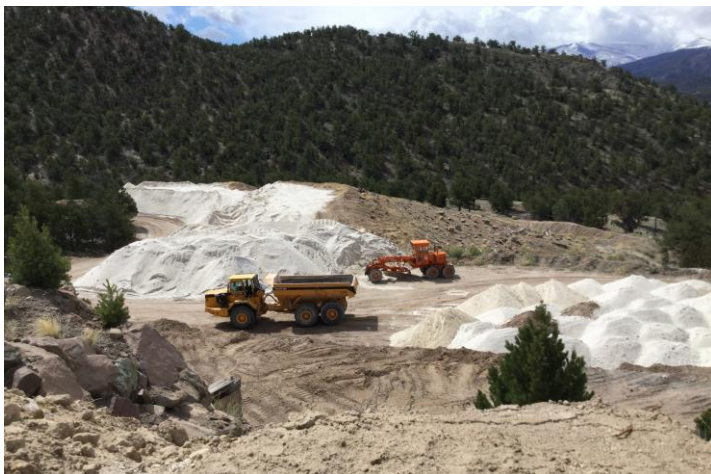
Photo 11. An overview of the fines staging area, note that the right-hand slope has been reclaimed.

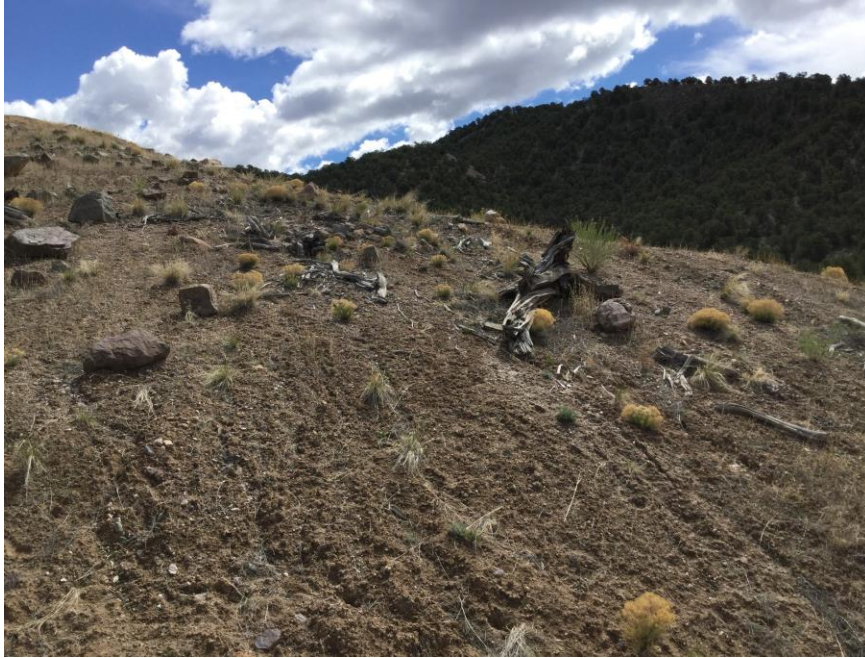
Photo 12. The reclaimed Southwestern slope of the staging area fines stockpile. Note the successful vegetation growth.

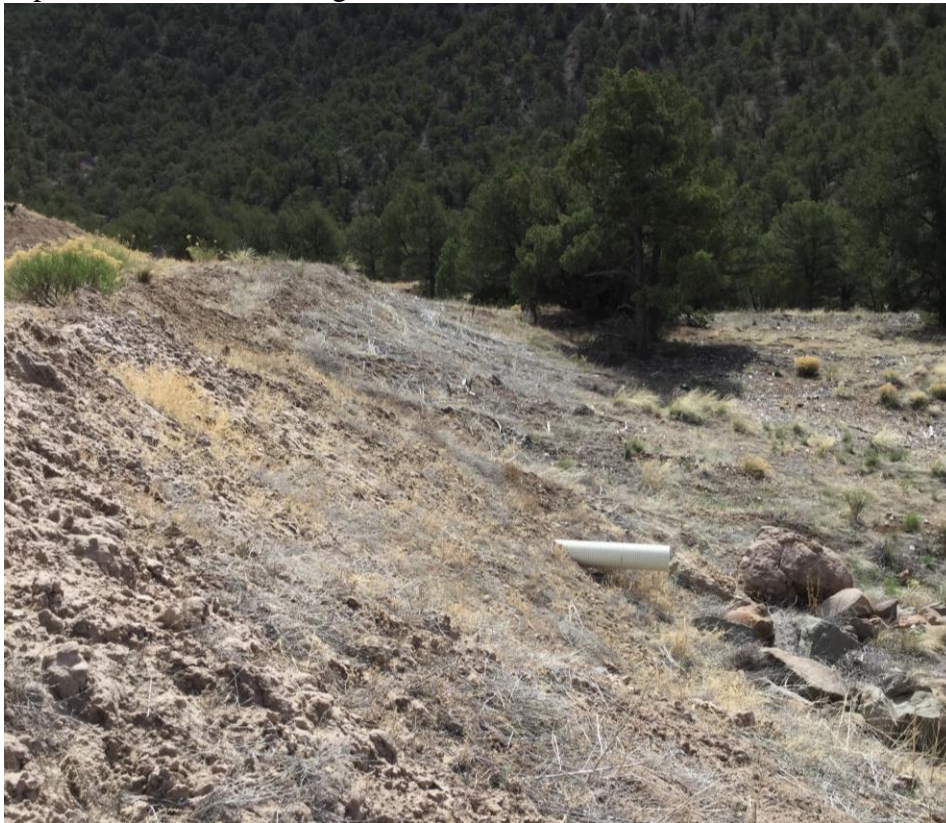
Photo 13. The outlet culvert of the sediment catchment basin below the reclaimed staging area slope. Note that the drainage below the culvert is armored.
