**COLORADO**Division of Reclamation,  
Mining and Safety

**MINERALS PROGRAM INSPECTION REPORT****PHONE: (303) 866-3567**

<b>MINE NAME:</b> Blue Valley Pit	<b>MINE/PROSPECTING ID#:</b> M-2015-008	<b>MINERAL:</b> Sand and gravel	<b>COUNTY:</b> Grand
<b>INSPECTION TYPE:</b> Surety-Related Inspection	<b>INSPECTOR(S):</b> Peter S. Hays	<b>INSP. DATE:</b> September 28, 2017	<b>INSP. TIME:</b> 13:00
<b>OPERATOR:</b> Kirkland Construction, L.L.L.P.	<b>OPERATOR REPRESENTATIVE:</b> David King	<b>TYPE OF OPERATION:</b> 111 - Construction by Government Agency

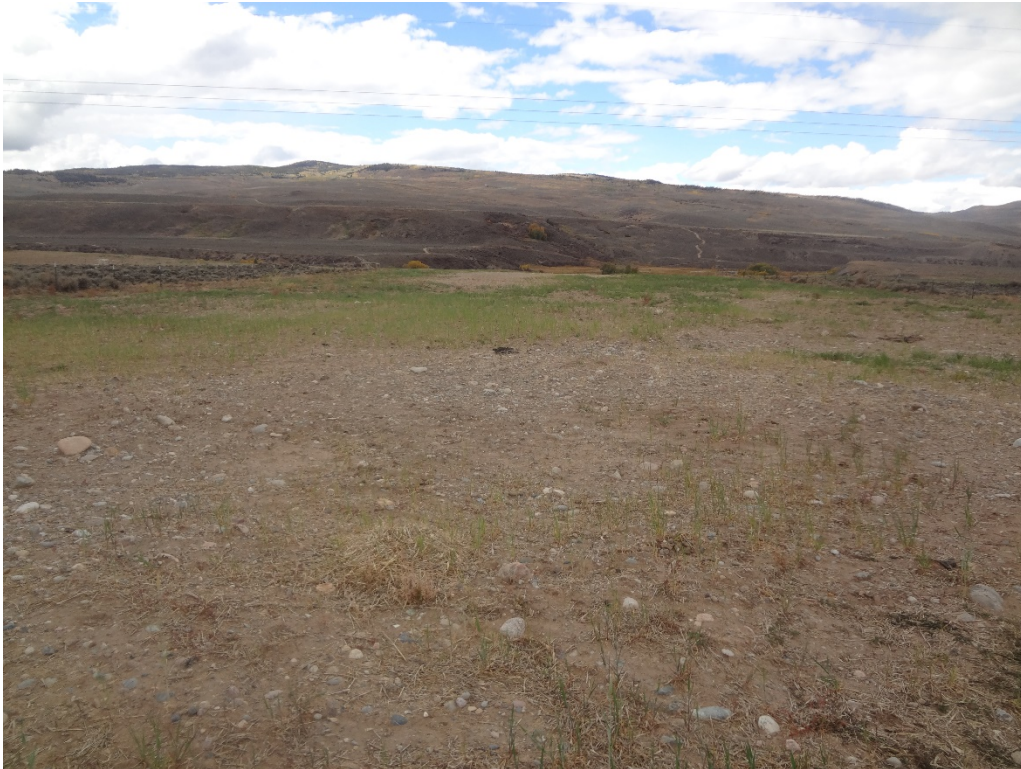
View of former access road area from Hwy 9 looking west

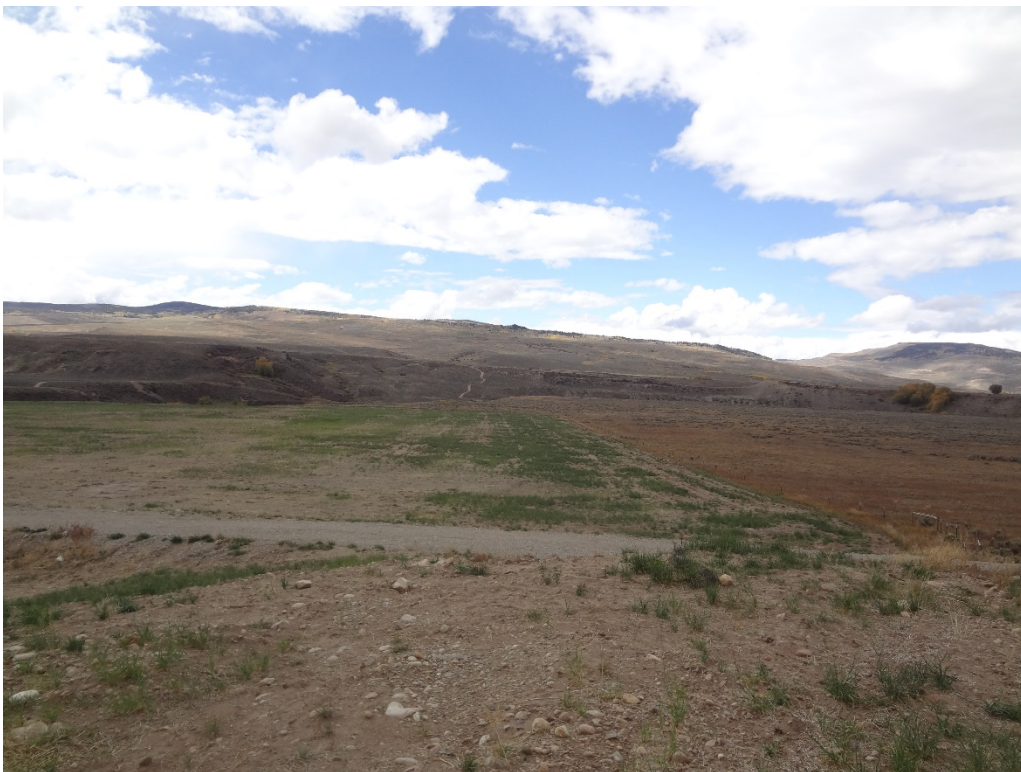
View from the northeast corner of the site looking west

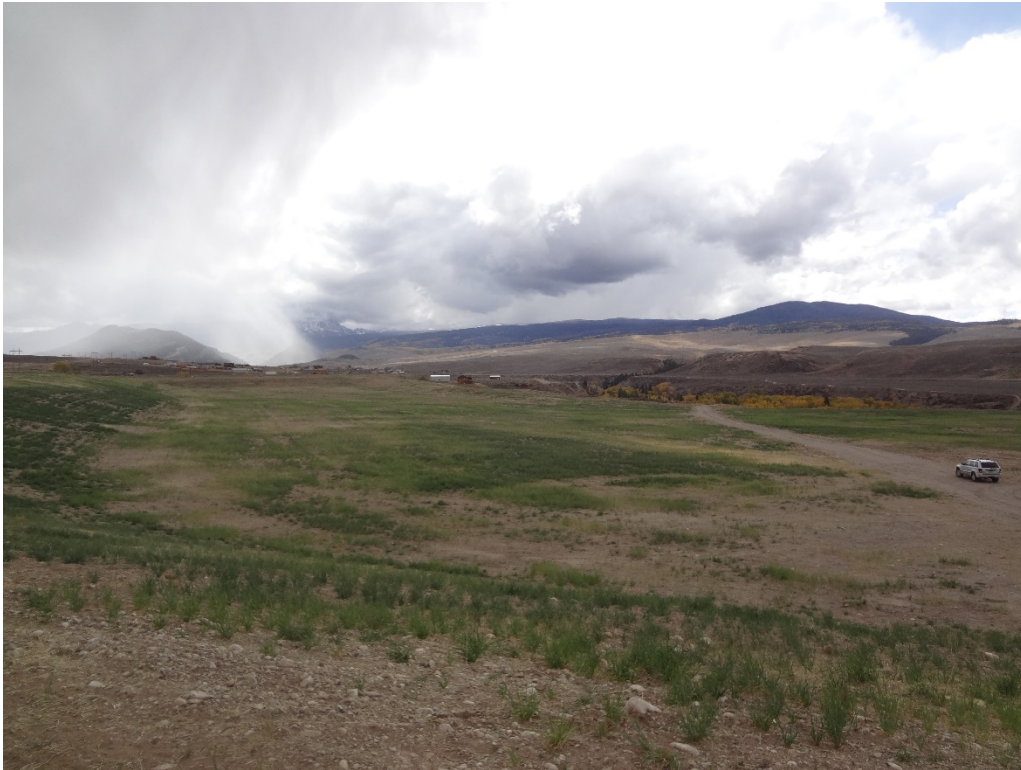
View from the northeast corner of the site looking southwest

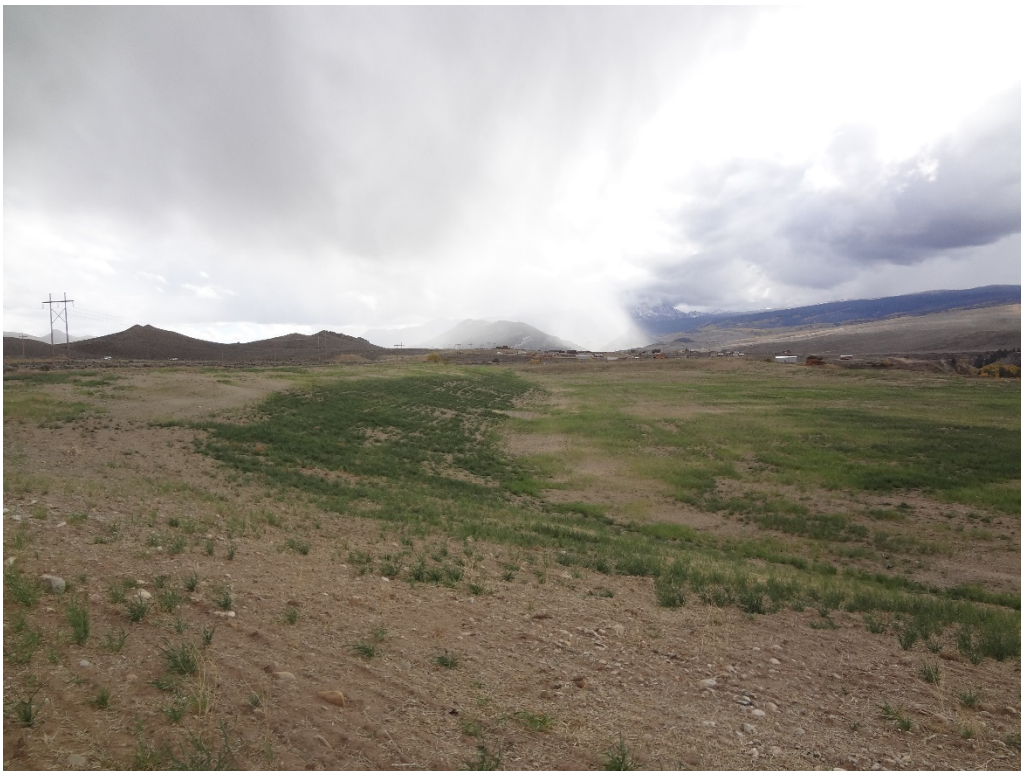
View from the northeast corner of the site looking south

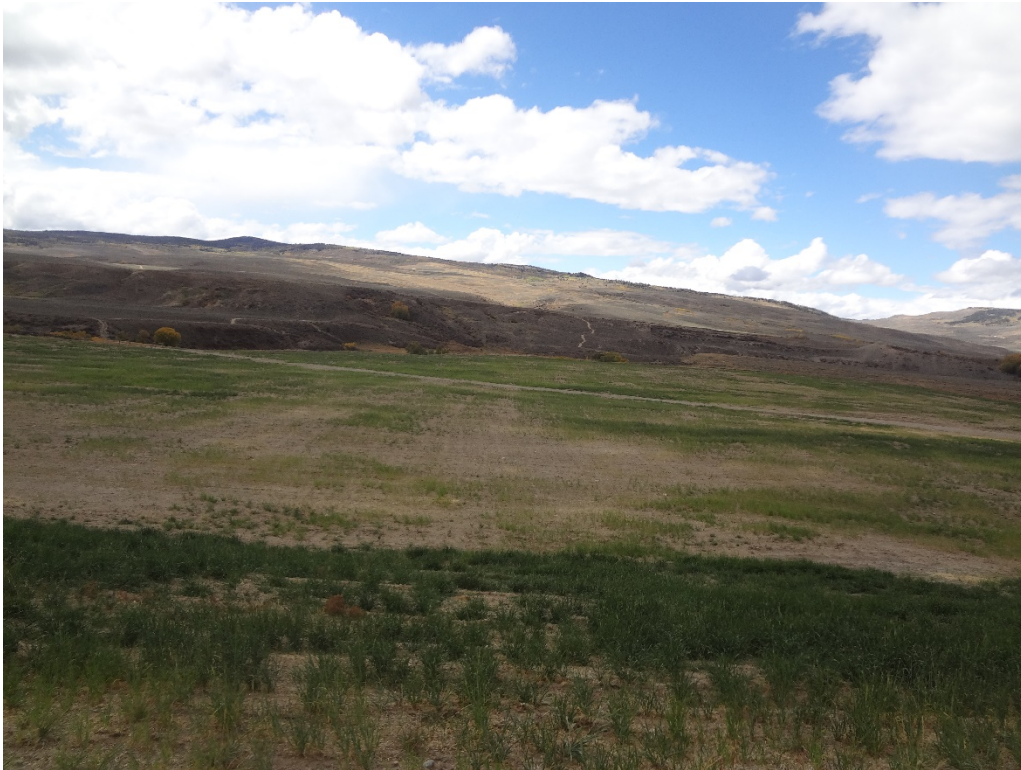
View from the east side of the site looking west

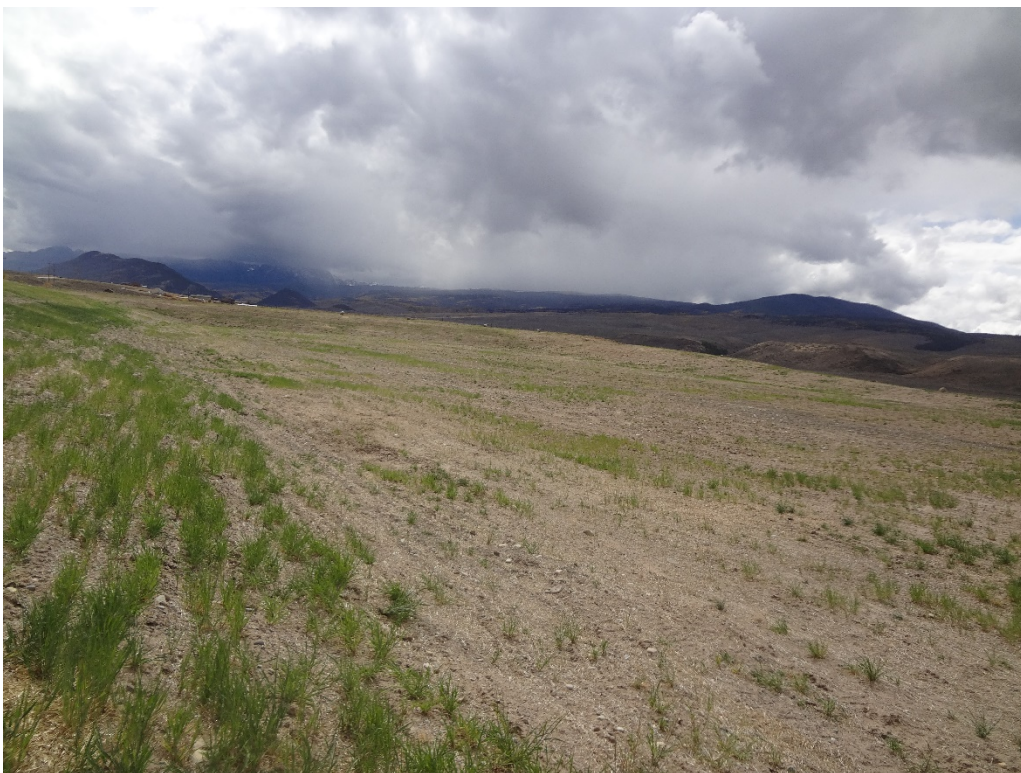
View from the east side of the site looking southwest

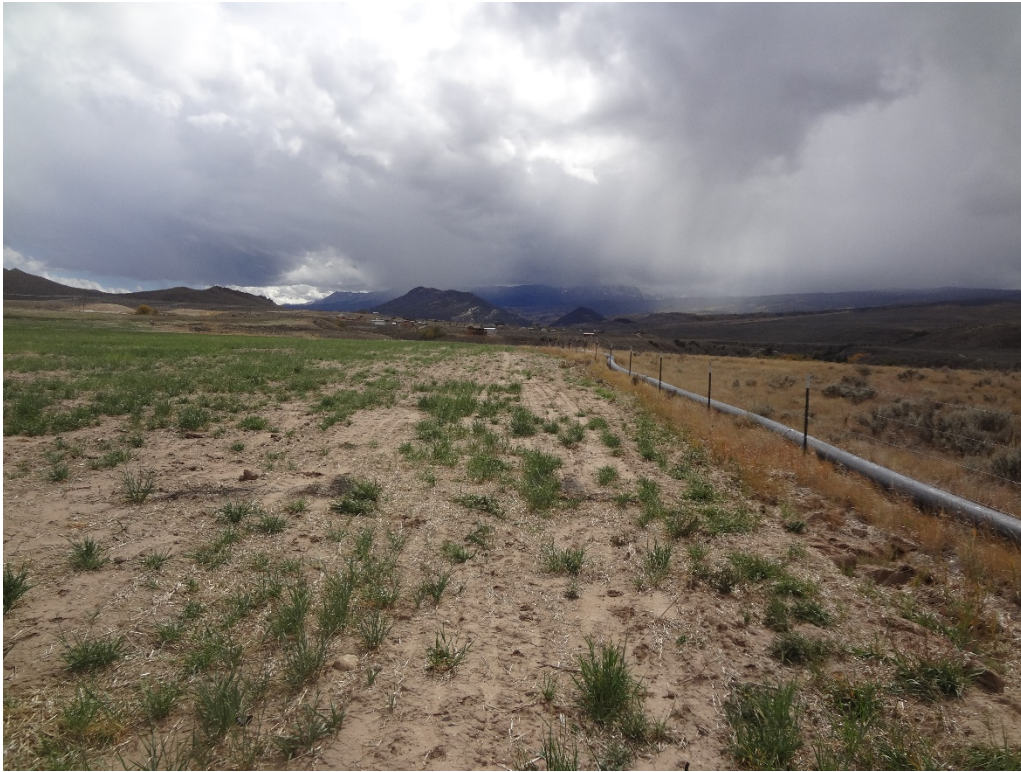
View from northwest corner of the site looking south

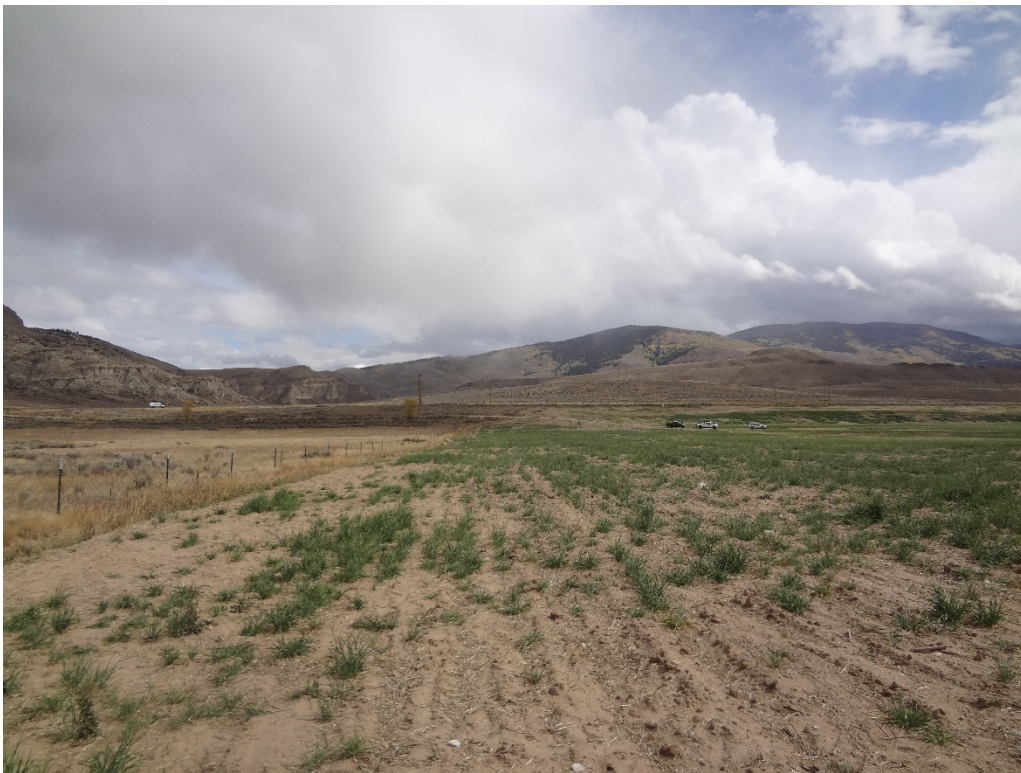
View from northwest corner of the site looking east
