## MINERALS PROGRAM INSPECTION REPORT

<b>MINE NAME:</b> The Rise Above	<b>MINE/PROSPECTING ID#:</b> M-2014-054	<b>MINERAL:</b> Gemstones	<b>COUNTY:</b> El Paso
<b>INSPECTION TYPE:</b> Monitoring	<b>INSPECTOR(S):</b> Timothy A. Cazier	<b>INSP. DATE:</b> September 21, 2017	<b>INSP. TIME:</b> 13:00
<b>OPERATOR:</b> Amanda Adkins Anderson & Travis Anderson	<b>OPERATOR REPRESENTATIVE:</b> Amanda Adkins	<b>TYPE OF OPERATION:</b> 110(2) - Hard Rock Limited Impact

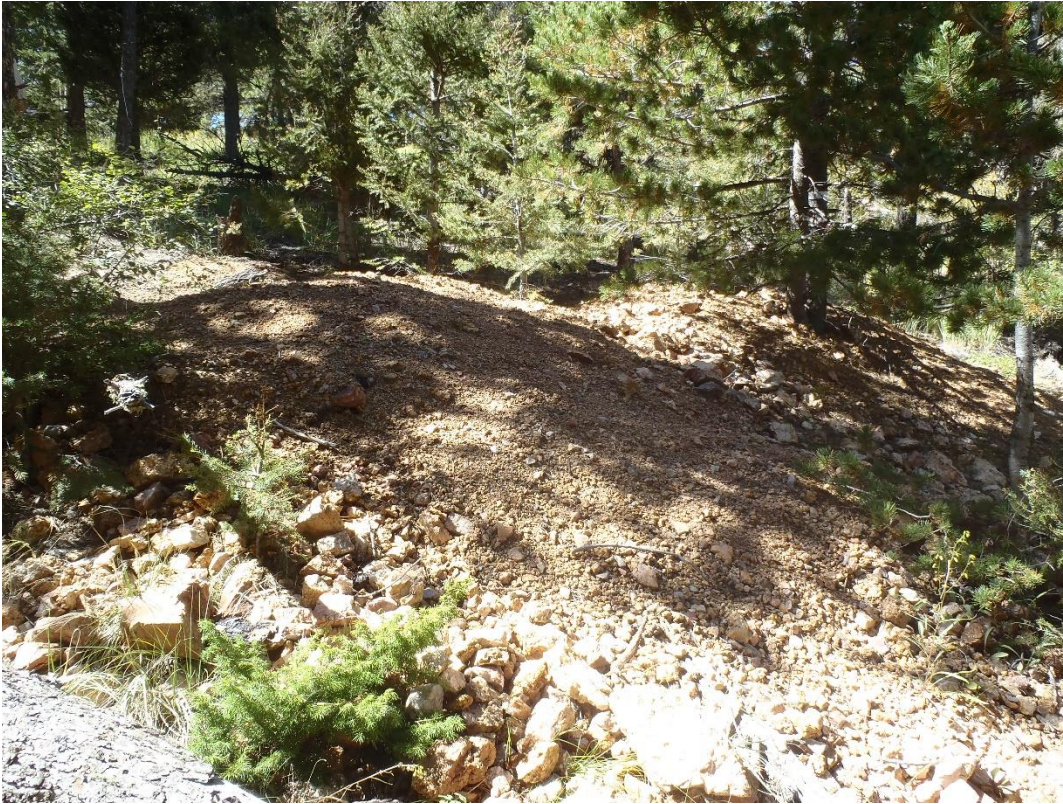
Excess Spoil and Dev. Waste: Overburden/spoil piles were generally on the downgradient side of the dig sites (see **Photo 1**). Generally speaking, it is better to have the spoil piles on the uphill side of the dig so eroded material does not get washed off site, but rather into the pit for containment. However, given the coarse nature of the spoil material and the relatively flat terrain, not downhill erosion was observed.

Photo 1. Overburden/spoil piles downgradient side of dig site (looking north).

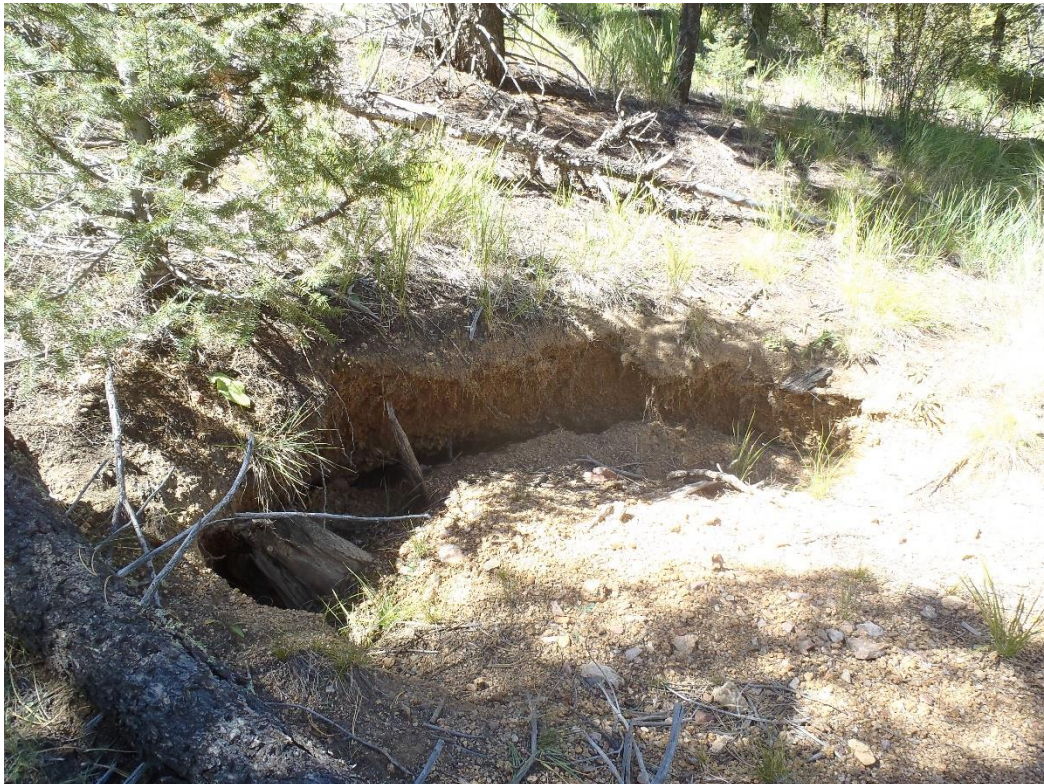
Reclamation Success: Two dig sites were identified as being in reclamation (Shrew Pocket and the unnamed dig site). Ms. Adkins explained her reclamation process involves backfilling most of the dig (see **Photo 2**), then allows this backfill to settle (typically for one season), then placing the coarser rock on top followed by topsoil, then seeding. She has also transplanted some trees (see **Photo 3**). Given that no mechanized equipment is allowed in the area, the DRMS concedes this approach is acceptable. Mr. Hovermale indicated dividing bunch grass and transplanting portions would be acceptable as well.

Photo 2. Backfilled Shrew Pit, awaiting settling (looking north).

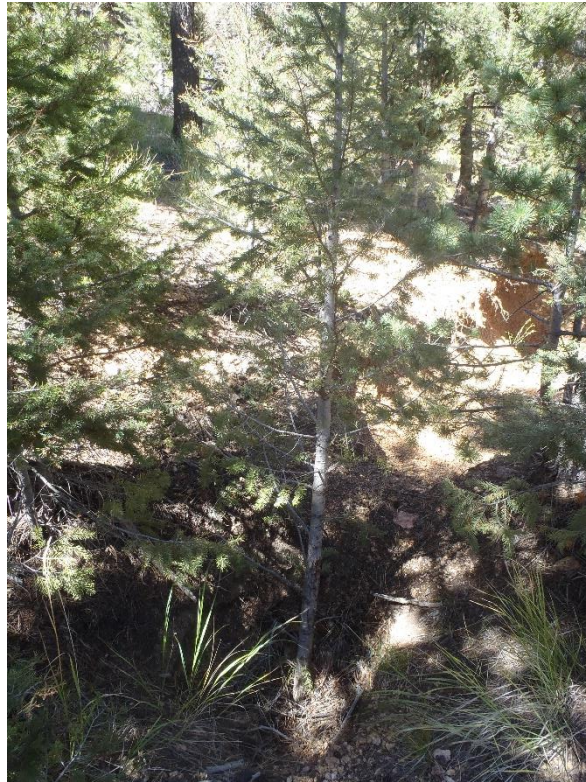
Photo 3. Transplanted tree (unnamed dig site) Permit sign.

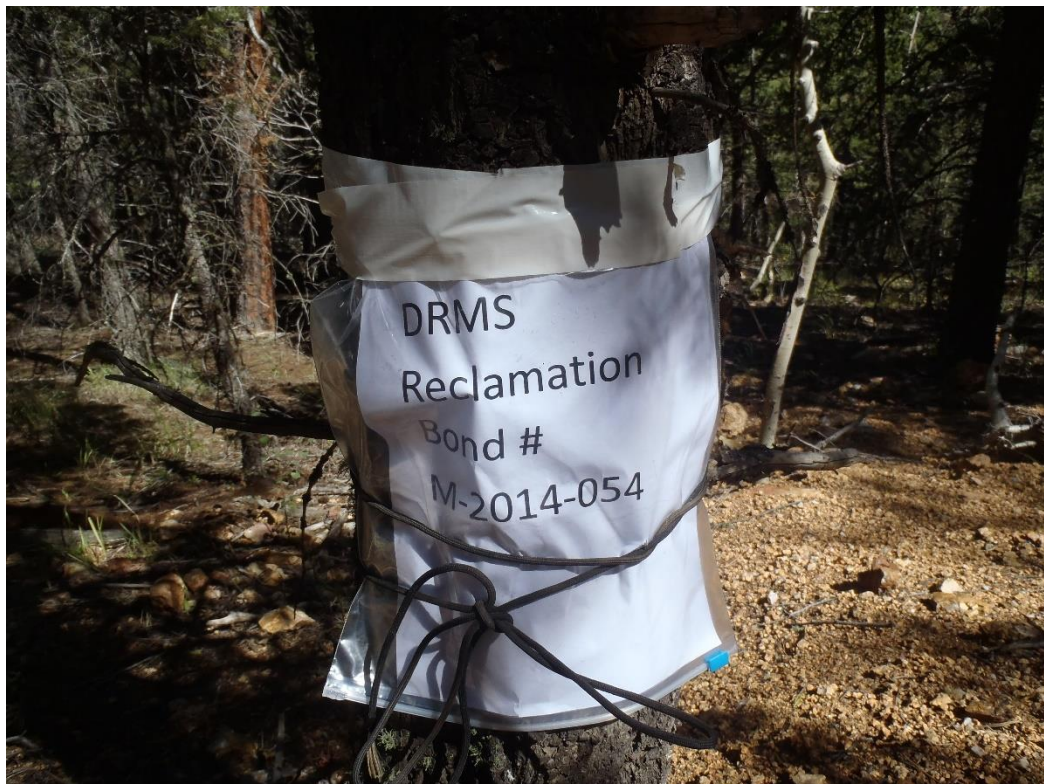
Signs and Markers: A permit sign was posted at each of the two active dig sites (see **Photos 4 and 5**). As mentioned above, more boundary markers would be helpful around both the active sites and those in reclamation.

Photo 4. Permit sign (North Pocket).

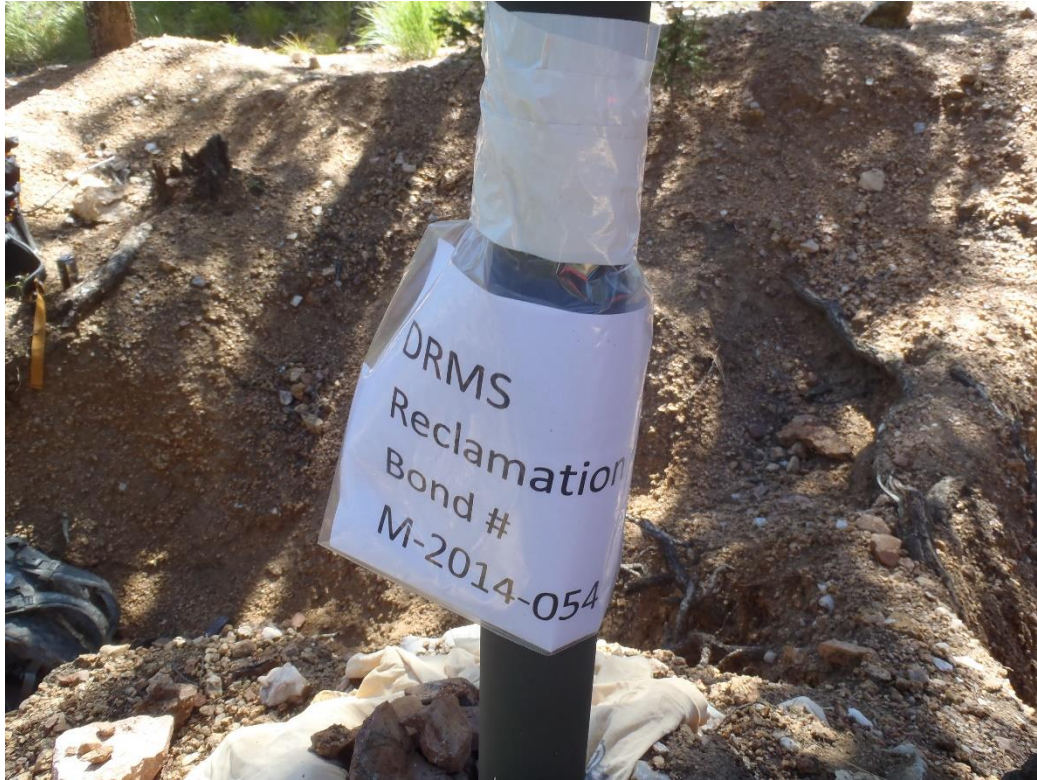
Photo 5. Permit sign (Short Cut Pit).

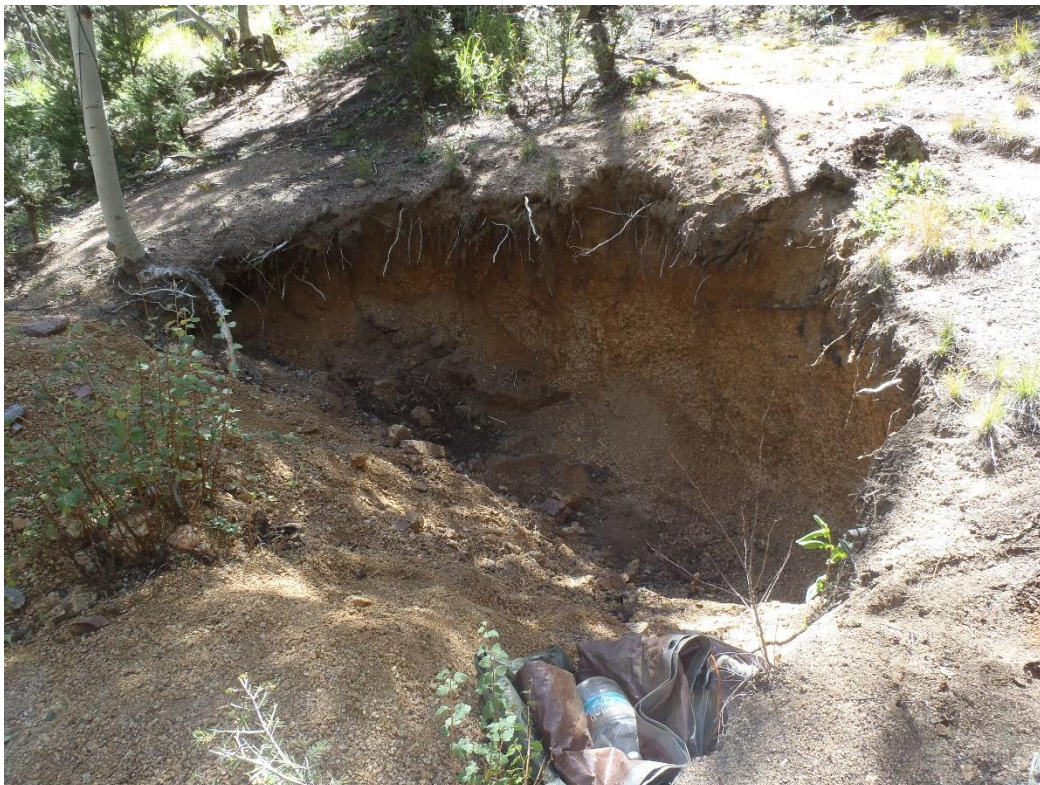
Photo 6. Active dig site (North Pocket).

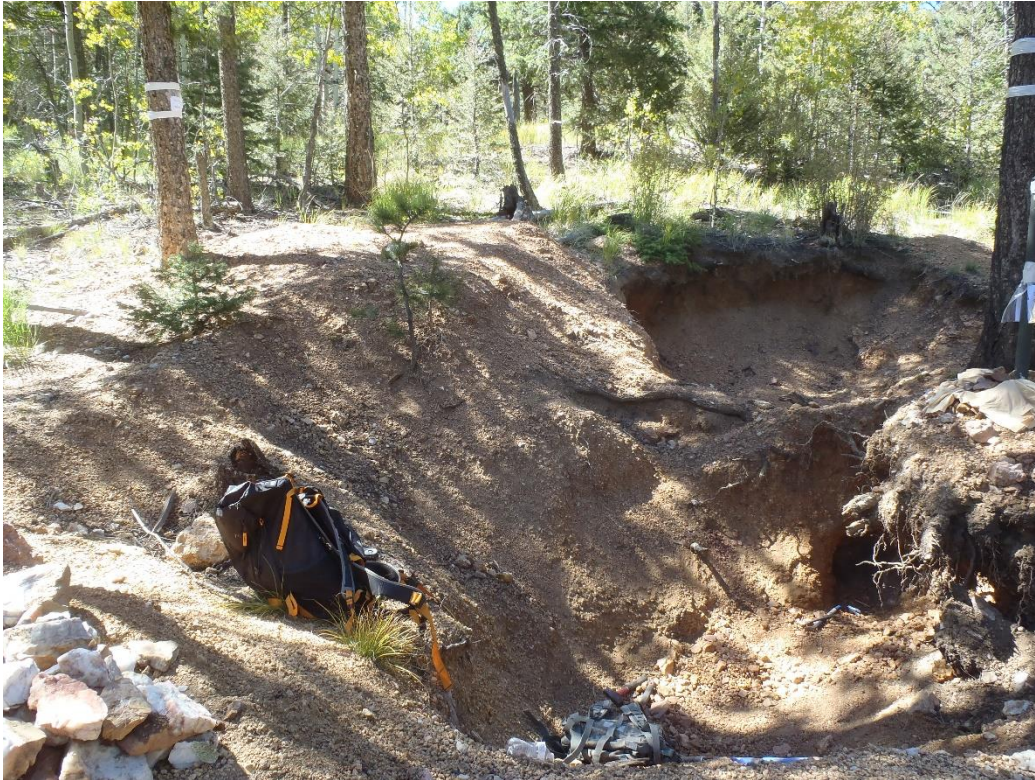
Photo 7. Active dig site (Short Cut Pit).
