**MINERALS PROGRAM INSPECTION REPORT**  
**PHONE: (303) 866-3567**

<b>MINE NAME:</b> Hobo Mine	<b>MINE/PROSPECTING ID#:</b> M-2017-044	<b>MINERAL:</b> UNK	<b>COUNTY:</b> San Juan
<b>INSPECTION TYPE:</b> Illegal(Unpermitted Operation)	<b>INSPECTOR(S):</b> Lucas J. West	<b>INSP. DATE:</b> September 18, 2017	<b>INSP. TIME:</b> 13:39
<b>OPERATOR:</b> Keith McFarland	<b>OPERATOR REPRESENTATIVE:</b> Keith McFarland	<b>TYPE OF OPERATION:</b> ILL - Illegal	
<b>REASON FOR INSPECTION:</b> Citizen Complaint	<b>BOND CALCULATION TYPE:</b> None	<b>BOND AMOUNT:</b> No Bond Held	
<b>DATE OF COMPLAINT:</b> NA	<b>POST INSP. CONTACTS:</b> None	<b>JOINT INSP. AGENCY:</b> None	
<b>WEATHER:</b> Clear	<b>INSPECTOR'S SIGNATURE:</b>

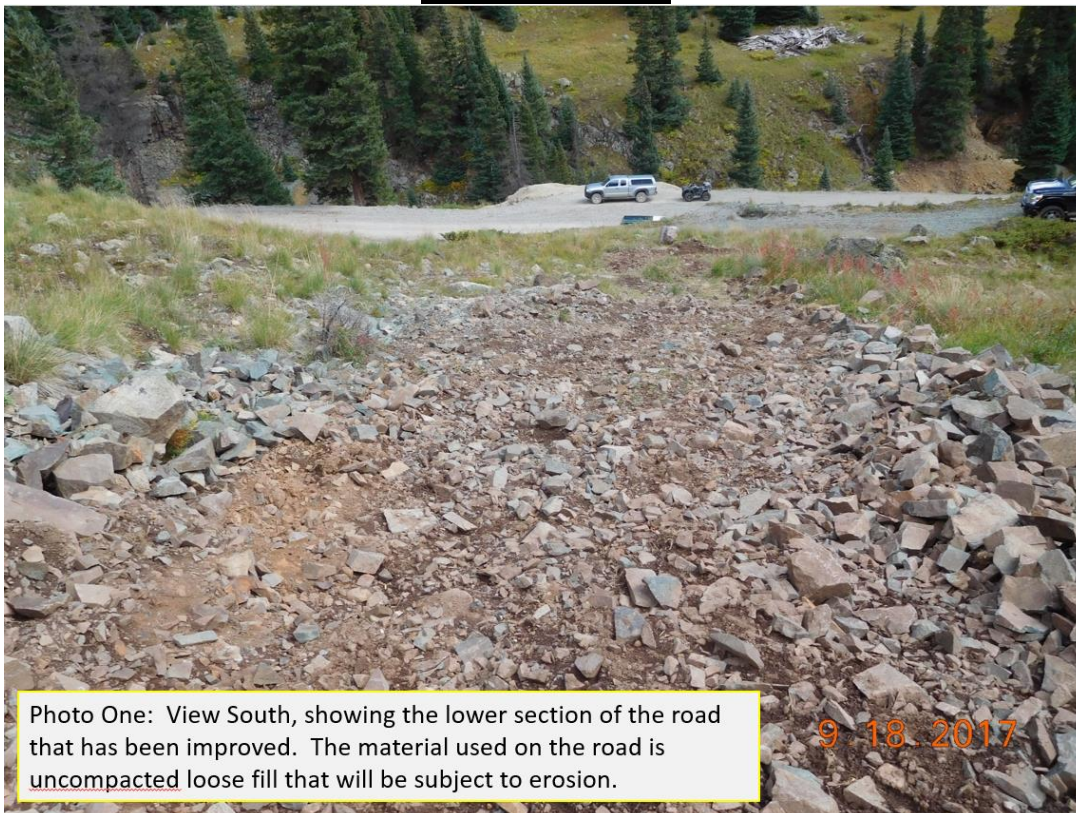
A file number was created for the site, as the site is not currently a permitted operation. The site was named the Hobo Mine and given file number M-2017-044. Along with the inspector listed on page one of this report, Keith McFarland, Operator, who conducted the work, as well as Lisa Richardson of the Bureau of Land Management were present during the inspection. The work was conducted on a historic road, leading to a historic portal just above County Road 2. The road and portal are adjacent to an area known as the Toltec Tunnel which is associated with, but not part of the permitted area for another permitted mine site. The road and portal were observed in 2015 when no recent disturbance was present. In the recent months the road has undergone major road improvements to allow vehicles and equipment to access the portal. The road has been graded and in some areas it appears to have been widened. No storm water control measures of any kind were installed along the road to prevent erosion. The road totals approximately 612 Linear Feet and is constructed to angular, un-compacted material that appears to have been sourced on site. Photos One and Two show the road with its improvements. The activities appear to have destabilized the hill side by exposing a 18-24 inch unsupported drop between the native hillslope and the base of the road. This is a concern as the un-supported drop will likely develop more severe erosional issues than what was already observed and cause head-cutting of the hillslope.

Photo One: View South, showing the lower section of the road that has been improved. The material used on the road is uncompacted loose fill that will be subject to erosion.

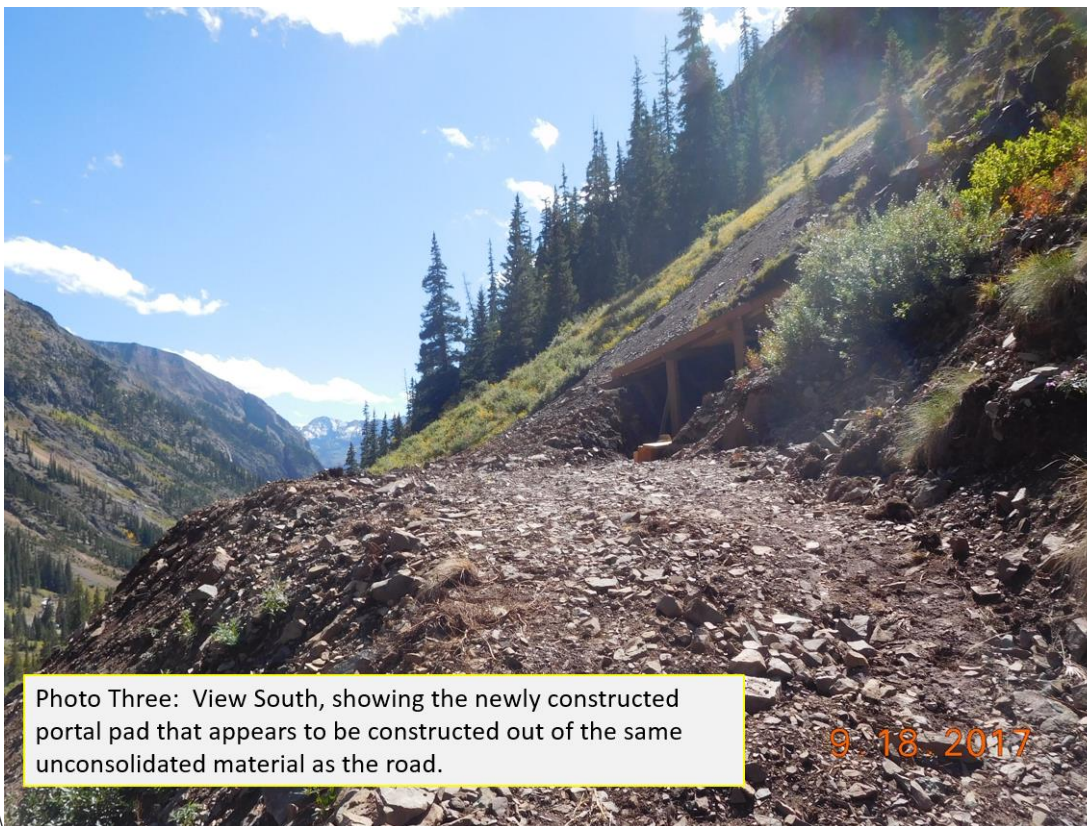
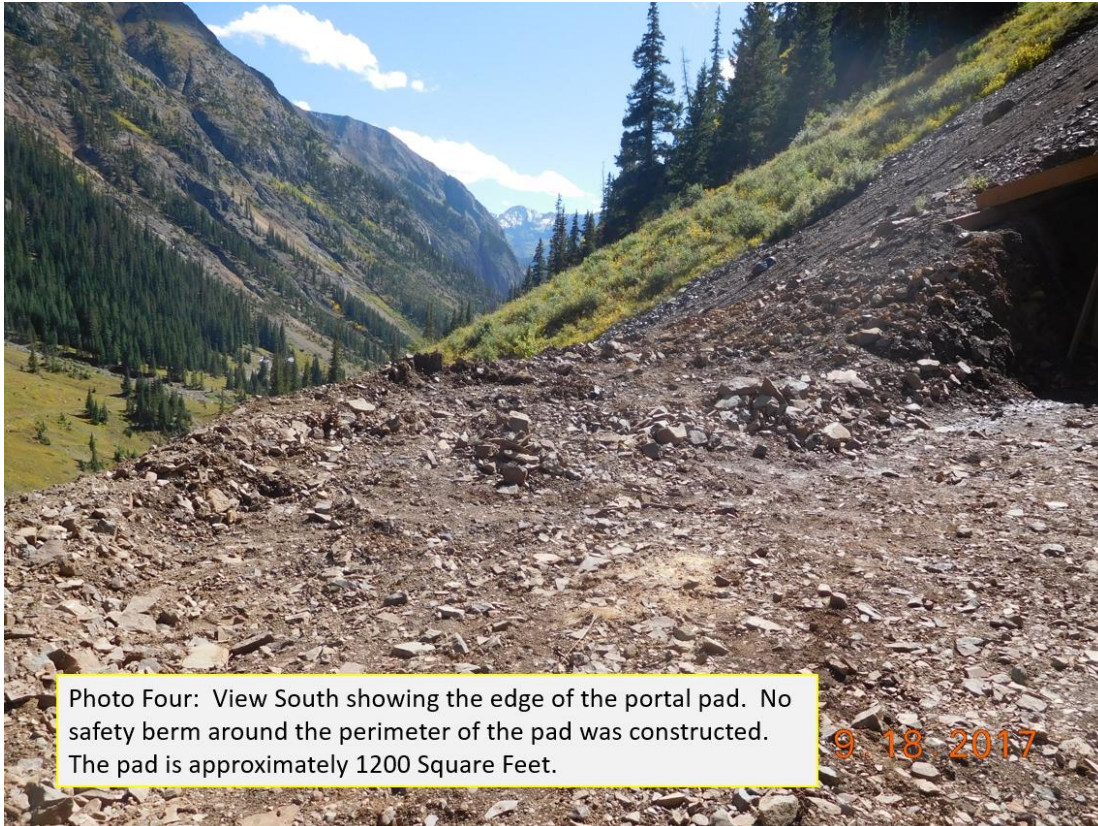
At the top of the road, the portal was excavated and opened for access, a portal pad was constructed and a timber framed portal structure was installed to prevent degradation of the portal itself. The portal pad is approximately 1200 Square feet with no safety berm around its perimeter. Photos Three and Four show the newly constructed portal pad. Evidence observed indicate that some of the material was pushed over the edge of the pad, and allowed to fall down the slope. The material fell and estimated 30 feet down the hill and resulted in an approximate 1.5H: 1V slope. Photo Five shows the newly excavated material that has been pushed over the edge of the portal pad. The timber framed portal structure consists of 2 x 6 inch framing supported by native rock outcrops and two 6 x 6 inch posts. The 6 x 6 inch posts are approximately 6-8 feet away from the exposed portal opening. The two posts are roughly 12 and 14 feet tall supporting the roof framing is approximately 16-18 feet across. The roof of the structure is sheeted with plywood, and evidence observed during a follow up inspection conducted by the BLM showed evidence of waterproofing and staged corrugated tin to complete the roof of the structure. Discussions with the Operator indicate that he was having custom steel gates fabricated by a shop in town, and the gates will be installed between the two 6 x 6 posts upon their completion. The Operator also indicated that once the gates were installed, the void space between the timbers and the rock outcropping would be back filled to prevent unauthorized access. Photo Six shows the framed structure.

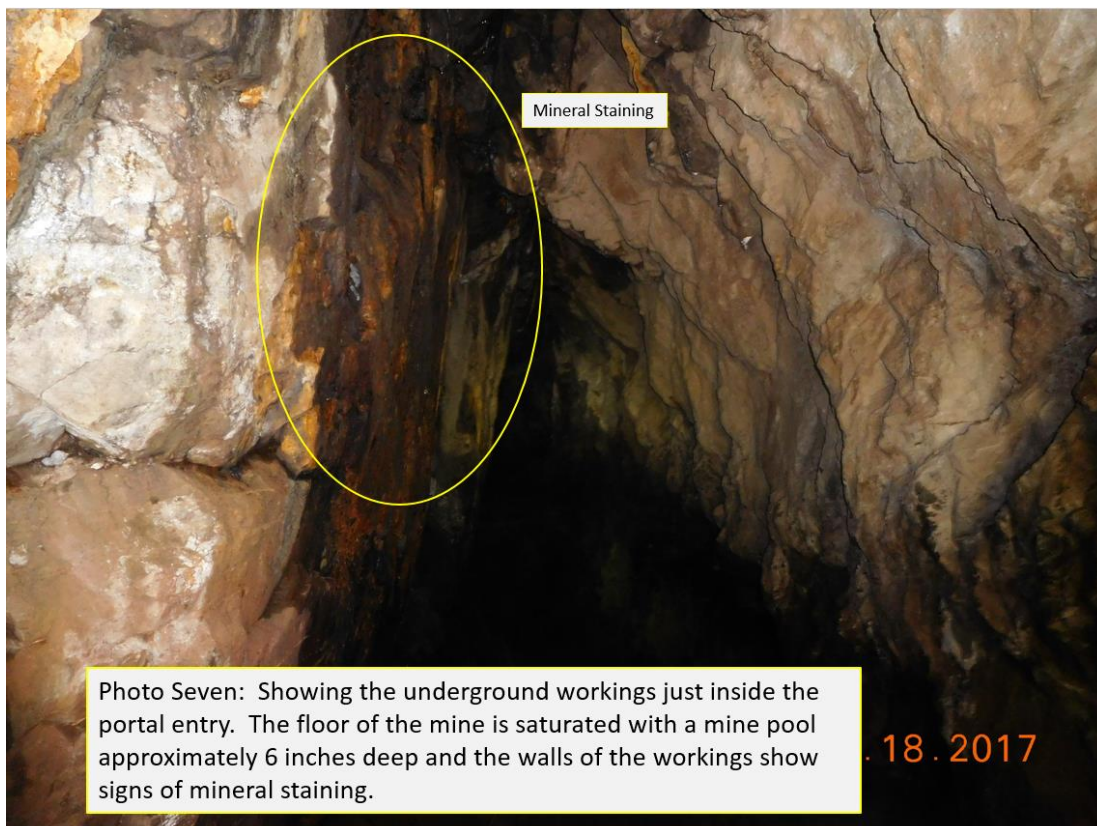
entering the underground workings along the walls of the mine. The water is of an unknown quality at this time. However mineral staining and deposition along the walls and floor of the mine indicate that the site has acid producing potential. Photo Seven shows the underground workings just inside the portal with mineral staining along the walls of the workings. The flow was not discharging from the portal at the time of the inspection. A discharge is reasonably anticipated during the snowmelt season of next spring. Due to the unknown quality of the water a discharge of any kind is a significant concern for the Division. No control measures such as drainage ditches or retention ponds were observed to control any anticipated flow from the portal.
