**MINERALS PROGRAM INSPECTION REPORT**  
**PHONE: (303) 866-3567**

<b>MINE NAME:</b> CM-25 Mine	<b>MINE/PROSPECTING ID#:</b> M-1977-307	<b>MINERAL:</b> Uranium and vanadium	<b>COUNTY:</b> Montrose
<b>INSPECTION TYPE:</b> Monitoring	<b>INSPECTOR(S):</b> Dustin M. Czaplá	<b>INSP. DATE:</b> September 12, 2017	<b>INSP. TIME:</b> 12:30
<b>OPERATOR:</b> Cotter Corporation	<b>OPERATOR REPRESENTATIVE:</b> Gus Gaviotis	<b>TYPE OF OPERATION:</b> 110d - Designated Limited Impact	
<b>REASON FOR INSPECTION:</b> Normal I&E Program	<b>BOND CALCULATION TYPE:</b> None	<b>BOND AMOUNT:</b> \$100.00	
<b>DATE OF COMPLAINT:</b> NA	<b>POST INSP. CONTACTS:</b> None	<b>JOINT INSP. AGENCY:</b> U.S. Energy	
<b>WEATHER:</b> Clear	<b>INSPECTOR'S SIGNATURE:</b>

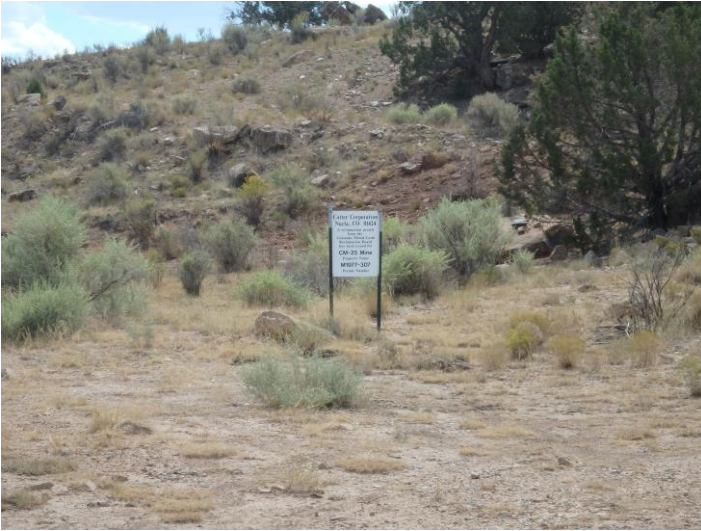
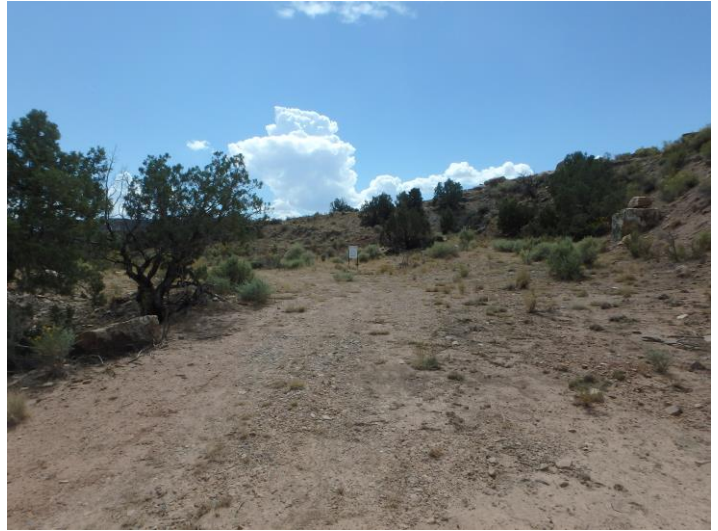
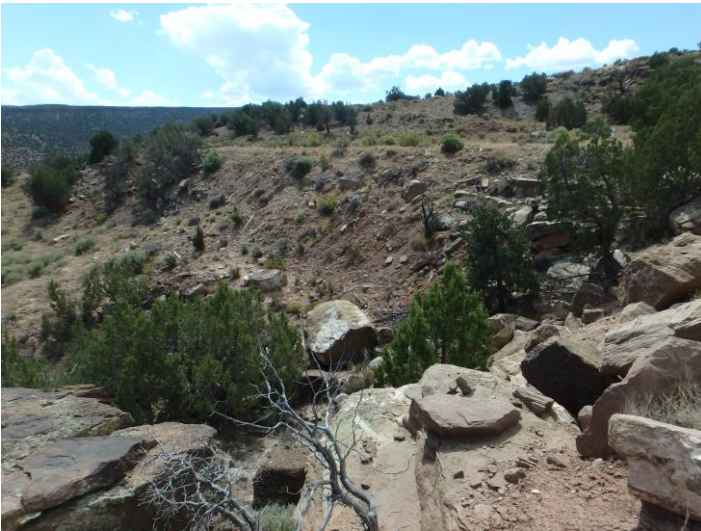
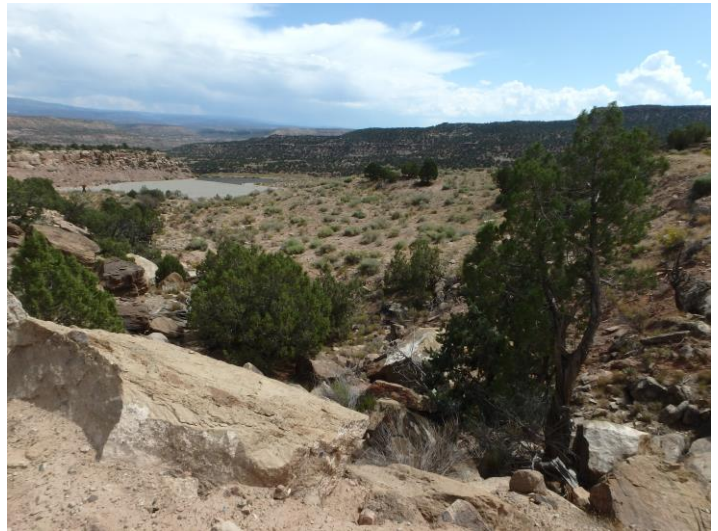
According to the operator's annual reports, final reclamation was completed at this site in February, 2003. All reclaimed slopes appeared stable and vegetation is well established over the reclaimed areas.
