MINERALS PROGRAM INSPECTION REPORT PHONE: (303) 866-3567

MINE NAME:		MINE/PROSPECTING ID#:	MINERAL:	COUNTY:	
Blue Star #1		M-2014-030	Gemstones	Chaffee	
INSPECTION TYPE:		INSPECTOR(S):	INSP. DATE:	INSP. TIME:	
Monitoring		Dustin Czapla, Michael Cunningham	September 5, 2017	15:00	
OPERATOR:		OPERATOR REPRESENTATIVE:	TYPE OF OPERATION:		
Blue Star Exploration, LLC		None	110(2) - Hard Rock Limited Impact		
REASON FOR INSPECTION:		BOND CALCULATION TYPE:	BOND AMOUNT:		
Normal I&E Program		Complete Bond	\$4,880.00		
DATE OF COMPLAINT:		POST INSP. CONTACTS:	JOINT INSP. AGENCY:		
NA		None	None		
WEATHER:	INSPECTOR'S SIGNATURE:		SIGNATURE DATE:		
Clear	R		September 11, 2017

PERMIT #: M-2014-030 INSPECTOR'S INITIALS: DMC INSPECTION DATE: September 5, 2017

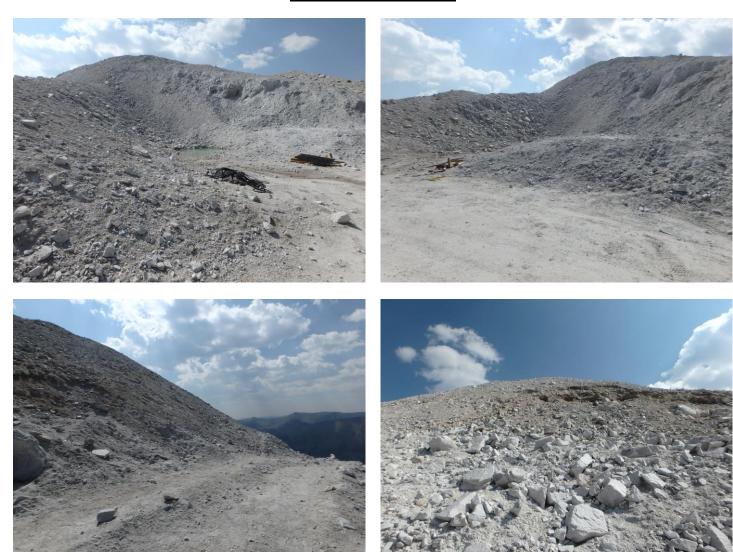
Adequate mine identification signage or boundary markers were not noted. However, it appears mining has ceased at the site and final reclamation is underway, therefore the sign and markers are not considered a problem at this time. The dig area on the west side of the disturbance has been mostly pulled back and made to blend with the surrounding topography. In the screening area the operator has left a roll of hose, a metal grate and a pile of lumber. The operator will need to remove these items prior to release.
