PERMIT INFORMATION

Permit Number: C-1981-013 Mine Name: Golden Eagle Mine Operator: New Elk Coal Company, LLC Operator Address: Mr. Louis Head 12250 Highway 12 Weston, CO 81091	County: Las Animas Operation Type: Underground Permit Status: Permanent Cessation Ownership: Private
	Operator Representative Present: Nick Mason, Louis Head
Operator Representative Signature: (Field Issuance Only)

INSPECTION INFORMATION

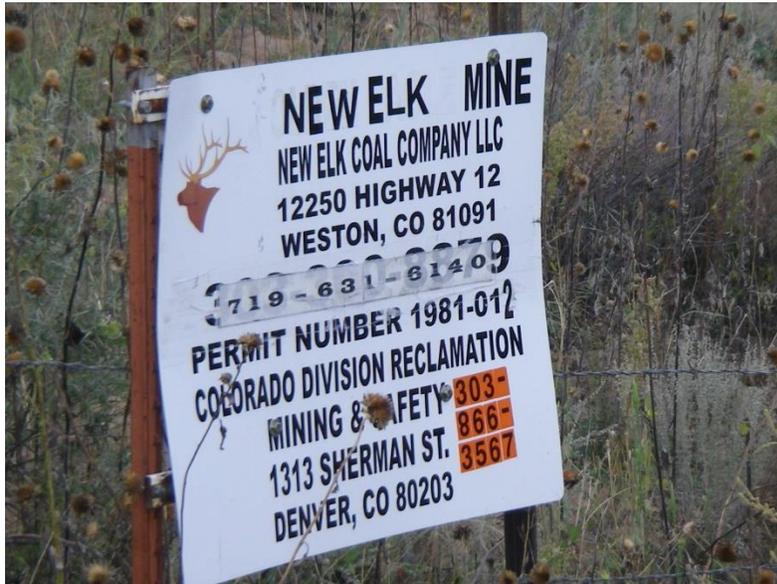
The sign at the entrance has been changed to reflect the fact that the Northwest Airshaft site is now within the New Elk Mine permit.

Entrance sign with information for New Elk Mine

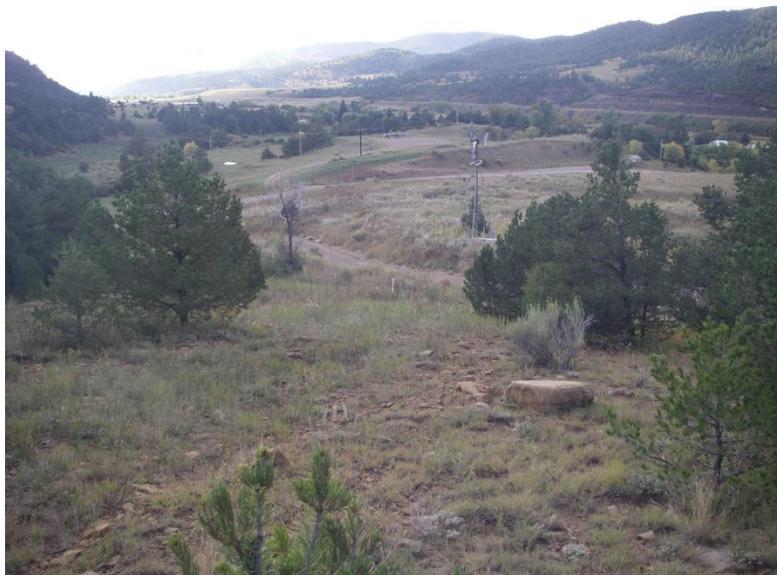
The reclamation appears to be very good at the former pad for the airshaft, and there is decent vegetation cover on the road leading up to the pad (the southeast side of the area). The recently disturbed area (where work was done on the bottom of the upgradient diversion ditch) is recovering well.

Former road up to pad site

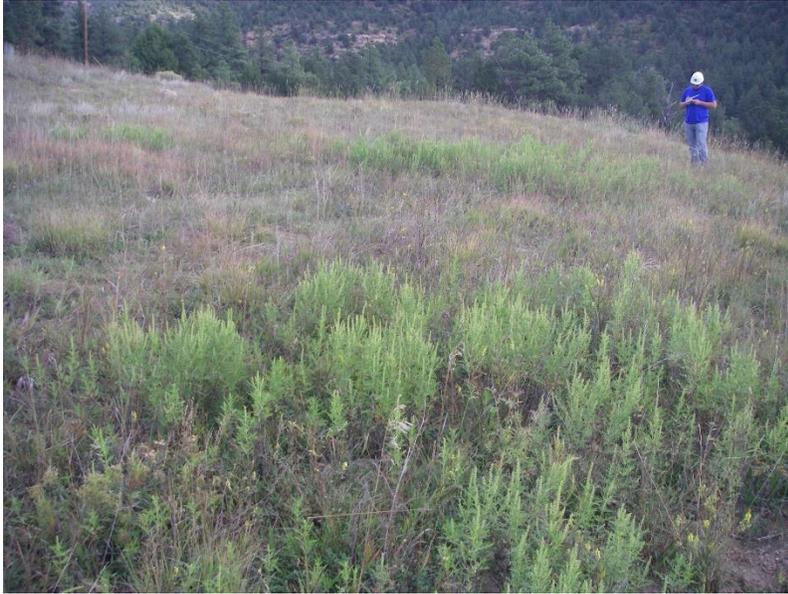
Former pad site

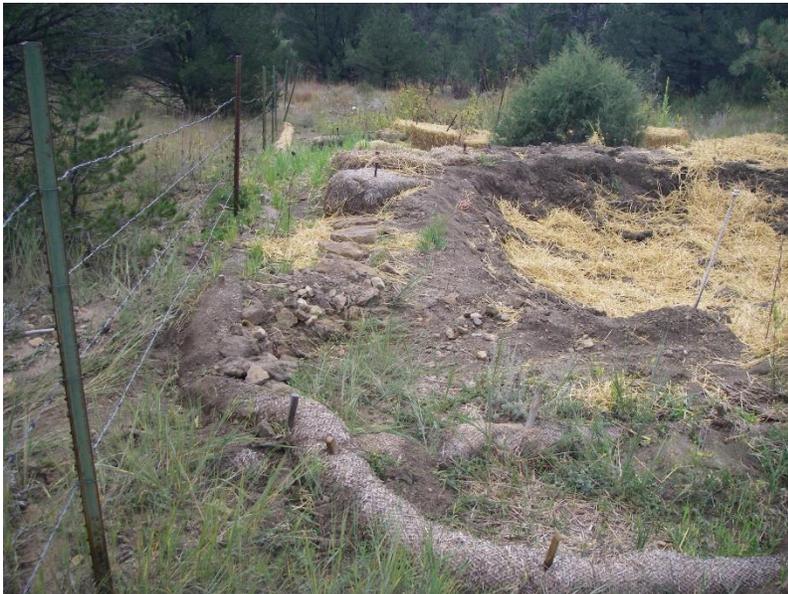
NECC staff have added wattles to the straw bales on the north side of the site. These wattles are intended to divert runoff from the adjacent land away from the NECC site. Where the wattles end (lower end of line of wattles)

Wattles added to north end of site

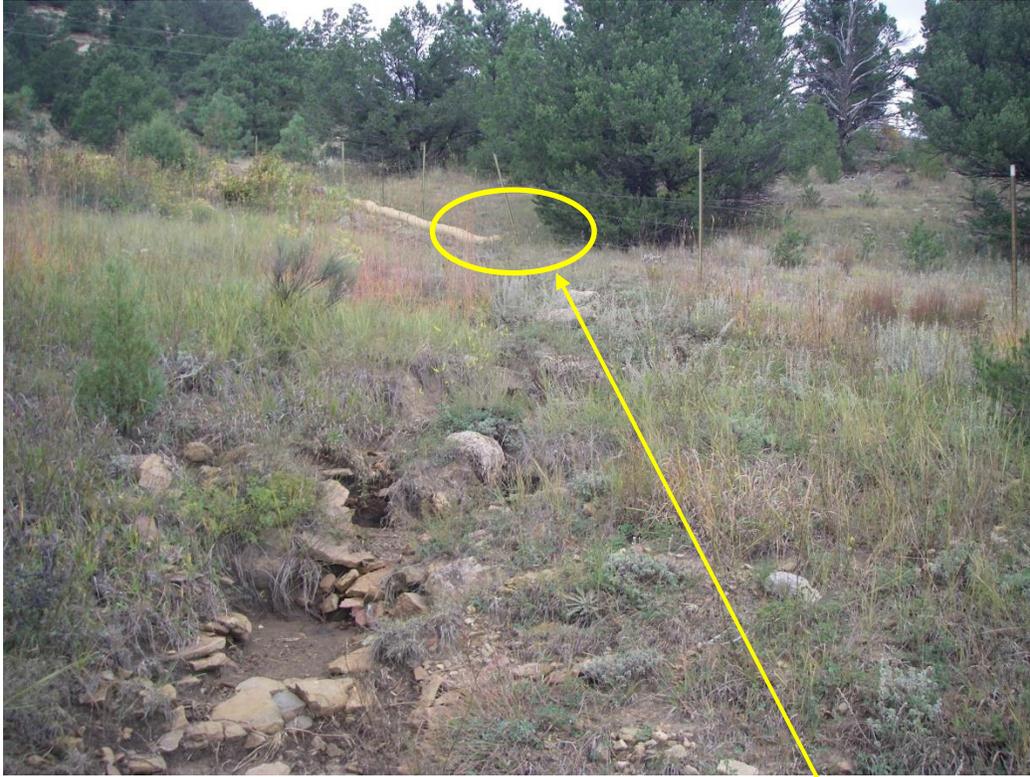
Erosion below the straw bales

End of line of wattles along fence line

needs to be monitored closely to make sure that area does not erode. Below the BMPs, recent rains have caused erosion, and maintenance is recommended (although the rills may heal themselves over time). Branches packed in the rills would be beneficial, and NECC should seed the bare areas.
