**COLORADO**  
Division of Reclamation,  
Mining and Safety  
Department of Natural Resources

<b>Permit Number:</b> C-1981-012 <b>Mine Name:</b> New Elk Mine <b>Operator:</b> New Elk Coal Company, LLC <b>Operator Address:</b> Mr. Louis Head 12250 Highway 12 Weston, CO 81091	<b>County:</b> Las Animas <b>Operation Type:</b> Underground <b>Permit Status:</b> Active <b>Ownership:</b> Private
	<b>Operator Representative Present:</b>  Nick Mason
<b>Operator Representative Signature: (Field Issuance Only)</b>

<b>Inspection Start Date:</b> October 3, 2017 <b>Inspection Start Time:</b> 15:00 <b>Inspection End Date:</b> <b>Inspection End Time:</b>		<b>Inspection Type:</b> Coal Partial Inspection <b>Inspection Reason:</b> Normal I&E Program <b>Weather:</b> Clear	
<b>Joint Inspection Agency:</b>  None		<b>Joint Inspection Contacts:</b>	
<b>Post Inspection Agency:</b>  None		<b>Post Inspection Contacts:</b>	
<b>Inspector(s):</b>  Robert D. Zuber, P.E.	<b>Inspector's Signature:</b>

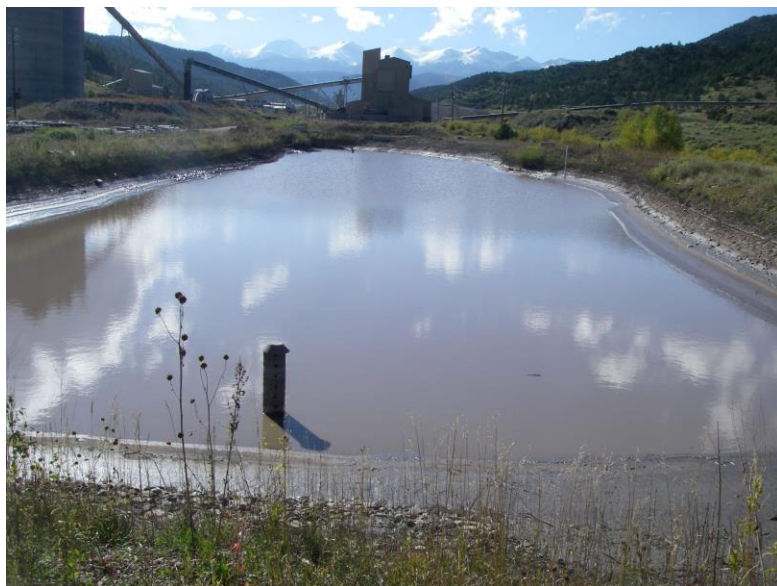
**Pond 007A**

Ponds 004A, 006A, and 007A were inspected. None of them were discharging, but all held significant quantities of water. No significant issues were seen with the pond spillways or embankments.

The impounded water in Pond 007A was below six rows of holes on the primary spillway. Bent vegetation indicated that there had been flow over the emergency spillway on Pond 007A (NECC staff indicated that there have been very large storms in the days before the inspection). There were no signs of problems due to this discharge; the flow appeared to be within the flow path of the spillway, and there was no sign that significant sediment had been transported out of the pond into the willows below.

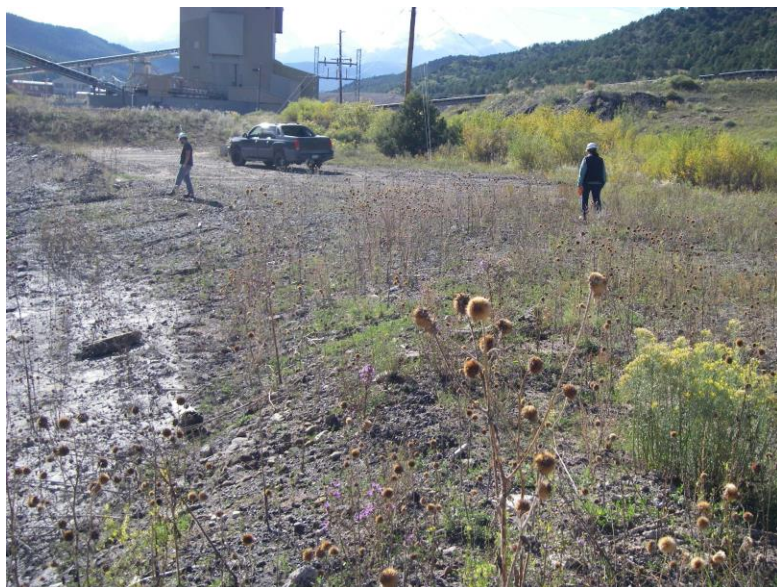
The area near the northwest corner of Pond 007A, which was disturbed when the pond was dredged in recent months, is still mostly bare and may require re-seeding.

**Bare area near northwest corner of Pond 007A**

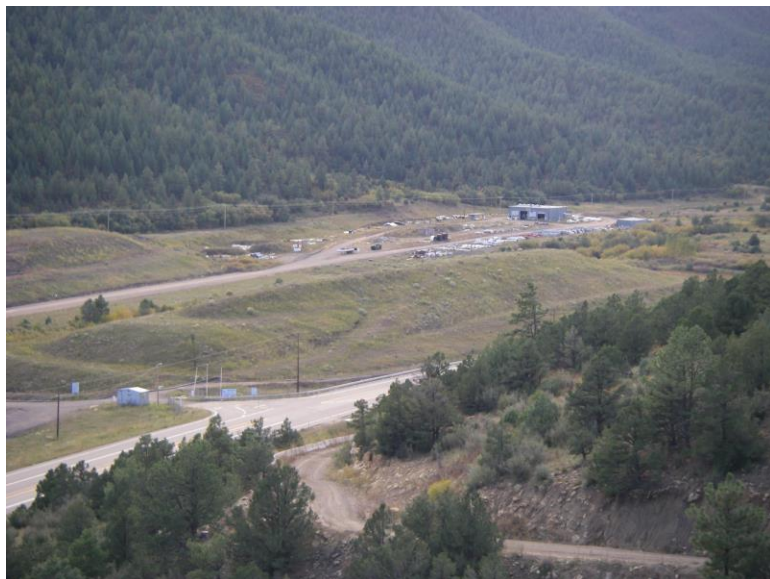
**Development Coal Waste Pile**

The north end of the Development Coal Waste Pile (viewed from afar) looked to be in good shape. No large rills or gullies were seen on the north side of DWDA#2.

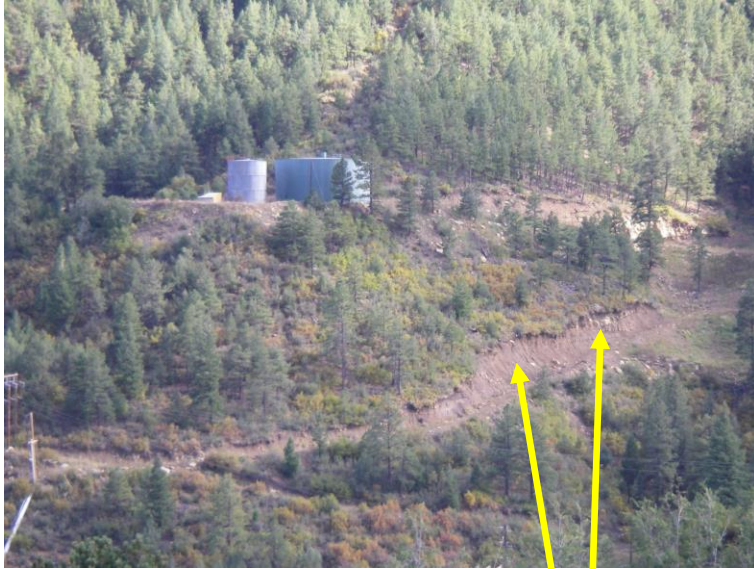
Some of the area above Ditch D26 (the cut slope on the hill above the ditch) may need stabilization (see photograph). This area should be closely monitored, and if the disturbed area moves further up the hill, NECC should address the problem.

The hill immediately below the water tanks was observed from afar, and no erosion or other problems were seen.

**Water tanks and hill above Ditch D26**

*Areas to monitor for further cutting*

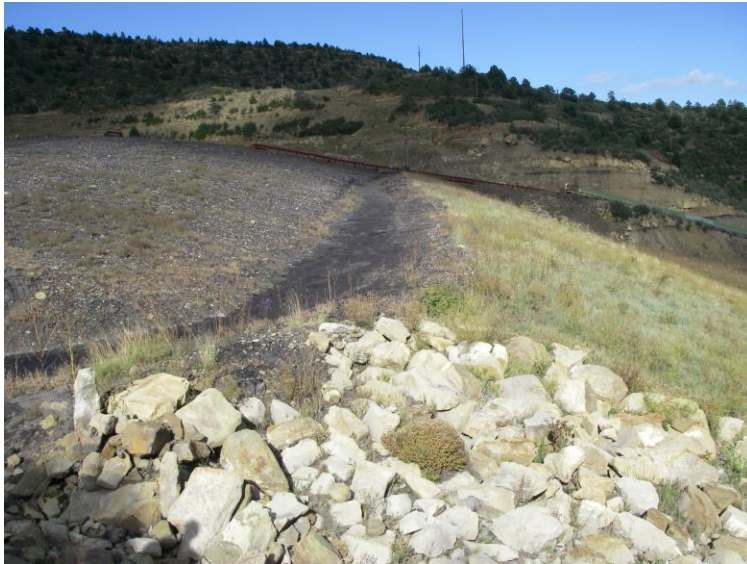
There is good vegetation cover on the reclaimed portion of the RDA, and no rills or gullies were seen on the face or in the side ditches. The ditch at the interface between the reclaimed (lower) and un-reclaimed segments of the RDA appears to be functioning well, and sumps near the interface are not in need of cleaning. No puddles, soft spots, or other problems were seen on the un-reclaimed portion of the RDA. The upper end of the underdrain appears to be clear and functioning.

**RDA – interface between reclaimed area and un-reclaimed area**
