COLORADO
Division of Reclamation,
Mining and Safety
Department of Natural Resources

Permit Number: C-1996-084 Mine Name: Lorencito Canyon Mine Operator: New Elk Coal Company, LLC Operator Address: Mr. Louis Head 12250 Highway 12 Weston, CO 81091	County: Las Animas Operation Type: Surface Permit Status: Permanent Cessation Ownership: Private
	Operator Representative Present: Ron Thompson, Nick Mason
Operator Representative Signature: (Field Issuance Only)

Inspection Start Date: October 3, 2017 Inspection Start Time: 12:00 Inspection End Date: Inspection End Time:	Inspection Type: Coal Partial Inspection Inspection Reason: Normal I&E Program Weather: Clear
Joint Inspection Agency: None	Joint Inspection Contacts:
Post Inspection Agency: None	Post Inspection Contacts:
Inspector(s): Robert D. Zuber, P.E.	Inspector's Signature: <i>Robert D. Zuber</i> Signature Date: 10/10/2017

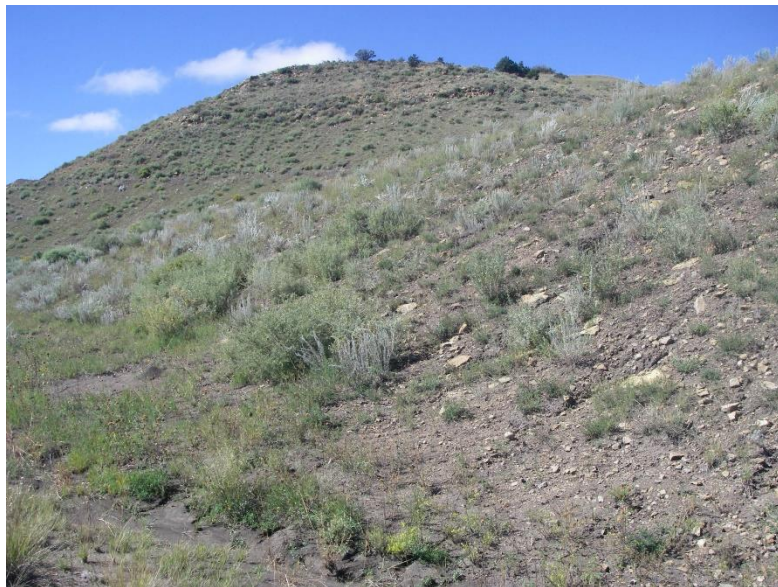
The inspection began at the road above (north) of Fill 9. This area is depicted as Fill 9A on the 2008 ARR map. This slope previously had significant rilling and thin vegetative cover. The vegetative cover was in very good condition during this inspection, visually dominated by winterfat, alfalfa, and fourwing saltbush, along with perennial wheatgrasses. This area has healed nicely and visually has established diverse vegetation.

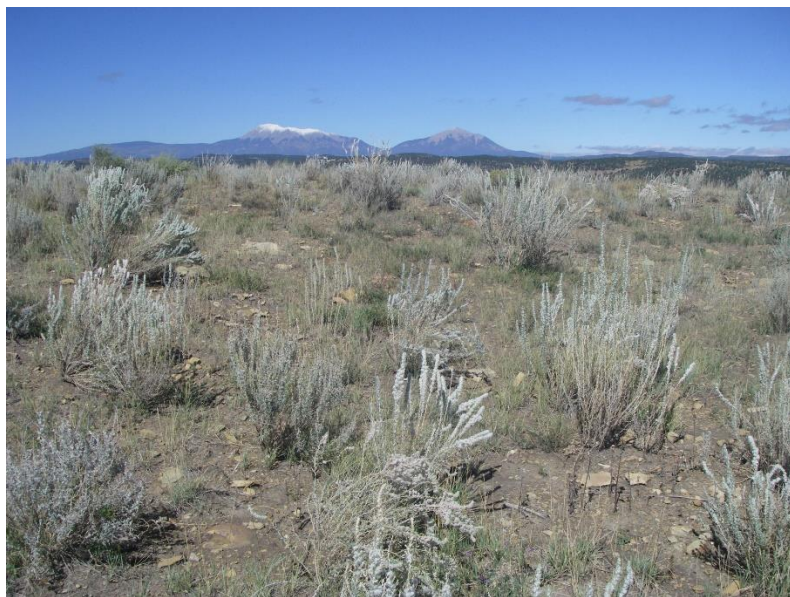
Parcel N-1 is flatter and has shallow puddles from the recent rain storms. Vegetative cover on the flat portion of this parcel is a little thin, but still well-established.

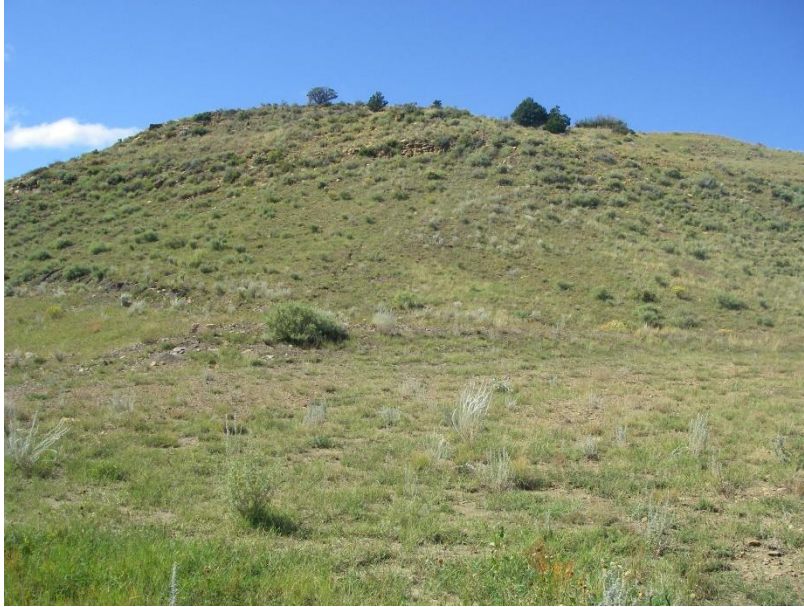
East side of “the knob”

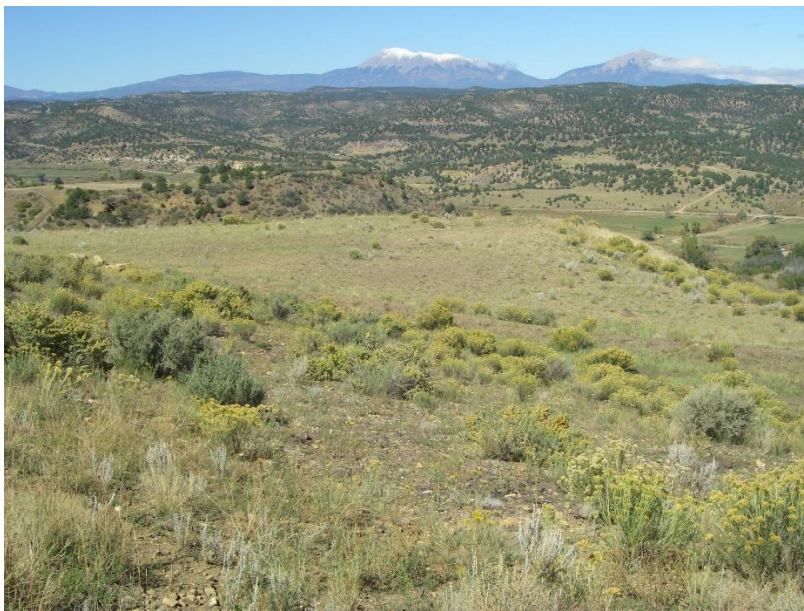
Parcel N-3 contains a relatively flat bench north of ditch D-9. This parcel is heavily used by wildlife (elk) and is heavily trampled and browsed. As a result, the vegetative cover is thin in this area. However, there are no erosional features initiating from this parcel.

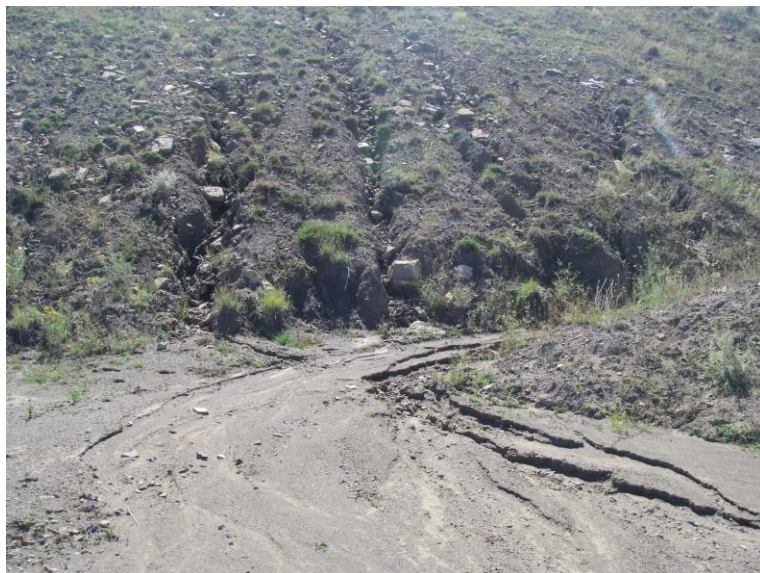
The north-facing slope of the knob, Parcel N-2 south of ditch D-9, was well vegetated and stable. Few forbs were visible on this steep slope, but well established grasses (western and intermediate wheatgrasses and Russian wildrye) and woody species exhibited a healthy, stable stand. Noxious weeds were not observed on this location. The northwest “corner” of the knob, still within parcel N-2, continues to contribute sediment to Ditch D-9. The lower portion of this northwest facing slope continues to exhibit rilling and bare conditions.

Rills at northwest “corner” of knob, which contribute sediment to D9

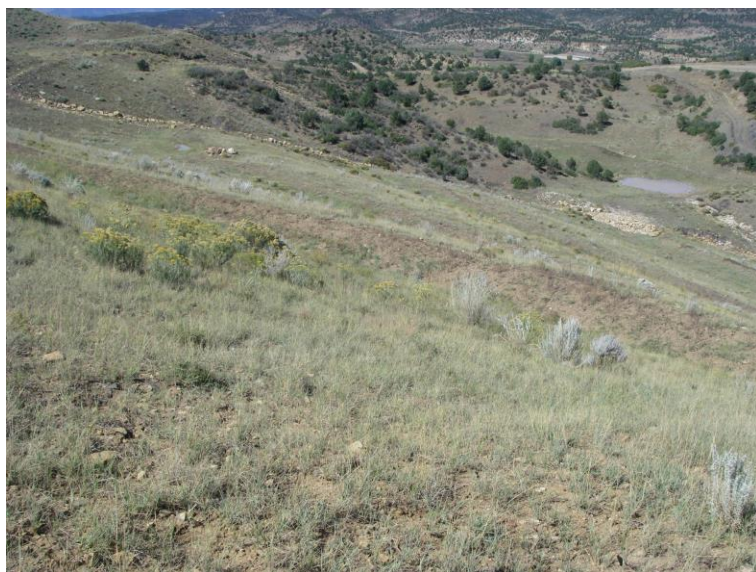
The north face of Fill 8 continues to have a healthy, stable stand of grass-dominated vegetation. No gullies were observed on the face of this fill. Few woody plants or forb species were observed on this slope.

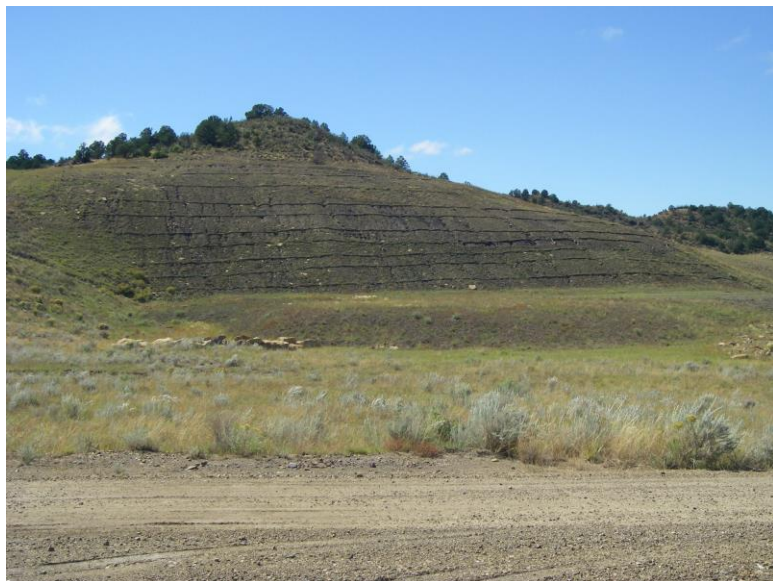
The slope south of the pond cleanings location, parcel W-4, has previously had wattles installed. Vegetation is becoming established on this steep slope between the wattles. Good vegetation establishment will aid in stabilizing this erosive slope.

Slope south of the pond cleanings location, in parcel W-4

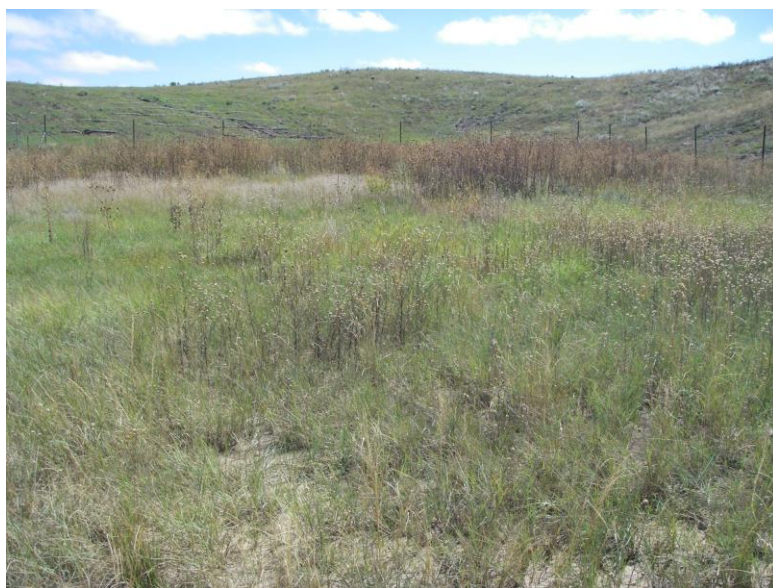
Shrub plot

The soil in the fenced shrub plot was very wet from recent rains. The center of the plot was dominated by sunflowers and robust grass species. Few woody transplants remained viable. The few living woody plants observed were mountain mahogany, Woods’ rose, serviceberry, and fringed sagebrush. Unfortunately, it appears the grass species have out competed the shrub transplants. If NECC conducted efforts to control the grasses within the plot, they should provide this information to the Division. Action was recommended in the Division’s September 1, 2015 inspection report. There was no indication of any replanting of shrubs, or that weed/grass barriers had been installed.

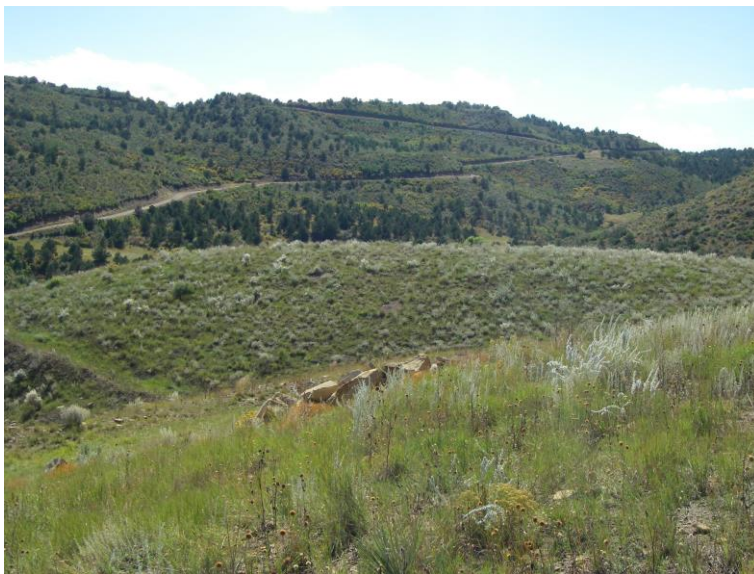
Vegetation on Fill 7 is well-established and appears stable. This slope is dominated by perennial grasses. The east side of the slope contains a good stand of shrub species.

Fill 7 (small southwestern portion in middle of photo)

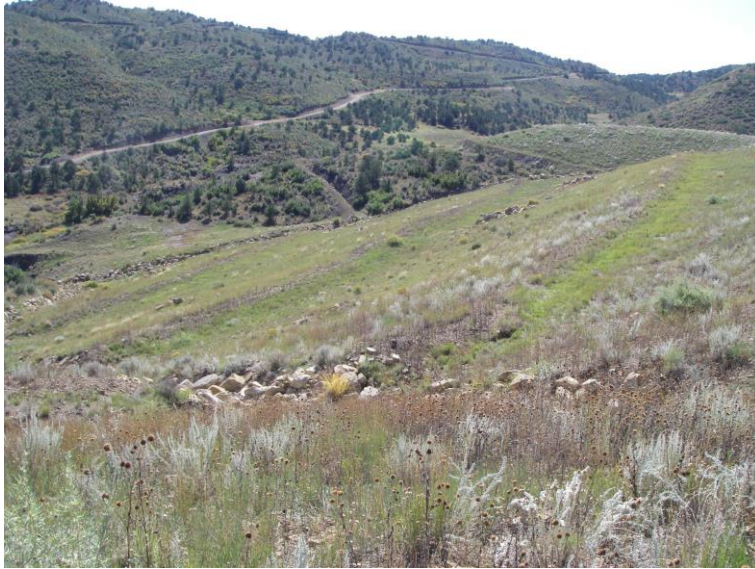
Fill 7 (main portion)

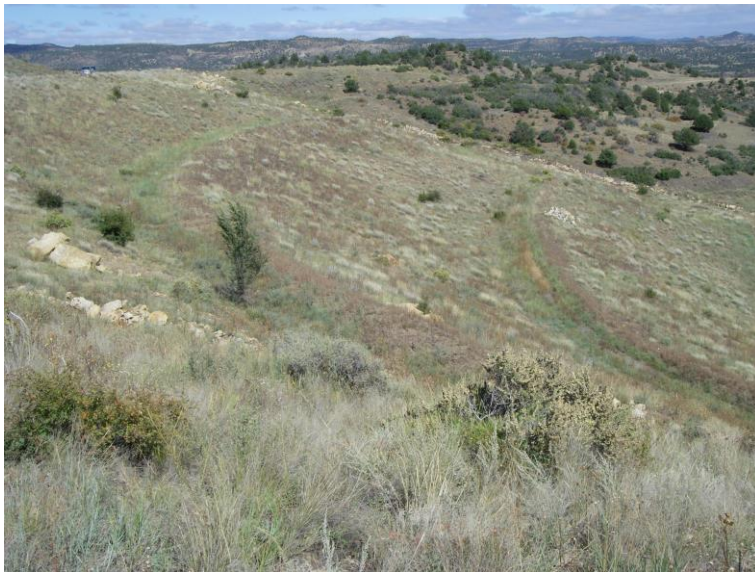
The lower portion of Fill 9 has good cover. The upper portion tends to have thinner vegetative cover and still exhibits a significant amount of annual species (sunflowers). But the south facing slope of Fill 9 appears stable with no obvious signs of gully formation.

Fill 9 – upper portion with some bare areas
