PERMIT INFORMATION

Permit Number: C-1981-012 Mine Name: New Elk Mine Operator: New Elk Coal Company, LLC Operator Address: Mr. Louis Head 12250 Highway 12 Weston, CO 81091	County: Las Animas Operation Type: Underground Permit Status: Active Ownership: Private
	Operator Representative Present: None
Operator Representative Signature: (Field Issuance Only)

Inspection Start Date: October 11, 2017 Inspection Start Time: 12:31 Inspection End Date: Inspection End Time:	Inspection Type: Aerial Inspection Inspection Reason: Normal I&E Program Weather: Clear
Joint Inspection Agency: None	Joint Inspection Contacts:
Post Inspection Agency: None	Post Inspection Contacts:
Inspector(s): Harry B. Ranney	Inspector's Signature: <i>Robert D. ZL</i> Signature Date: 10/12/2017

The New Elk Mine was photographed from an airplane by Harry Ranney of DRMS on October 11, 2017. These photos were reviewed by Rob Zuber of DRMS on October 12, 2017. The weather was clear.

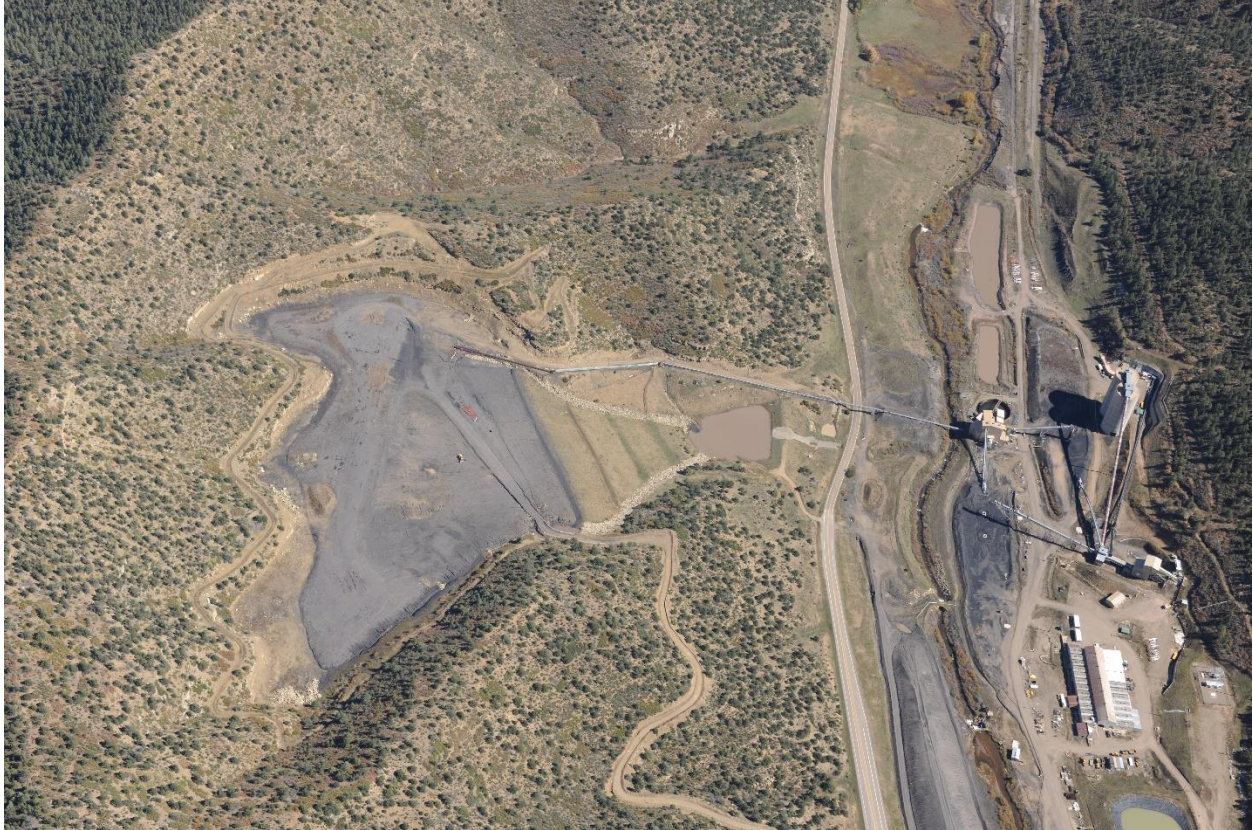
The following ponds were inspected: Pond 001A, Pond 004A, Pond 006A, Pond 007A, and Pond 08. All of the ponds were holding water but did not appear to be discharging. No issues were identified with any embankments or spillways.

RDA and eastern portion of mine
Ponds 006A, 007A, and 08 holding water

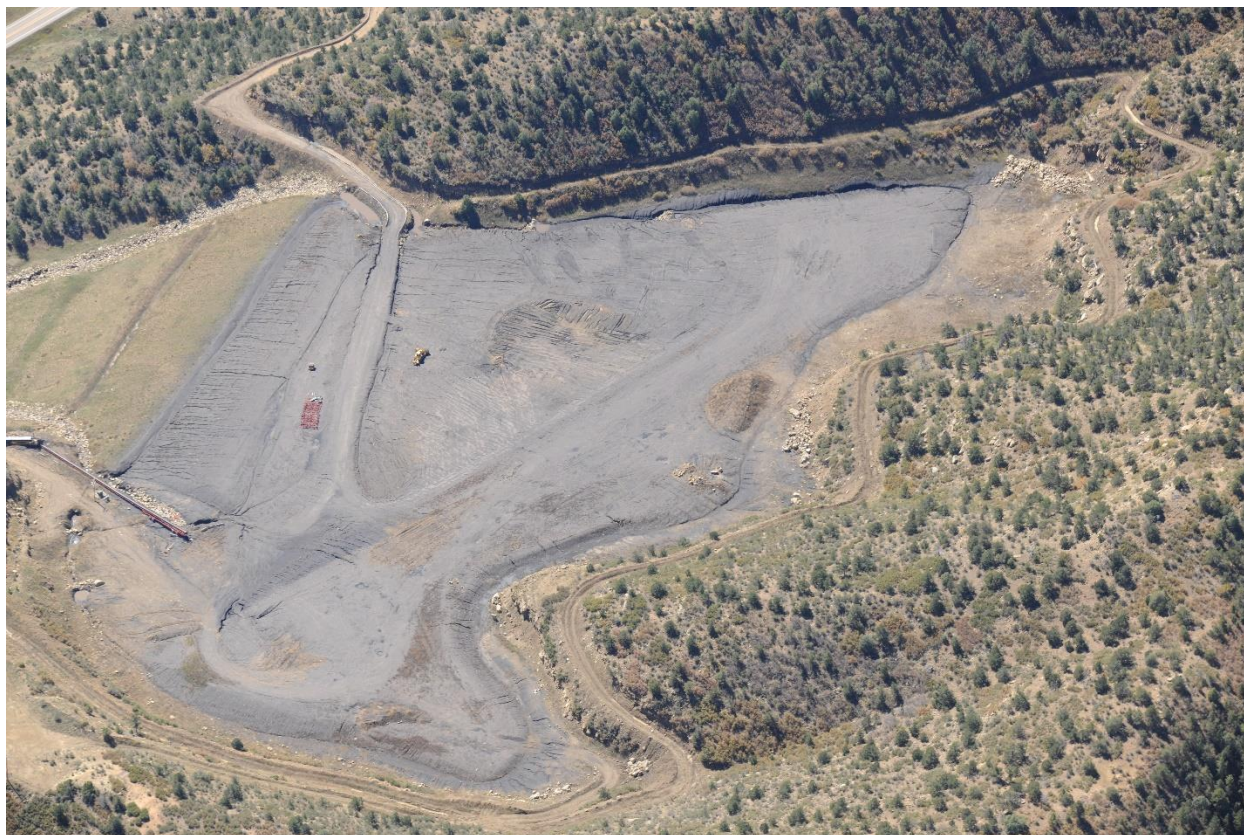
No erosion was seen on the face of the lower RDA (reclaimed portion) other than a small rill that appears to be healing well. There is possible erosion in the western side ditch. The ditch and other surface water control structures (namely sumps) between the upper RDA and lower RDA appears to be functioning well. No problems were seen with the upper (un-reclaimed) portion of the RDA.

Upper portion of RDA

No issues with roads were identified. The berm and fill next to the road to the RDA appears stable, but hydroseeding is recommended to keep it stable and prevent significant sediment transport into the undisturbed area.

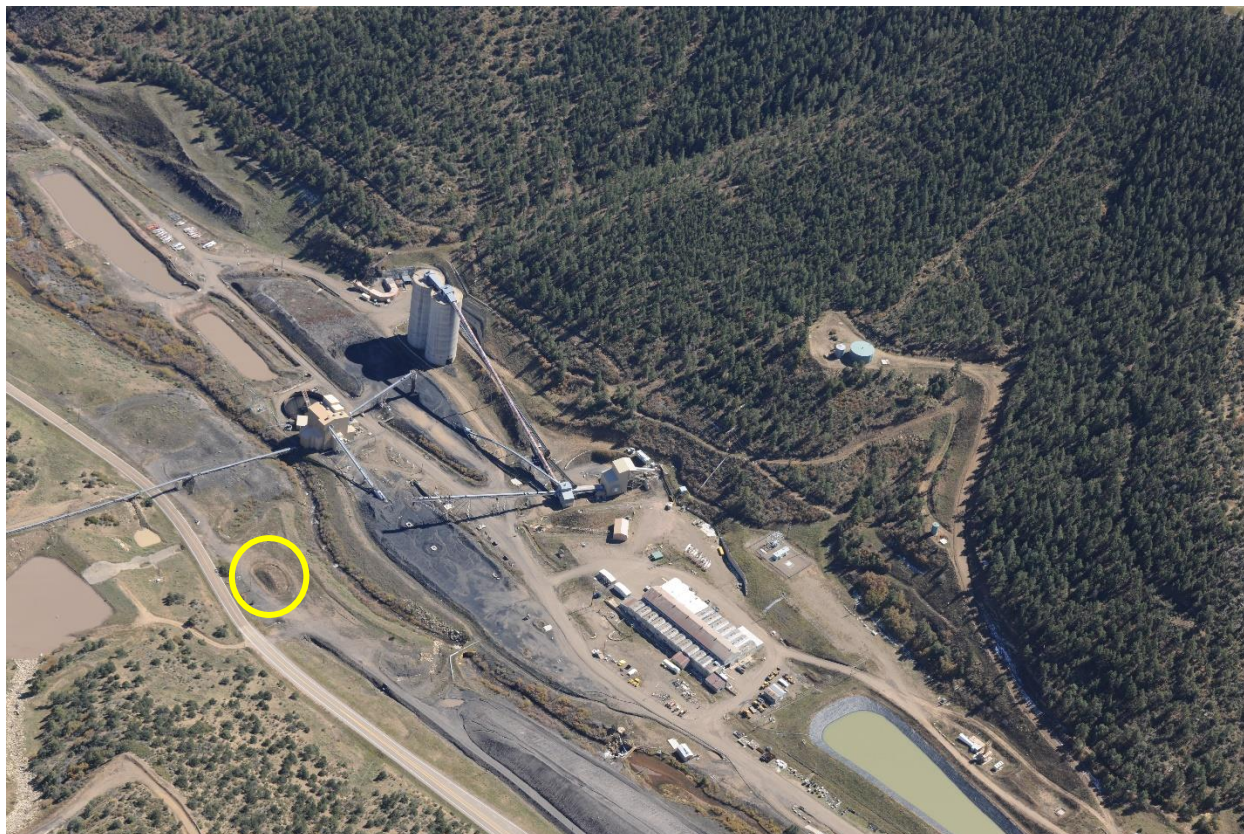
Neither loss of material nor other issues were identified with Topsoil Stockpile #2.

Central portion of mine

Topsoil Stockpile #2 is circled
