Re: King I Mine, C-1981-035
Stoner Engineering: Quarterly Inspection: Water Quality Improvements
3rd Quarter 2017

Date: September 29, 2017

Re: King Coal I – Quarterly Water Quality Improvements Inspection

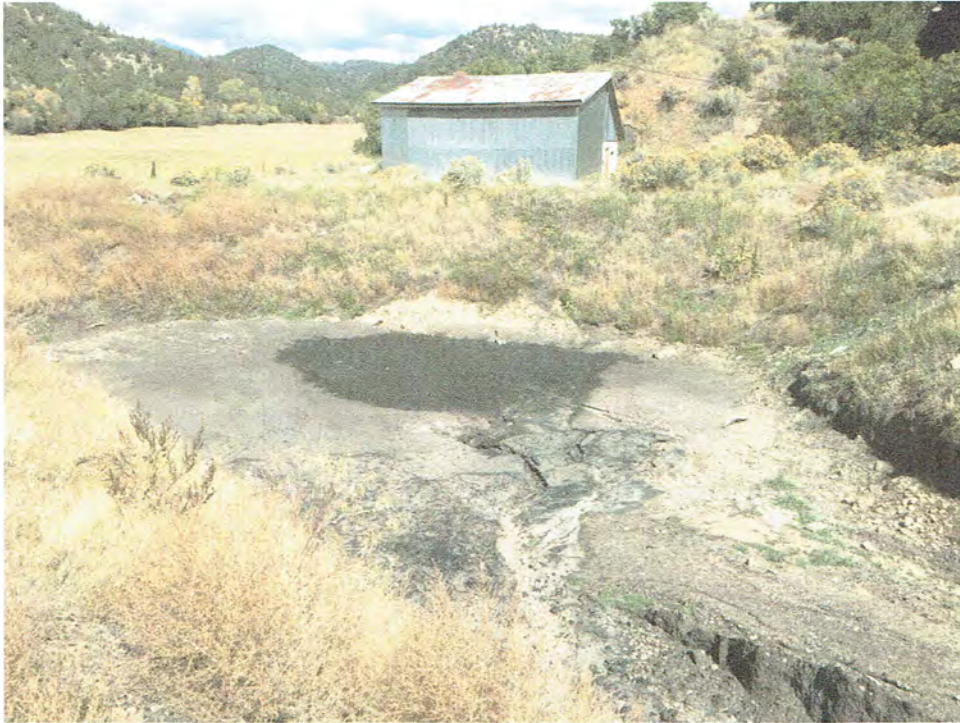
Both ponds were dry at the time of the inspection. The east pond was undergoing some work at the time of the inspection (see Pic. 1 & 2). The bottom of the east pond has been raised though the exact amount is unknown. It appears that the work on the east pond is not complete though the pond will still accept site runoff. The results of the construction and survey should be forwarded as soon as the work is completed. As-built survey will be required to set proper gage level for sedimentation levels. The markings on the sediment gage for the west pond have come off though the location is still visible (see Pic. 3). The gage should be repaired to show the maximum sedimentation level so ensure the proper maintenance schedule is followed. The ponds are both in generally good condition. The required storage volume appears to be adequate at this time based upon the sedimentation gage installed in the west pond and the visual volume of the east pond (currently no sedimentation gage). The sedimentation levels of the ponds should be checked after the existing water dissipates from the ponds. The ponds should continue to be monitored after storm events to ensure that excess sediment does not reduce the required storage capacity available for storm water runoff.

Pic. 1 – East pond, fill material installed in base, no sediment gage.

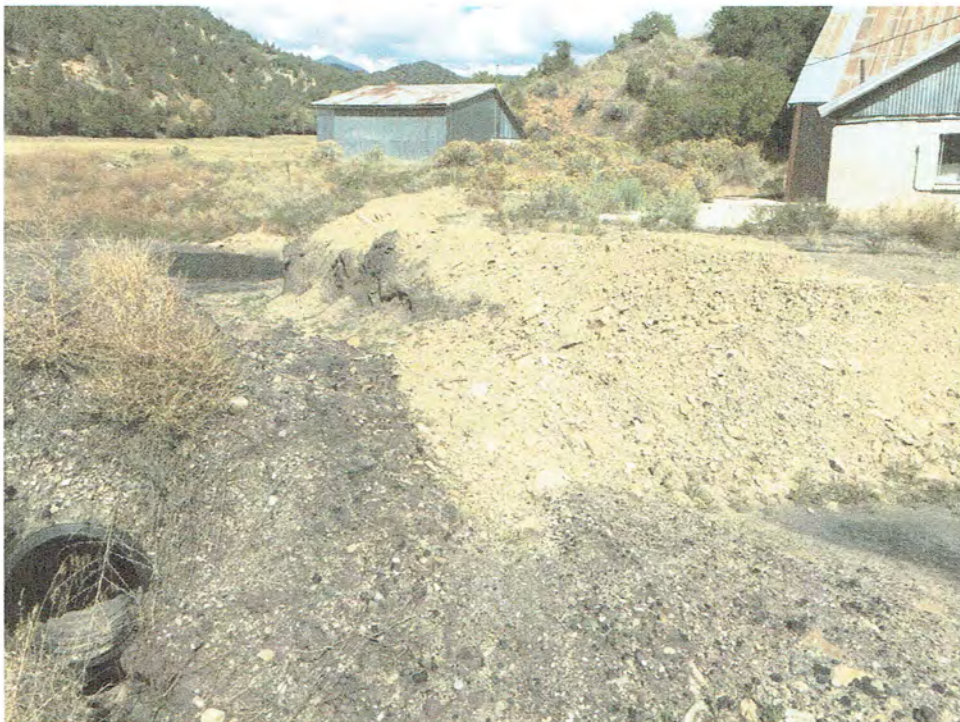
Pic. 2 – East pond inlet pipe and berming at equipment access.

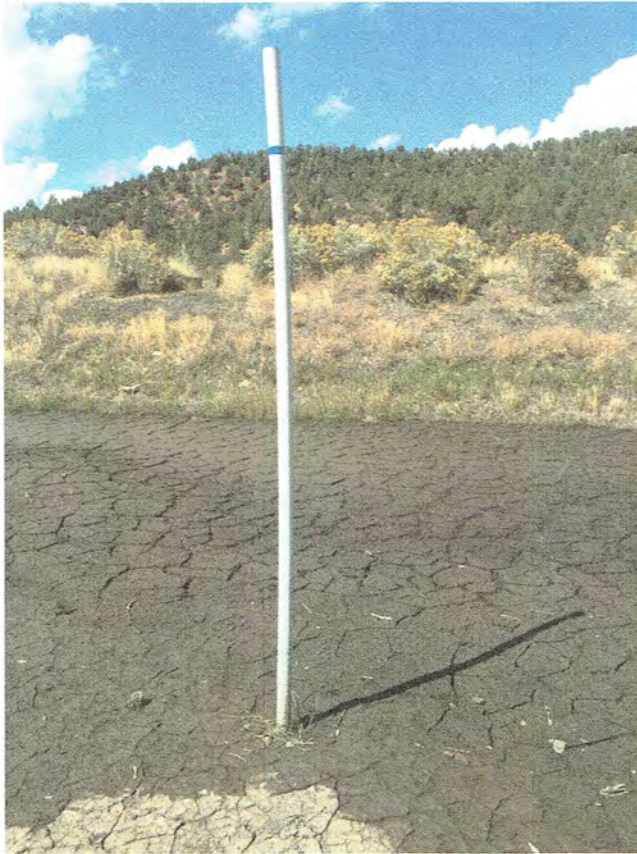
Pic. 3 – West pond sediment gage.

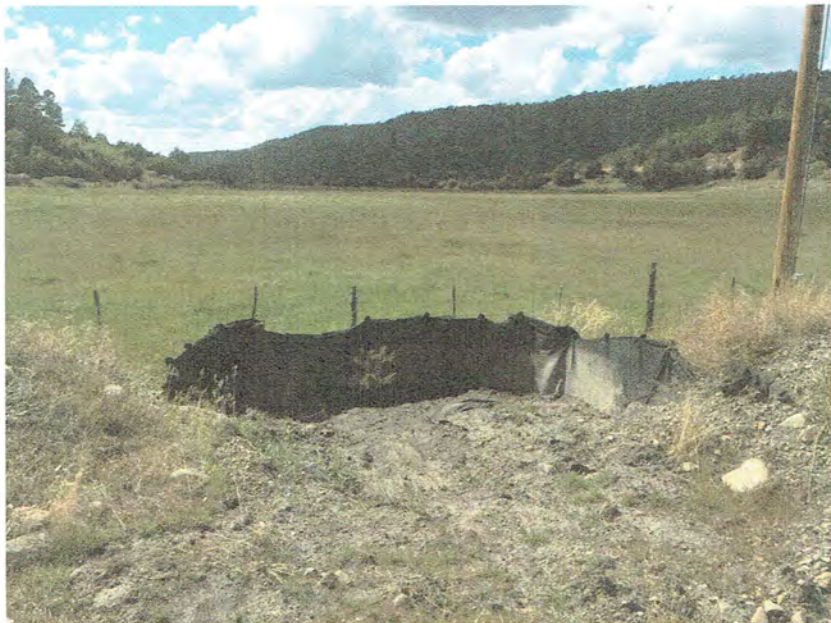
The sediment traps located along the west side of the driveway at the entrance are in good condition (see Pic 4).

Pic. 4 – Sediment traps along west side of driveway in good condition.
