Re: King II Mine
Pond Quarterly Inspection
3rd Quarter 2017

Re: King Coal II - Annual Water Quality Improvements Inspection (Amended)

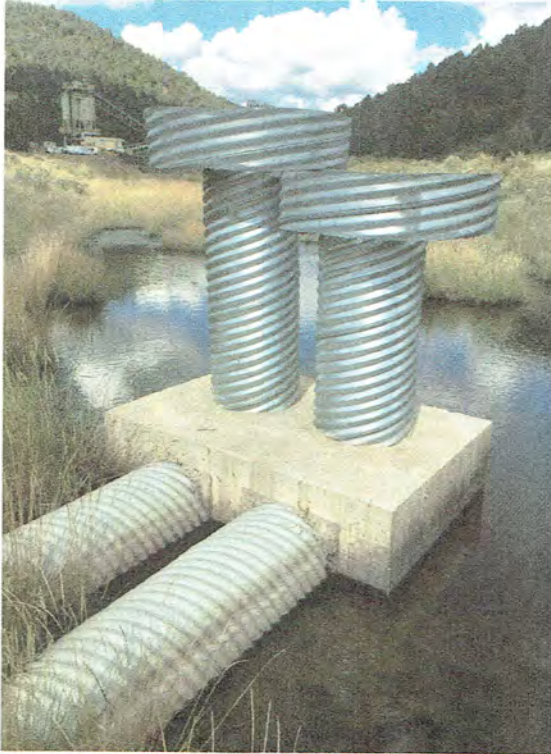
The vegetation established both inside and out of the pond is well established to minimize the erosion impacts of storm runoff. The outlet structure shows no signs of damage and was functioning as designed at the time of the inspection (see Pic. 1). The water quality pond appears to be in generally good condition. There were no signs of weakness or distress to either the outlet structure or the embankment material. The water quality pond has the storage capacity to function as designed.

Pic. 1 – Detention Pond with 2-inches of water at outlet structure.

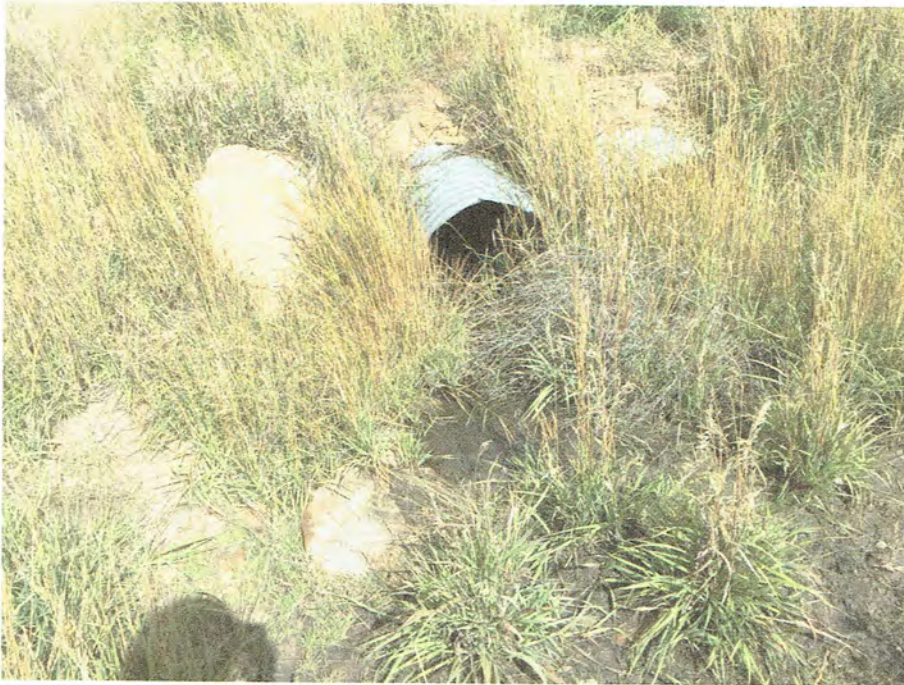
The drainage ditches were found to be in generally good condition and clean of debris (see Pic. 2 & 3). All ditches should be inspected and repaired as necessary, especially after storm events.

Pic. 2 – Dual culverts under main access driveway in good condition.

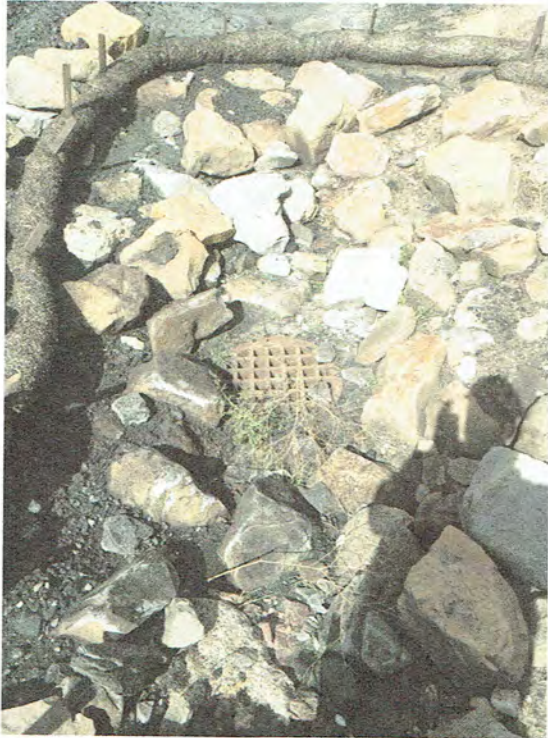
Pic. 3 Inlet east of truck loading/scale area.

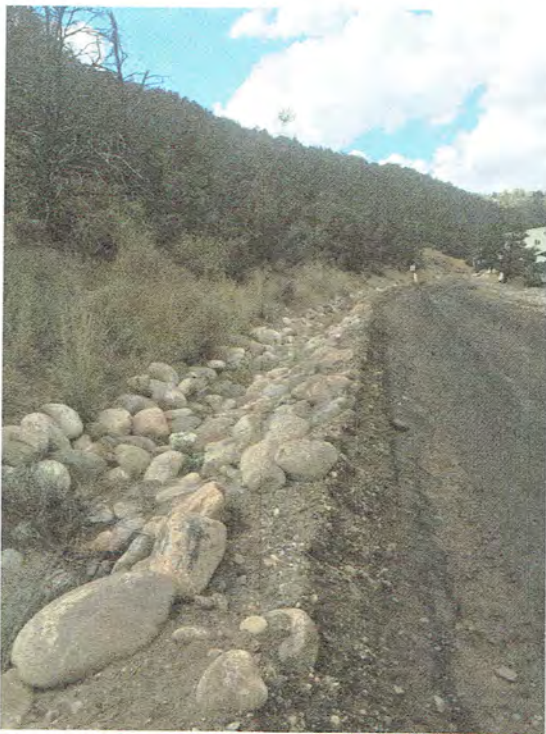
The culvert pipes on the site were in good condition overall. The west clear water ditch has been cleaned out which prevents runoff from overtopping and potentially eroding the main roadway (see Pic. 4).

Pic. 4 –West clean water ditch has been cleaned.
