Re: King I Mine, C-1981-035
Stoner Engineering: Quarterly Inspection: Refuse Pile
3rd Quarter 2017

Date: September 29, 2017

Re: King Coal I – Quarterly Waste Pile/Embankment Inspection

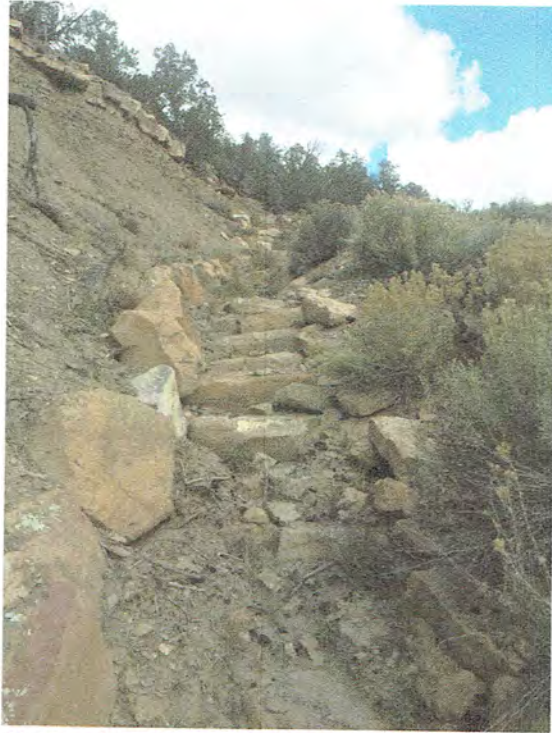
The condition of the perimeter ditches located along the north and south sides of the property were generally in good condition though the north channel has some accumulation of sediment and small rock as a result of recent storms (see Pic. 1). The drainage channels were generally clear of debris and there was no damage observed to any of the channel sections.

Pic. 1 – North channel with some sedimentation.

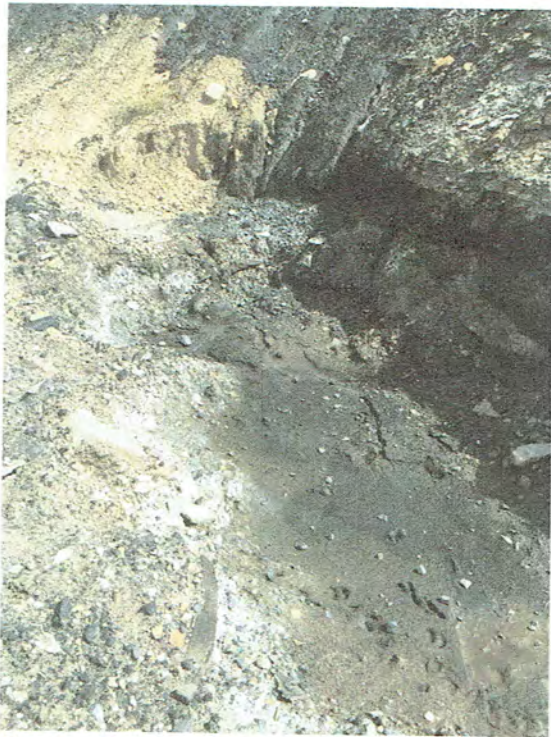
The drain located at the base of the waste pile/embankment has been repaired (see Pic. 2) and extended to the drainage channel which directs flows to the west (see Pic. 3). Fill material and topsoil has been stockpiled near the area for possible placement along the base of the pile (see Pic. 4). Additional fill material appears necessary to meet the 2.5:1 slope specified in the original design.

Pic. 2 – Daylight location of under drain.

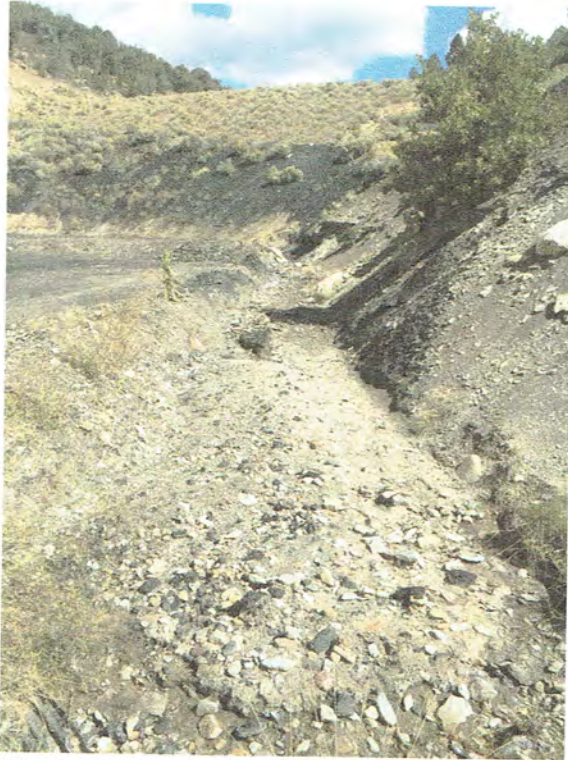
Pic. 3 –Drainage channel routing under drain flows to west.

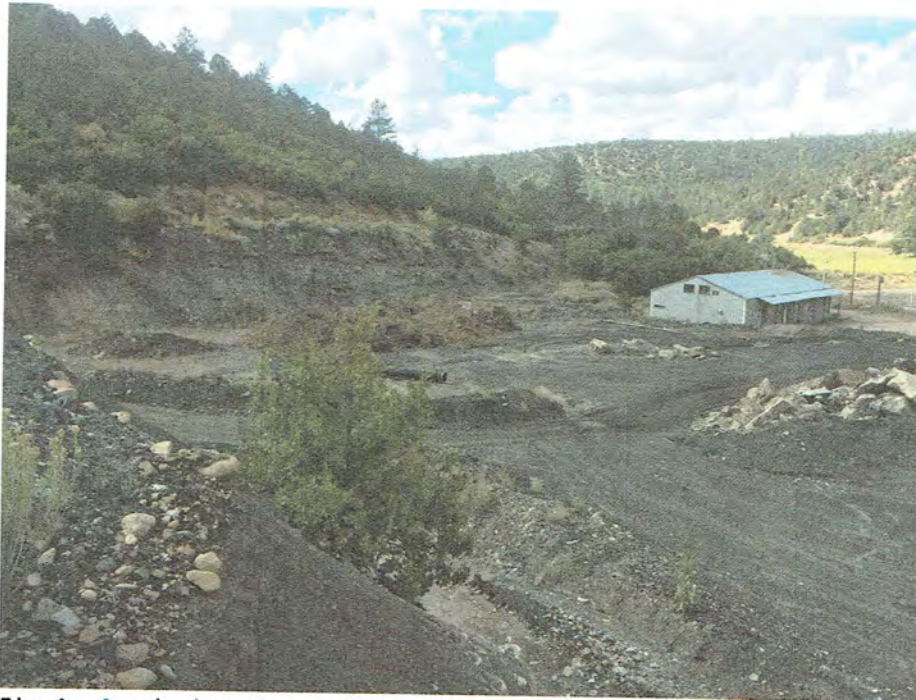
Pic. 4 – Stockpiles of topsoil and fill material near waste pile base.

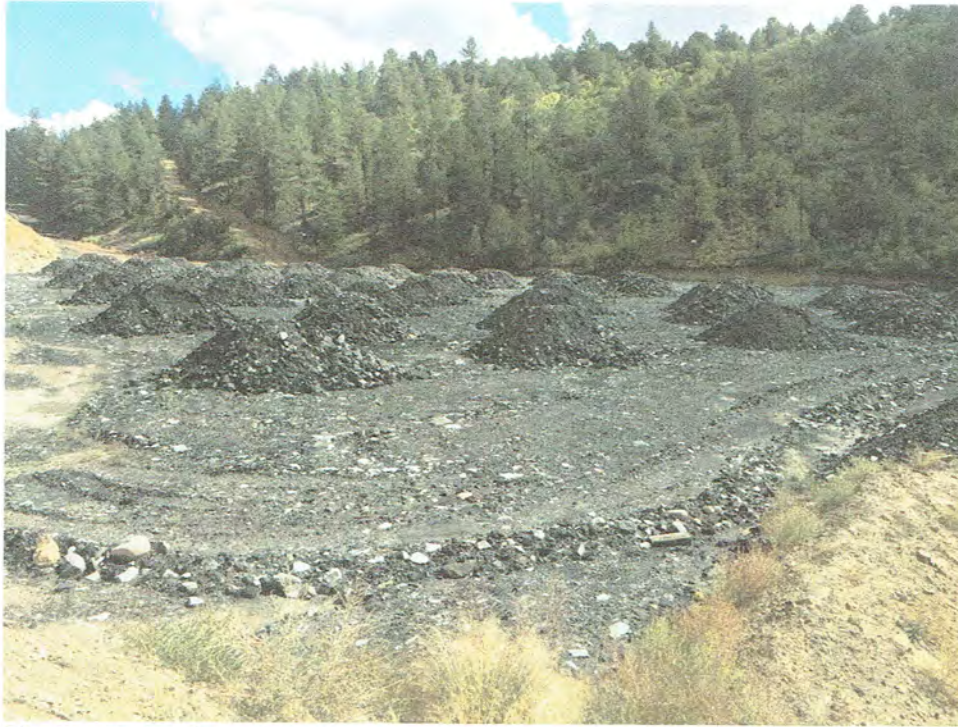
Pic. 5 – Embankment material stockpiled at top of the waste pile.

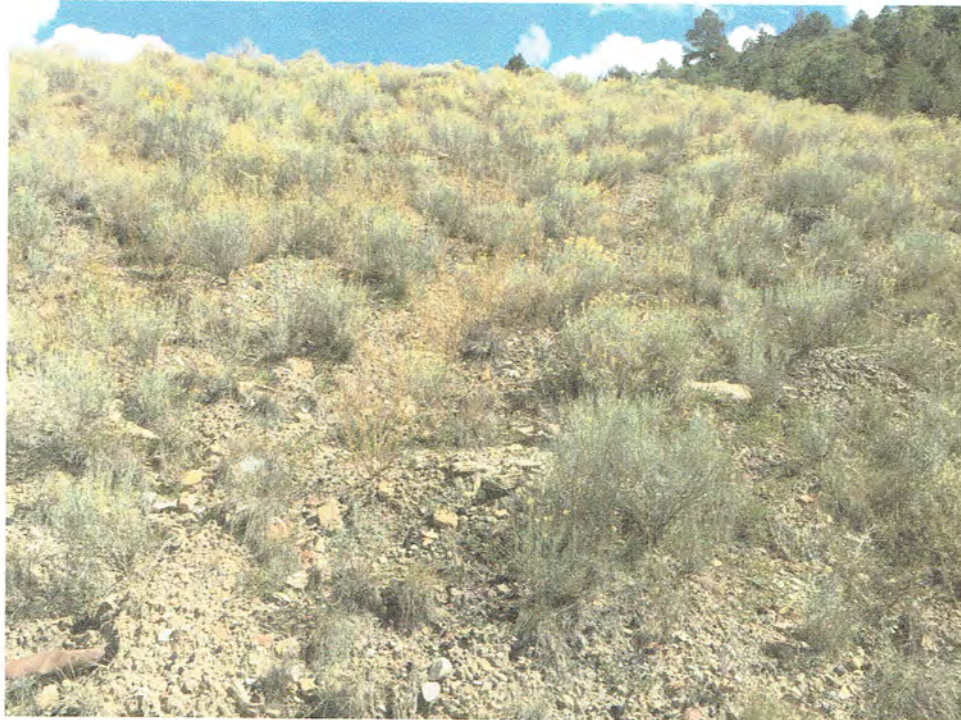
Some drainage improvements (riprap) have been installed in the ditch along the access roadway to the top of the waste pile/embankment to reduce erosion. There was material stockpiled at the top of the embankment awaiting placement as embankment fill (see Pic. 5). The face of the embankment was in good condition and does not show any signs of excessive erosion, instability or weakness (see Pic 6).

Pic. 6 – Waste pile/embankment face in good condition.
