**PERMIT INFORMATION**

<b>Permit Number:</b> C-1981-035 <b>Mine Name:</b> King Coal Mine <b>Operator:</b> GCC Energy, LLC <b>Operator Address:</b> Mr. Tom Bird 6473 County Road 120 Hesperus, CO 81326	<b>County:</b> La Plata <b>Operation Type:</b> Underground <b>Permit Status:</b> Active <b>Ownership:</b> Federal
	<b>Operator Representative Present:</b>  None
<b>Operator Representative Signature: (Field Issuance Only)</b>

<b>Inspection Start Date:</b> October 11, 2017 <b>Inspection Start Time:</b> 11:17 <b>Inspection End Date:</b> <b>Inspection End Time:</b>	<b>Inspection Type:</b> Aerial Inspection <b>Inspection Reason:</b> Normal I&E Program <b>Weather:</b> Clear
<b>Joint Inspection Agency:</b>  None	<b>Joint Inspection Contacts:</b>  
<b>Post Inspection Agency:</b>  None	<b>Post Inspection Contacts:</b>  
<b>Inspector(s):</b>  Harry B. Ranney	<b>Inspector's Signature:</b>  <i>Robert D. Zh...</i>  <b>Signature Date:</b>  10/12/2017

The King Coal Mine was photographed from an airplane by Harry Ranney of DRMS on October 11, 2017. The weather was clear. The photos were reviewed by Rob Zuber of DRMS on October 12, 2017, resulting in the following report.

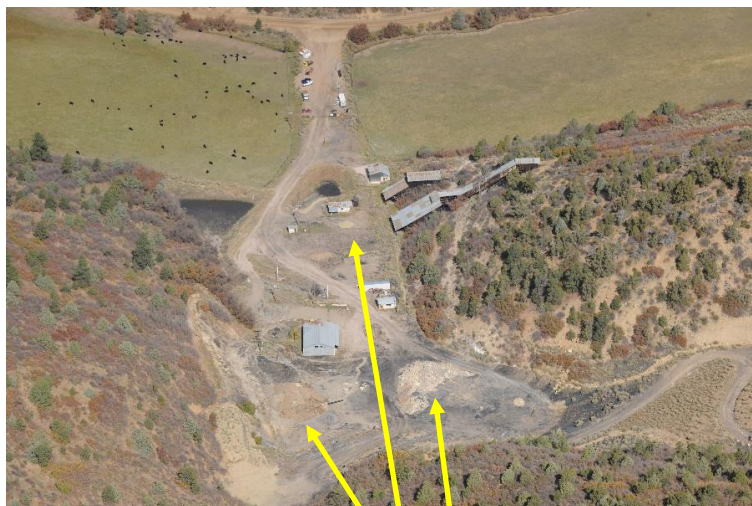
**King I**

*Temporary soil piles*

Piles of soil on the King I facilities area need to be placed on the Refuse Pile, either on the upper portion (active portion of the Refuse Pile) or the lower portion where GCC needs to lessen the slope of the pile (as discussed in past reports for several months).

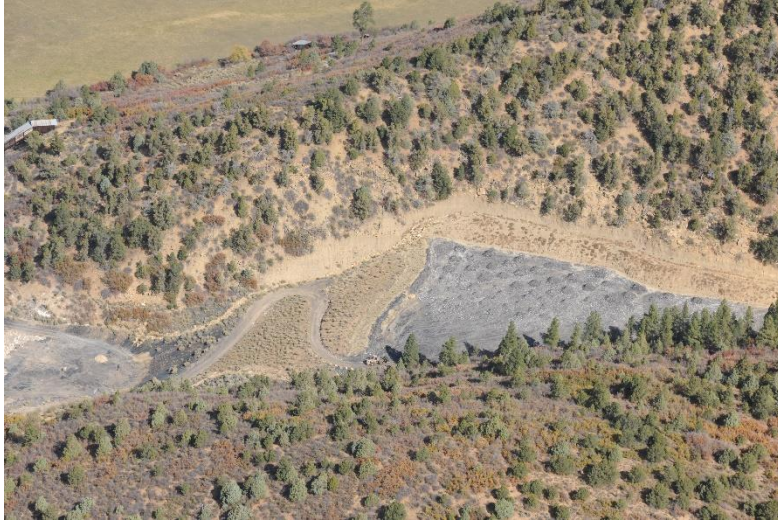
**King I Refuse Pile**

The Refuse Pile was inspected, and no slumps, erosion, or other problems were seen. Waste material (piles on upper portion of Refuse Pile) needs to be graded and compacted.

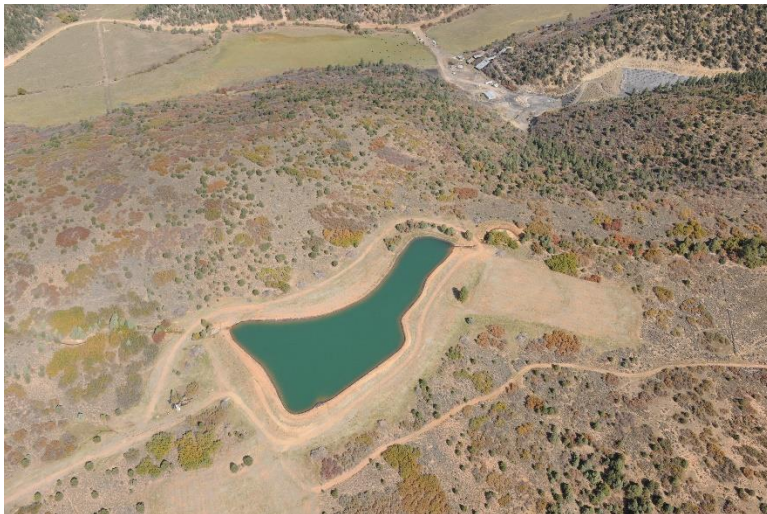
**Huntington Pond**

No damage from subsidence was seen in the affected areas near King I or King II. The areas seen in the photographs are approximately 500 – 1,000 feet from the facilities. The inspected areas include the Huntington pond.

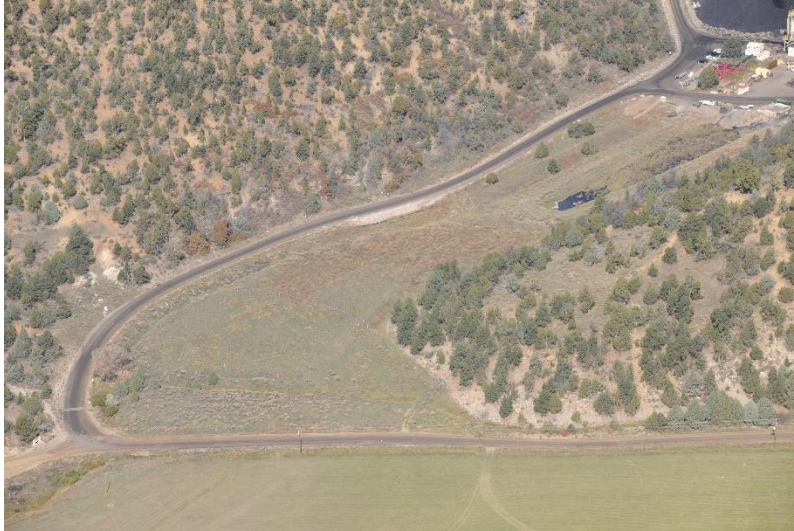
**King II entrance and pond**

The King II pond was holding a small amount of water, but did not appear to be discharging. No issues were found with the embankment.
