RE: Hobo Mine; DRMS File No. M-2017-044; Possible Unpermitted Mining Operation

MINERALS PROGRAM INSPECTION REPORT PHONE: (303) 866-3567

MINE NAME:		MINE/PROSPECTING ID#:	MINERAL:	COUNTY:			
Hobo Mine		M-2017-044	UNK	San Juan			
INSPECTION TYPE:		INSPECTOR(S):	INSP. DATE:	INSP. TIME:			
Illegal(Unpermitted Operation)		Lucas J. West	September 18, 2017	13:39			
OPERATOR:		OPERATOR REPRESENTATIVE:	TYPE OF OPERATION:				
Keith McFarland		Keith McFarland	ILL - Illegal				
REASON FOR INSPECTION:		BOND CALCULATION TYPE:	BOND AMOUNT:				
Citizen Complaint		None	No Bond Held				
DATE OF COMPLAINT:		POST INSP. CONTACTS:	JOINT INSP. AGENCY:				
NA		None	None				
WEATHER:	INSPE	CTOR'S SIGNATURE:	SIGNATURE DAT	E:			
Clear		7-AM	October 4, 2017

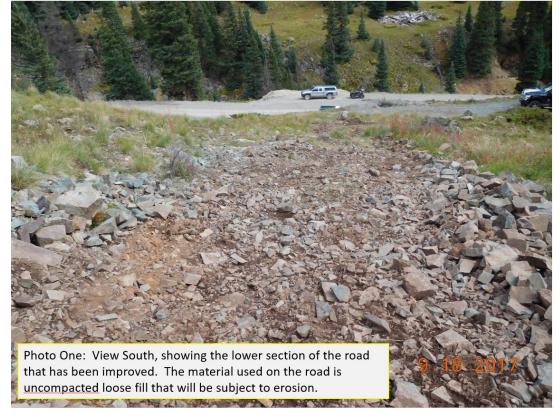
A file number was created for the site, as the site is not currently a permitted operation. The site was named the Hobo Mine and given file number M-2017-044. Along with the inspector listed on page one of this report, Keith McFarland, Operator, who conducted the work, as well as Lisa Richardson of the Bureau of Land Management were present during the inspection. The work was conducted on a historic road, leading to a historic portal just above County Road 2. The road and portal are adjacent to an area known as the Toltec Tunnel which is associated with, but not part of the permitted area for another permitted mine site. The road and portal were observed in 2015 when no recent disturbance was present. In the recent months the road has undergone major road improvements to allow vehicles and equipment to access the portal. The road has been graded and in some areas it appears to have been widened. No storm water control measures of any kind were installed along the road to prevent erosion. The road totals approximately 612 Linear Feet and is constructed to angular, un-compacted material that appears to have been sourced on site. Photos One and Two show the road with its improvements. The activities appear to have destabilized the hill side by exposing a 18 -24 inch unsupported drop between the native hillslope and the base of the road. This is a concern as the un-supported drop will likely develop more severe erosional issues than what was already observed and cause head-cutting of the hillslope.

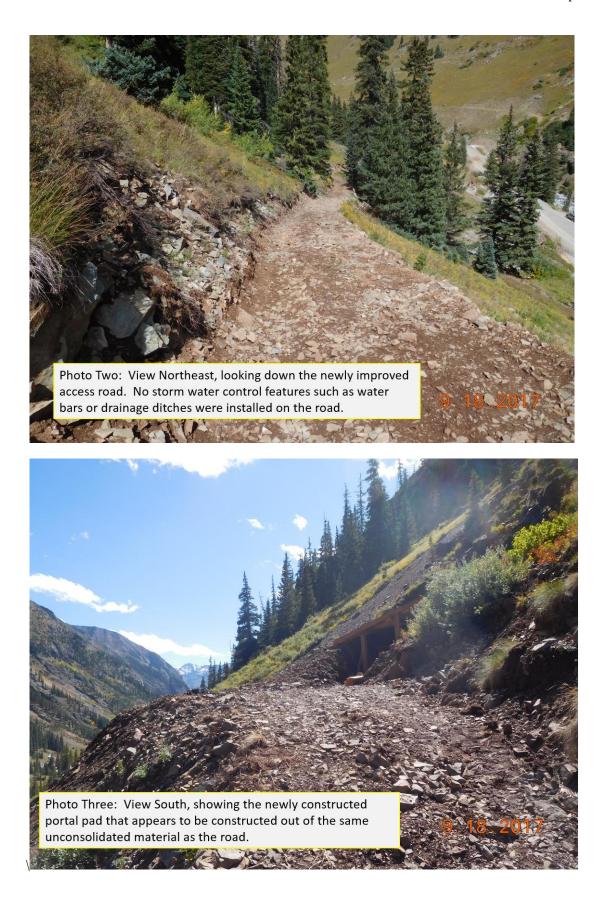
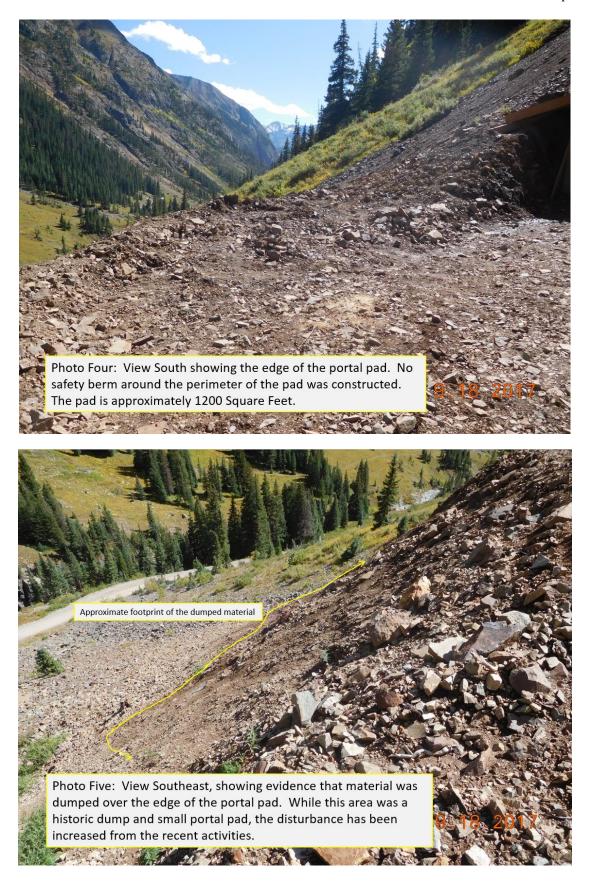
At the top of the road, the portal was excavated and opened for access, a portal pad was constructed and a timber framed portal structure was installed to prevent degradation of the portal itself. The portal pad is approximately 1200 Square feet with no safety berm around its perimeter. Photos Three and Four show the newly constructed portal pad. Evidence observed indicate that some of the material was pushed over the edge of the pad, and allowed to fall down the slope. The material fell and estimated 30 feet down the hill and resulted in an approximate 1.5H: 1V slope. Photo Five shows the newly excavated material that has been pushed over the edge of the portal pad. The timber framed portal structure consists of 2 x 6 inch framing supported by native rock outcrops and two 6 x 6 inch posts. The 6 x 6 inch posts are approximately 6-8 feet away from the exposed portal opening. The two posts are roughly 12 and 14 feet tall supporting the roof framing is approximately 16-18 feet across. The roof of the structure is sheeted with plywood, and evidence observed during a follow up inspection conducted by the BLM showed evidence of waterproofing and staged corrugated tin to complete the roof of the structure. Discussions with the Operator indicate that he was having custom steel gates fabricated by a shop in town, and the gates will be installed between the two 6 x 6 posts upon their completion. The Operator also indicated that once the gates were installed, the void space between the timbers and the rock outcropping would be back filled to prevent unauthorized access. Photo Six shows the framed structure.

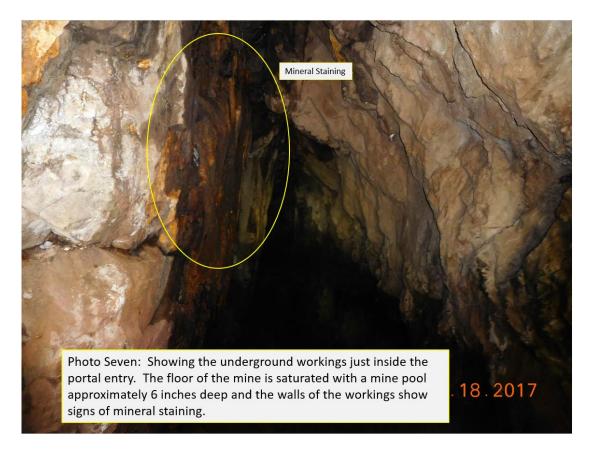
The portal itself is approximately 4 feet wide and 7-8 feet tall. According to the Operator the tunnel extends approximately 180 feet underground. This was not verified during the time of the inspection. On the floor of the mine there is a standing water mine pool that is approximately 6 inches deep. The water was observed

entering the underground workings along the walls of the mine. The water is of an unknown quality at this time. However mineral staining and deposition along the walls and floor of the mine indicate that the site has acid producing potential. Photo Seven shows the underground workings just inside the portal with mineral staining along the walls of the workings. The flow was not discharging from the portal at the time of the inspection. A discharge is reasonably anticipated during the snowmelt season of next spring. Due to the unknown quality of the water a discharge of any kind is a significant concern for the Division. No control measures such as drainage ditches or retention ponds were observed to control any anticipated flow from the portal.
