MINERALS PROGRAM INSPECTION REPORT
PHONE: (303) 866-3567

| MINE NAME: Sunnyside Gold Mine | MINE/PROSPECTING ID#: M-1977-378 | MINERAL: Lead, zinc, copper, iron | COUNTY: San Juan |
| INSPECTION TYPE: Multi Person Inspection | INSPECTOR(S): Lucas J. West | INSP. DATE: September 19, 2017 | INSP. TIME: 11:54 |

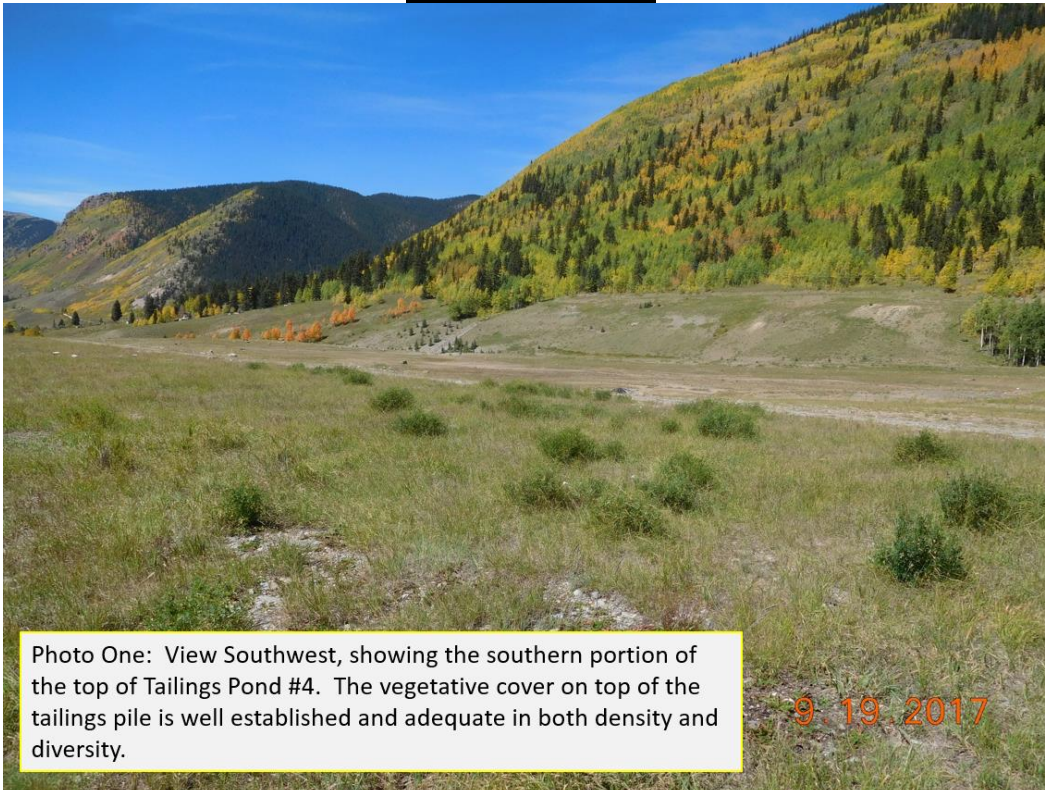
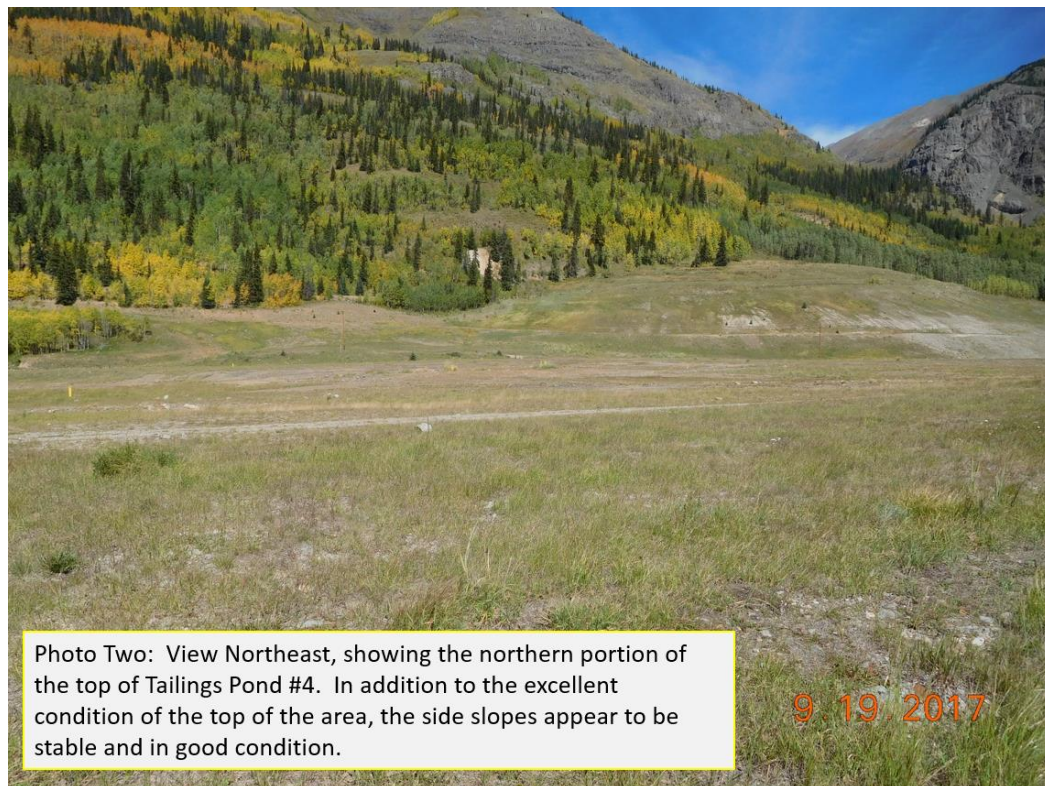
The side slopes and top of the constructed repository appear to be stable and are in good condition. Photos One and Two show the top of the repository which is well vegetated and showing signs of self-sustainment with previous years biomass observed. The operator expressed that vegetation management is ongoing and continuous, and evidence of chemical weed treatment was observed on site. 8 monitoring wells were observed on the top of the repository, all of which were properly collared and secured. Photo Three shows an example of the covers on the wells. The repository exhibits positive drainage and no impounded storm water or erosional issues were noted. The upland diversion ditch was inspected and appeared to be functioning as designed.

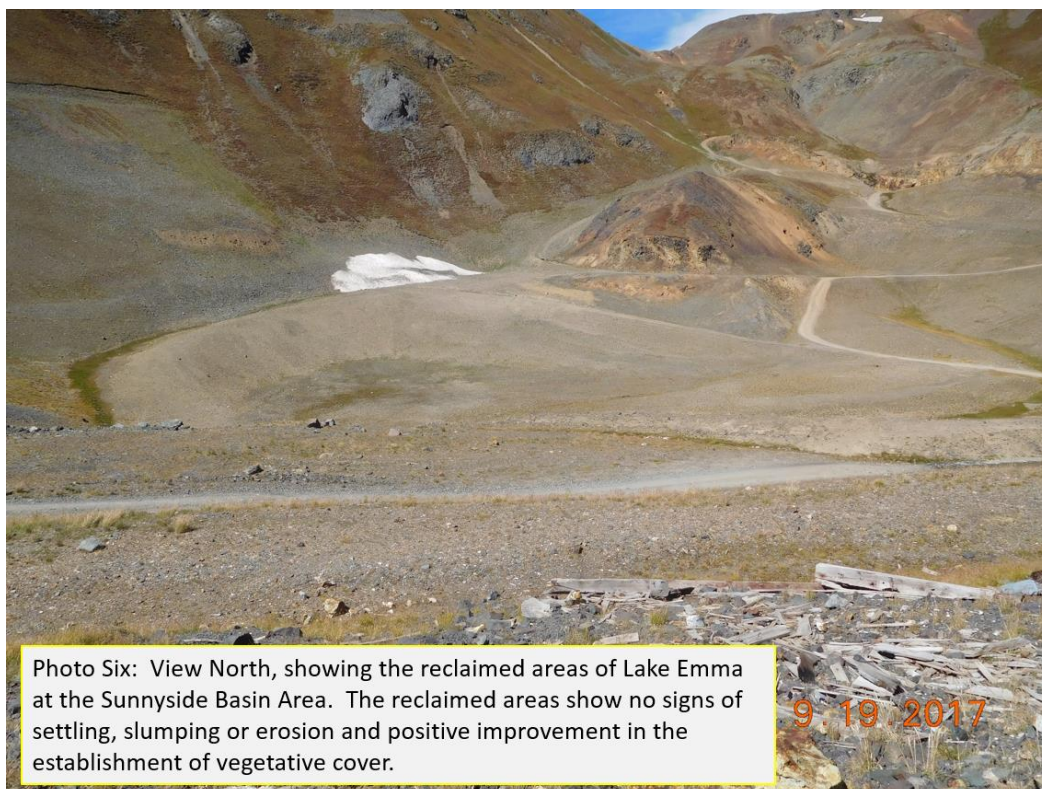
noted during the inspection. Despite the extremely short growing season, grazing from sheep in the area and unrestricted tourist traffic the vegetative cover of the affected area is very well established. The vegetation appears to be adequate in both density and diversity, and shows signs of multiple year's biomass indicating that the populations are self-sufficient. No erosional issues or noxious weeds were observed in this area. The reclaimed areas can be seen in Photos Six.

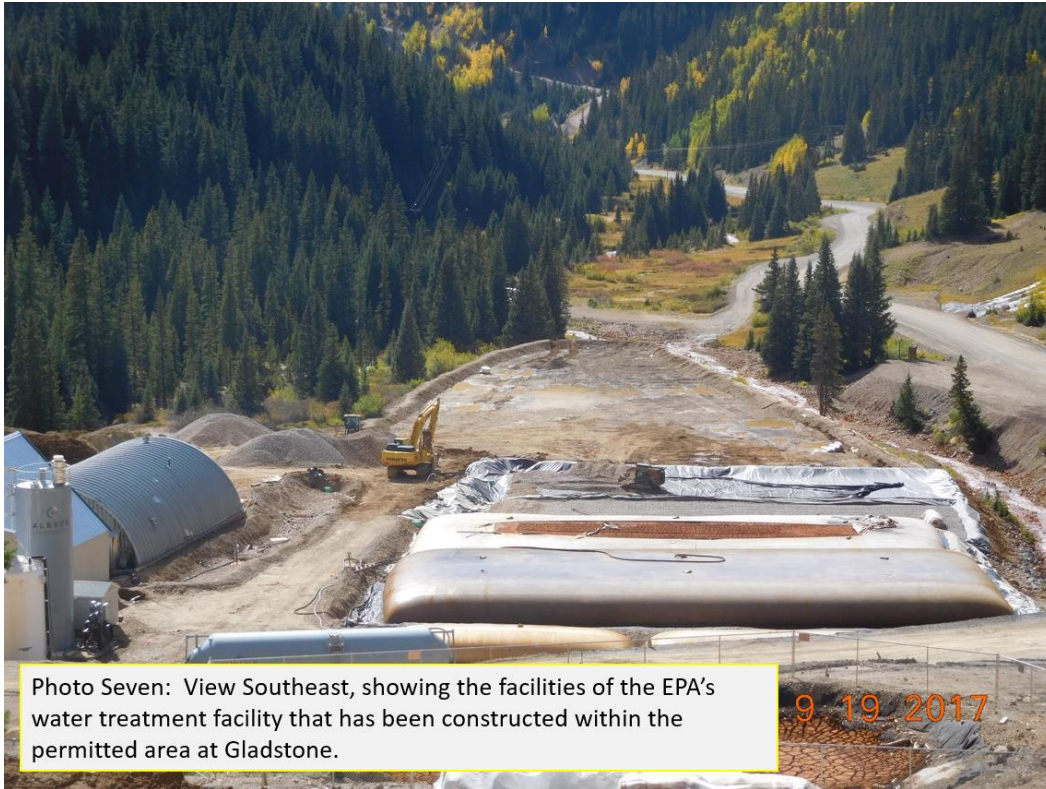
The entirety of the Gladstone area has been re-disturbed for use in the EPA cleanup efforts. Photos Seven, Eight and Nine show the recently constructed facilities that include settling ponds, storage facilities, large Quonset hut and other out buildings, filter bags with secondary containment, as well as a sludge drying area. Almost 100% of the permitted lands at the Gladstone area have been disturbed. Records kept by the Division demonstrate that the Operator had nearly completed the surface reclamation of the site prior to the Gold King Mine Spill. The subsequent re-disturbance of the permitted areas by the EPA have been done post reclamation and without consultation with the Operator. The EPA work will be on going and is not associated with any approved mining or reclamation activities under the jurisdiction of the Division.

Photo Seven: View Southeast, showing the facilities of the EPA's water treatment facility that has been constructed within the permitted area at Gladstone.

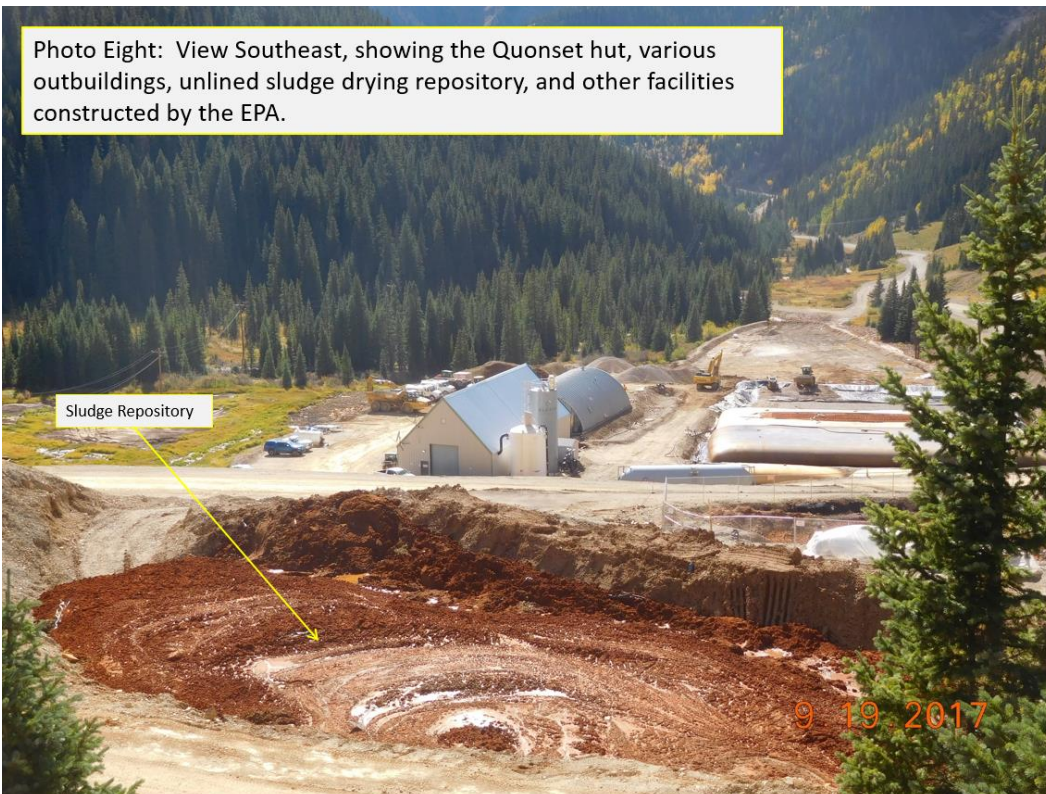
Photo Eight: View Southeast, showing the Quonset hut, various outbuildings, unlined sludge drying repository, and other facilities constructed by the EPA.

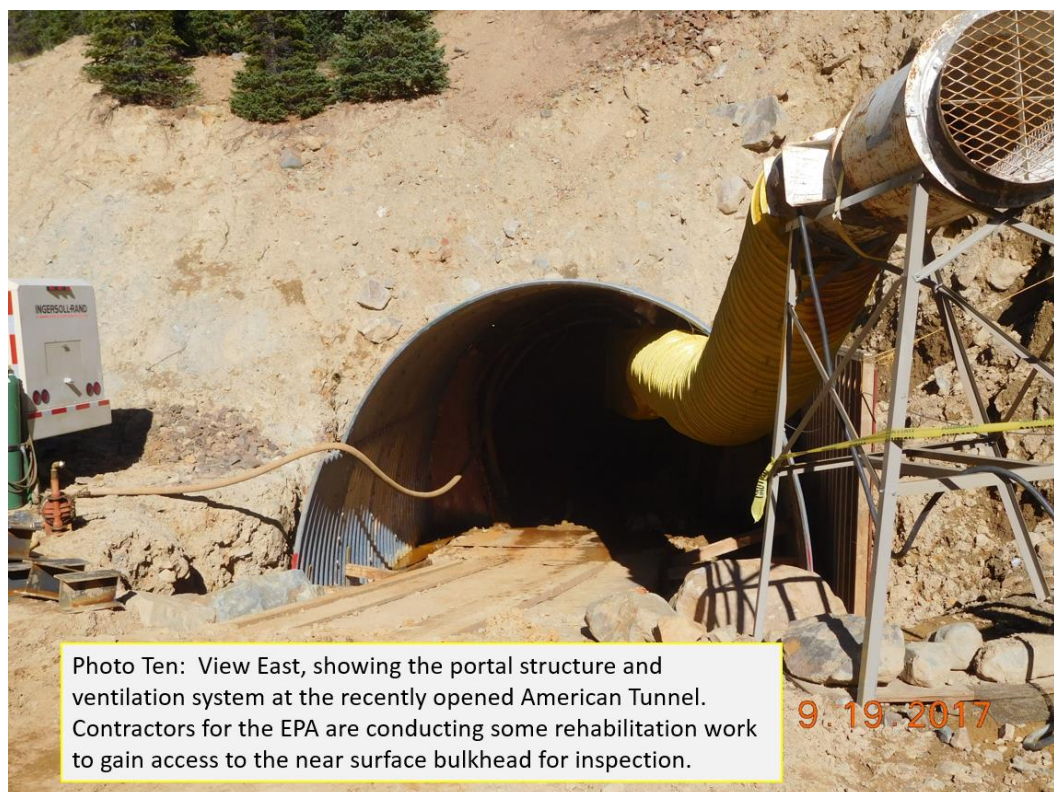
The previously backfilled American Tunnel has been re-opened by the EPA as seen in Photo Ten. The tunnel was opened to conduct an inspection of the near surface bulkhead. Discussions with the EPA representative on site indicate that further work will be required to inspect the other bulkheads in the tunnel. The discharge from the tunnel is being routed into a settling pond that feeds into the treatment system that has been established to treat waters from the Gold King Mine. The discharge from the American Tunnel into the EPA treatment system was visually estimated at approximately 100 GPM. The EPA work will be on going and is not associated with any approved mining or reclamation activities under the jurisdiction of the Division.
