**MINERALS PROGRAM INSPECTION REPORT**  
**PHONE: (303) 866-3567**

<b>MINE NAME:</b> Hoffman Pit	<b>MINE/PROSPECTING ID#:</b> M-2005-044	<b>MINERAL:</b> Sand and gravel	<b>COUNTY:</b> Lincoln
<b>INSPECTION TYPE:</b> Monitoring	<b>INSPECTOR(S):</b> Timothy A. Cazier	<b>INSP. DATE:</b> August 23, 2015	<b>INSP. TIME:</b> 11:00
<b>OPERATOR:</b> Lincoln County	<b>OPERATOR REPRESENTATIVE:</b> Trey James	<b>TYPE OF OPERATION:</b> 112c - Construction Regular Operation	
<b>REASON FOR INSPECTION:</b> Normal I&E Program	<b>BOND CALCULATION TYPE:</b> None	<b>BOND AMOUNT:</b> \$0.00	
<b>DATE OF COMPLAINT:</b> NA	<b>POST INSP. CONTACTS:</b> None	<b>JOINT INSP. AGENCY:</b> None	
<b>WEATHER:</b> Clear	<b>INSPECTOR'S SIGNATURE:</b>

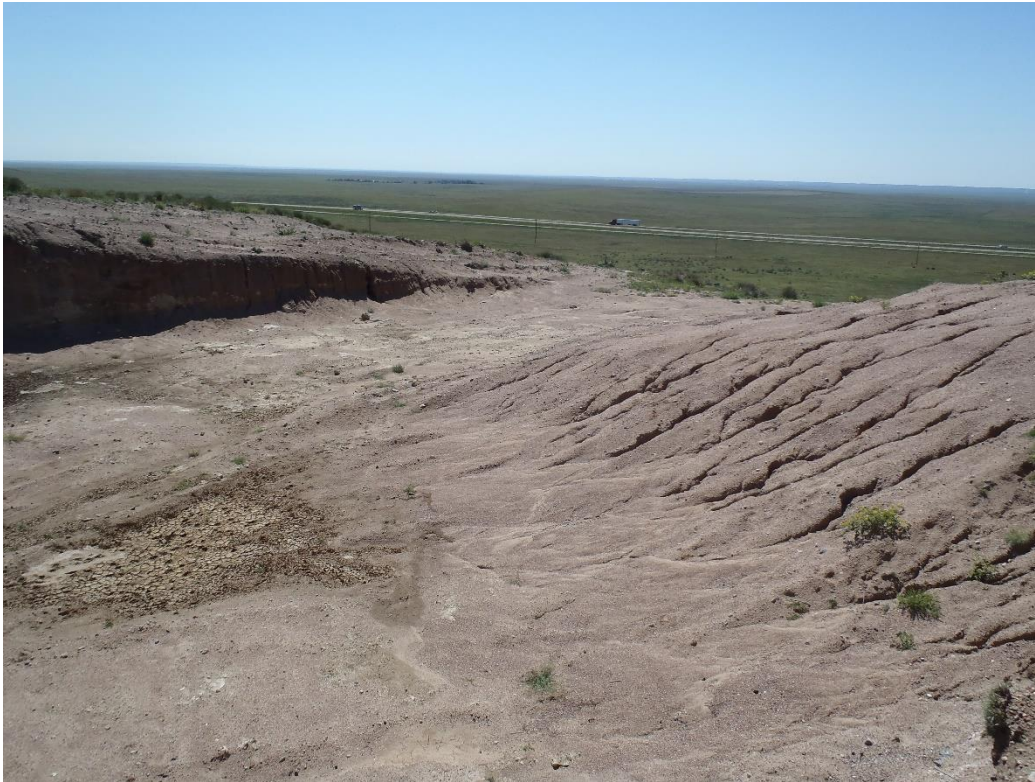
Gen. Compliance with Mine Plan: The operation appeared to be in compliance with the approved mine plan. Google Earth was used to measure the disturbed area, which was estimated to be approximately 12 acres. High walls were estimated to vary between 4 and 12 feet high and appeared stable on the perimeter (see **Photo 2**). Internal highwalls appeared less stable with respect erosion, but not considered problematic (see **Photo 3**).

Photo 2. High walls estimated between 4 and 12 feet in height and appeared stable (looking SW).

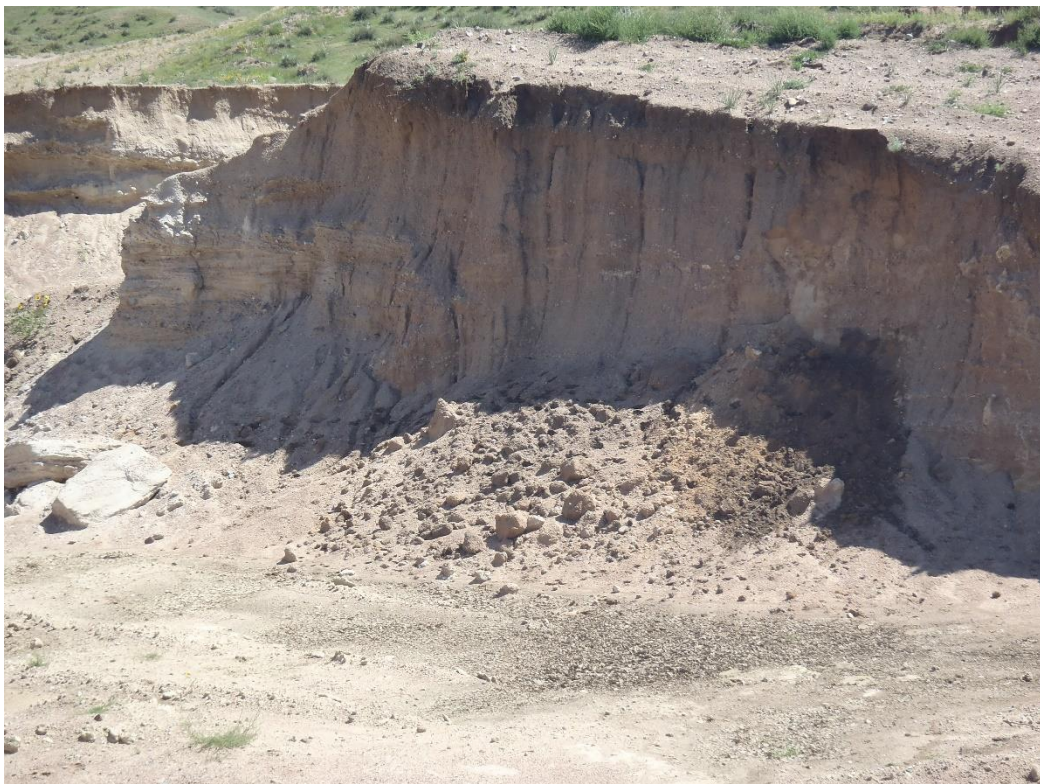
Photo 3. Less stable internal highwalls (with respect erosion), but not considered problematic.

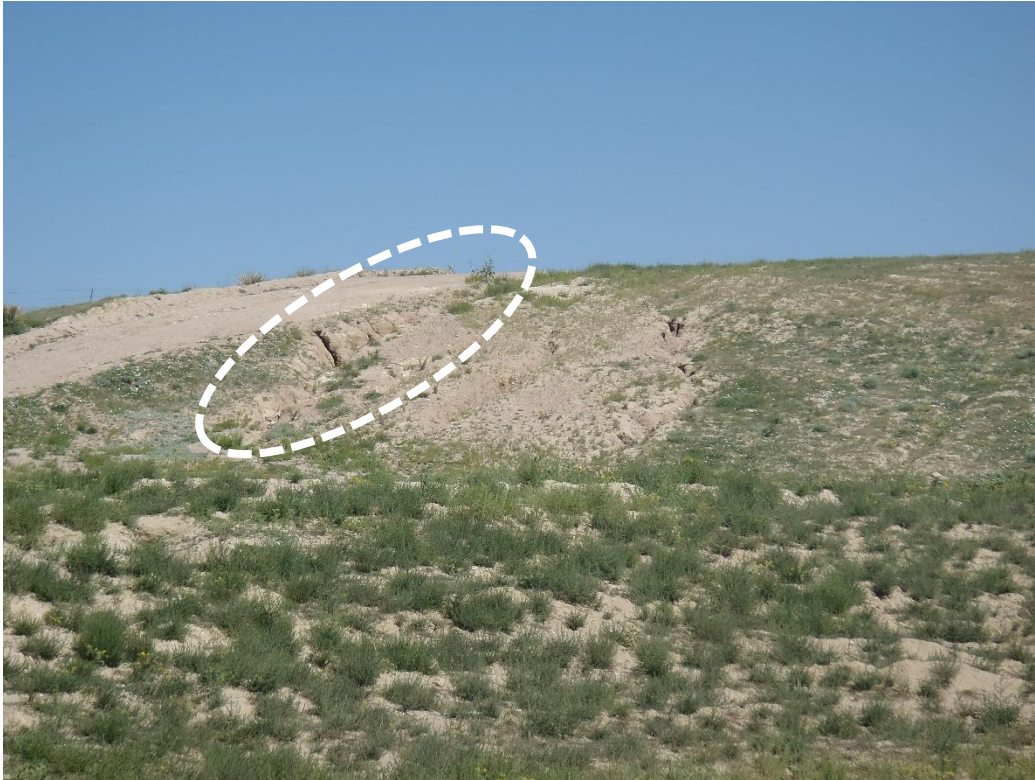
Sediment Control: A large erosion gully was observed along the haul road on the west side of the north slope (see **Photo 4**). This gully should be repaired and best management practices (BMPs) for erosion control be implemented before the erosion can migrate off site to the north.

Photo 4. Large erosion gully observed along the haul road (looking NW).

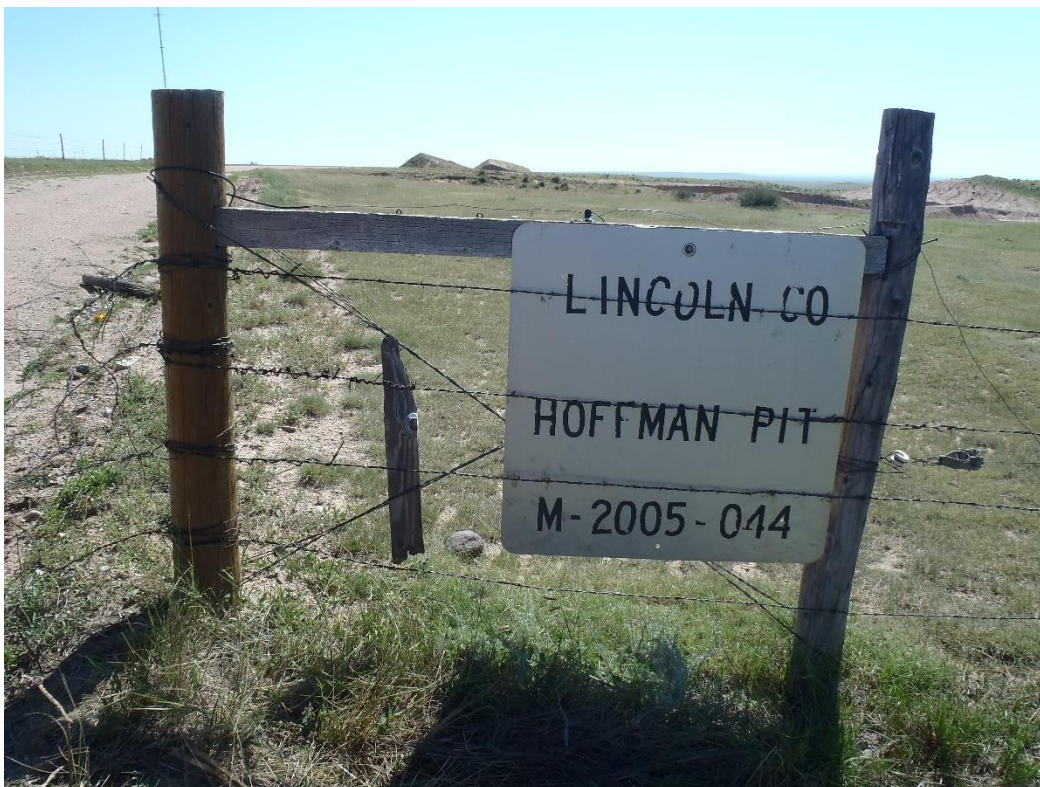
Signs and Markers: The permit sign was properly posted (see **Photo 5**) and boundary markers (T-posts) were observed to delineate the permit boundary (see **Photo 6**).

Photo 5. Permit sign properly posted (entrance) .

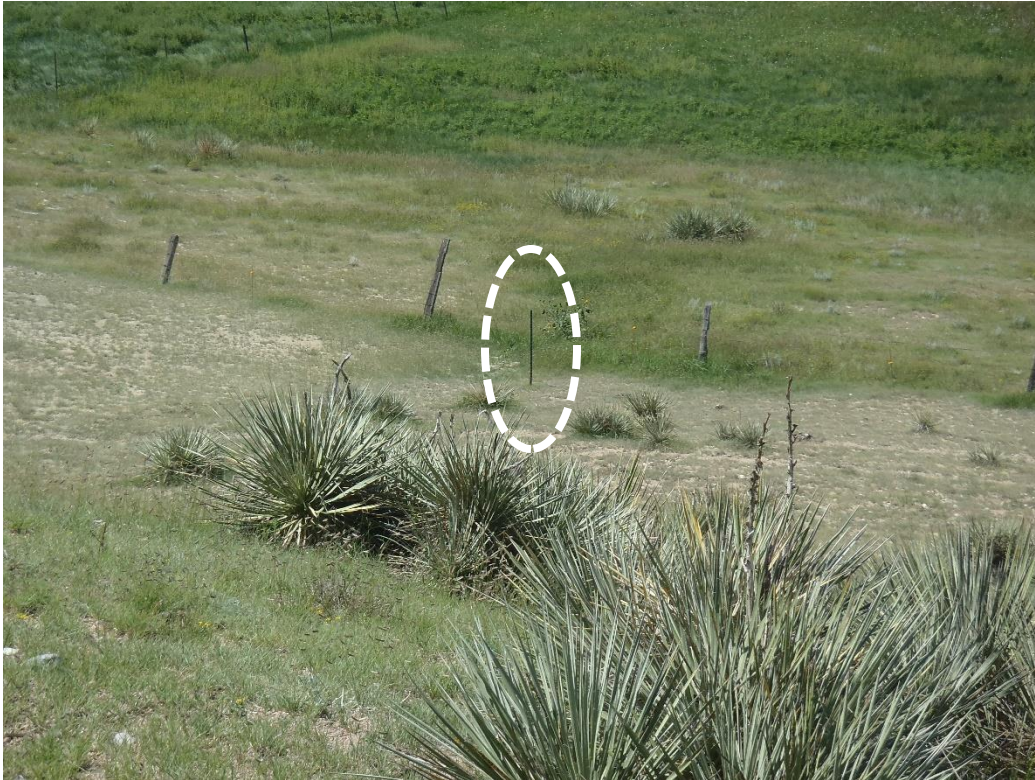
Photo 6. Typical boundary marker (T-posts) used to delineate the permit boundary.

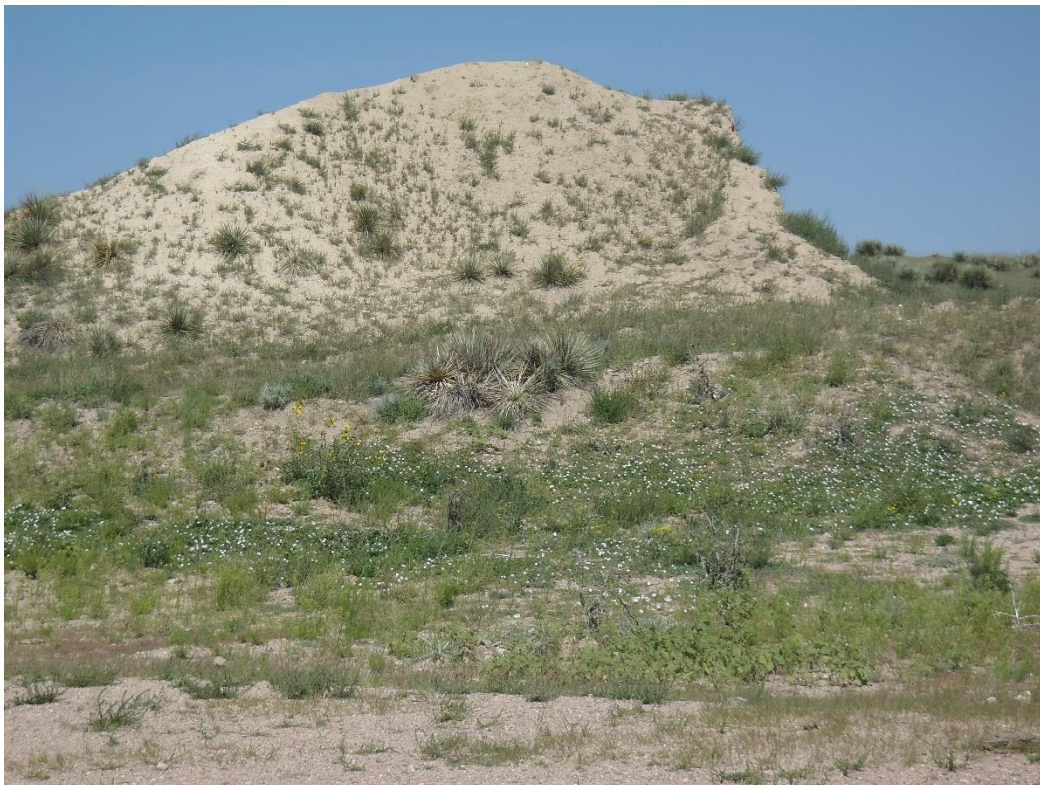
Revegetation: As mentioned above, the north slope has been seeded. Some bindweed (a List C species) was observed on topsoil stockpiles, but not in significant amounts. The Permittee should monitor the site for noxious weeds. No other noxious weeds were observed.

Topsoil: A topsoil stockpile is on the west side of the pit, south of the entrance road (see **Photo 7**).

Photo 7. Topsoil stockpile on west side of pit (Note bindweed in foreground).
