**MINERALS PROGRAM INSPECTION REPORT**  
**PHONE: (303) 866-3567**

<b>MINE NAME:</b> Caliche School Pit	<b>MINE/PROSPECTING ID#:</b> M-1989-023	<b>MINERAL:</b> Sand and gravel	<b>COUNTY:</b> Logan
<b>INSPECTION TYPE:</b> Monitoring	<b>INSPECTOR(S):</b> Jared L. Ebert	<b>INSP. DATE:</b> October 12, 2017	<b>INSP. TIME:</b> 11:15
<b>OPERATOR:</b> Kristine M Couch	<b>OPERATOR REPRESENTATIVE:</b> Kristine Couch	<b>TYPE OF OPERATION:</b> 110c - Construction Limited Impact	
<b>REASON FOR INSPECTION:</b> Normal I&E Program	<b>BOND CALCULATION TYPE:</b> Complete Bond	<b>BOND AMOUNT:</b> \$43,000.00	
<b>DATE OF COMPLAINT:</b> NA	<b>POST INSP. CONTACTS:</b> None	<b>JOINT INSP. AGENCY:</b> None	
<b>WEATHER:</b> Clear	<b>INSPECTOR'S SIGNATURE:</b>

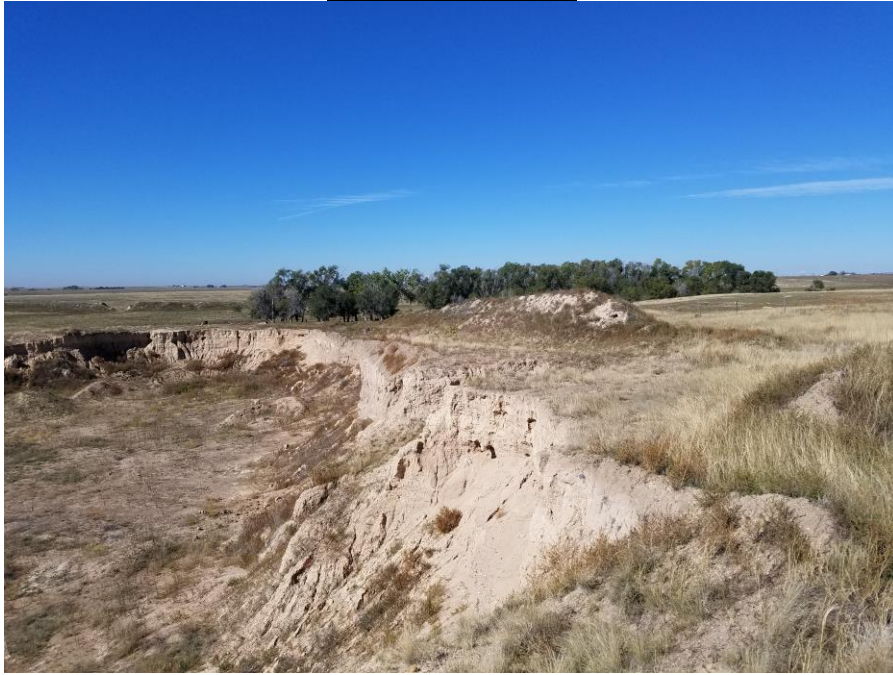
Figure 1. From the northeast corner of the pit looking west.

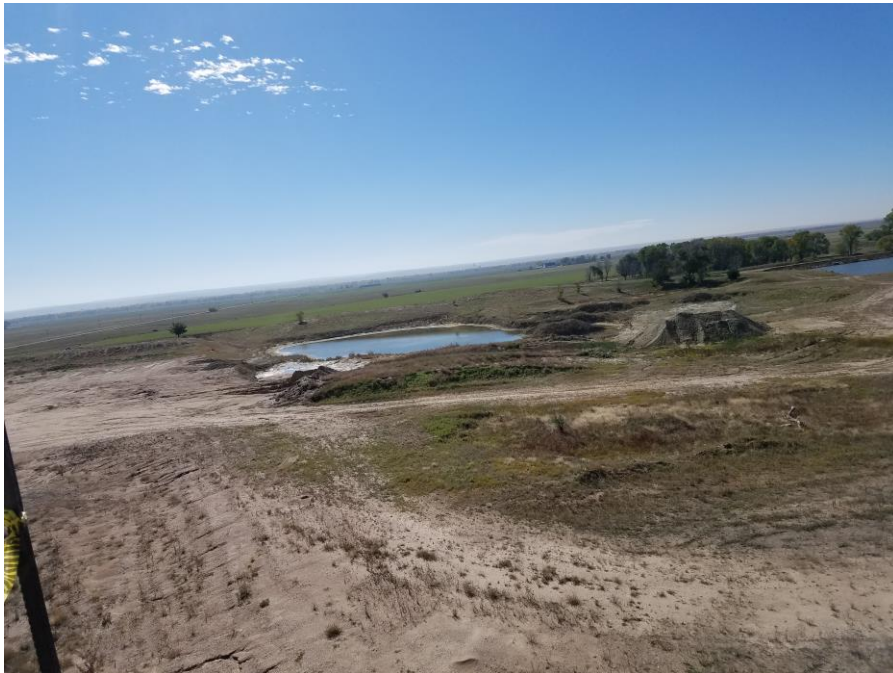
Figure 2. From the top of the pit looking south.

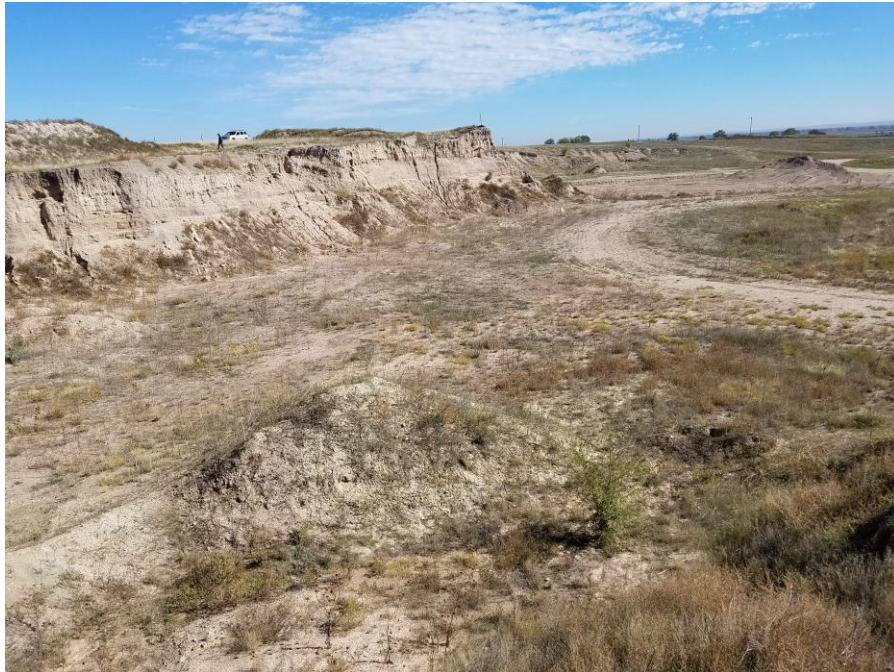
Figure 3. From the west end of the pit looking northeast.

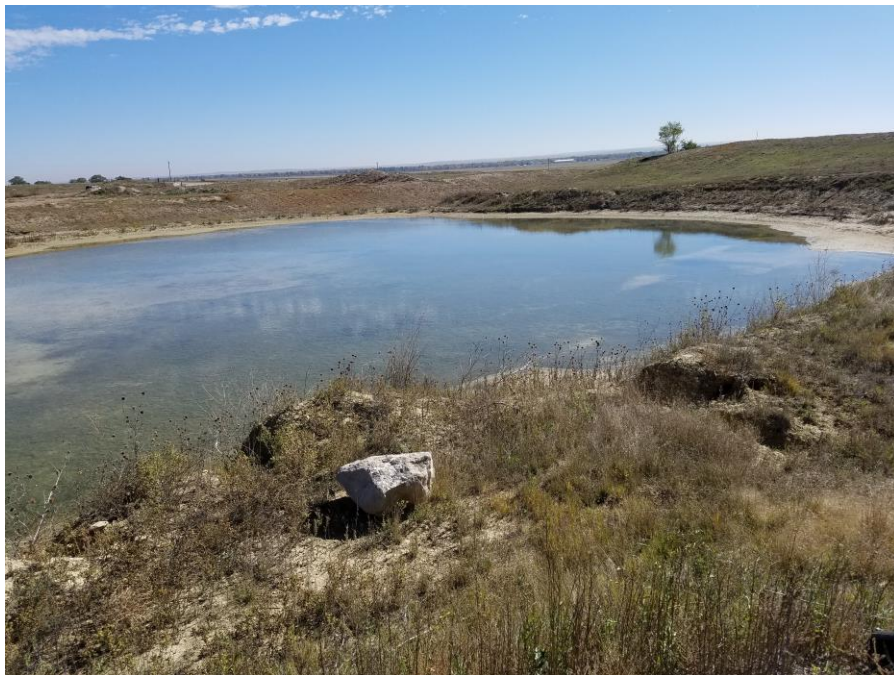
Mrs. Couch owns an augmentation pond that is adjacent to the permit area. Given the hydrologic conditions of the site it appears water from her pond has seeped into the pit area. It appears a small trench has been created on the south end of the site to help drain the pond to the adjacent ditch. However the inlet to the trench is above the pooled water in the pit. Mrs. Couch indicated that they intend to excavate the trench deeper to help drain the water collected in the bottom of the pit.

Figure 4. Water pooled at the base of the pit.

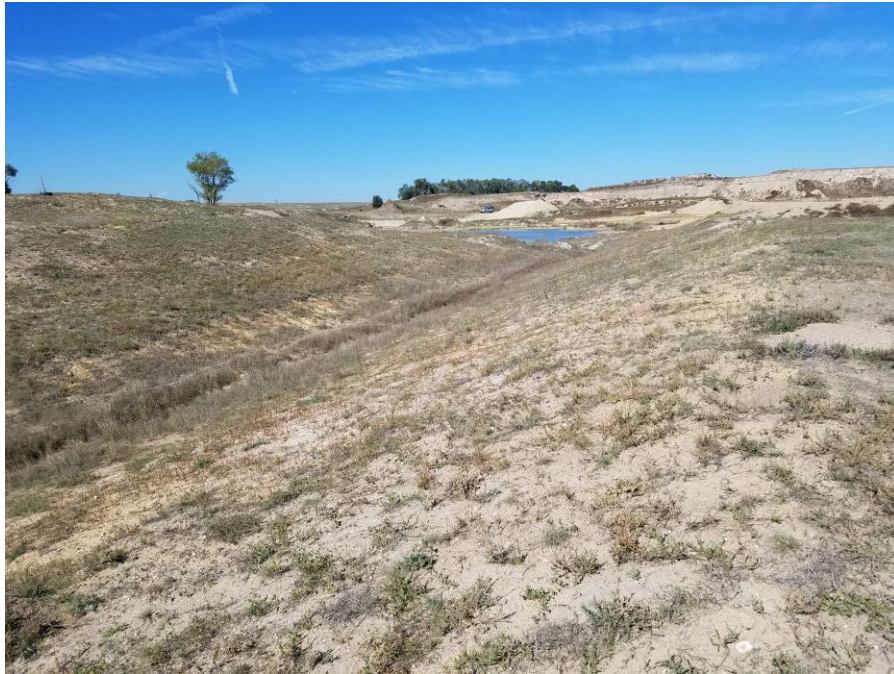
Figure 5. Trench from bottom of the pit, view from the south end looking north.
