PERMIT INFORMATION

Permit Number: C-1981-008 Mine Name: New Horizon Mine Operator: Elk Ridge Mining and Reclamation, LLC Operator Address: Mr. Tony Tennyson 5731 State Highway 13 Meeker, CO 81641	County: Montrose Operation Type: Surface Permit Status: Active Ownership: Private
	Operator Representative Present: Frank Ferris
Operator Representative Signature: (Field Issuance Only)

INSPECTION INFORMATION

Inspection Start Date: September 26, 2017 Inspection Start Time: 09:00 Inspection End Date: September 26, 2017 Inspection End Time: 16:00		Inspection Type: Coal Partial Inspection Inspection Reason: OSM Oversight Inspection Weather: Clear	
Joint Inspection Agency: OSM		Joint Inspection Contacts: Christine Belka	
Post Inspection Agency: None		Post Inspection Contacts: 	
Inspector(s): Brock F. Bowles	Inspector's Signature:

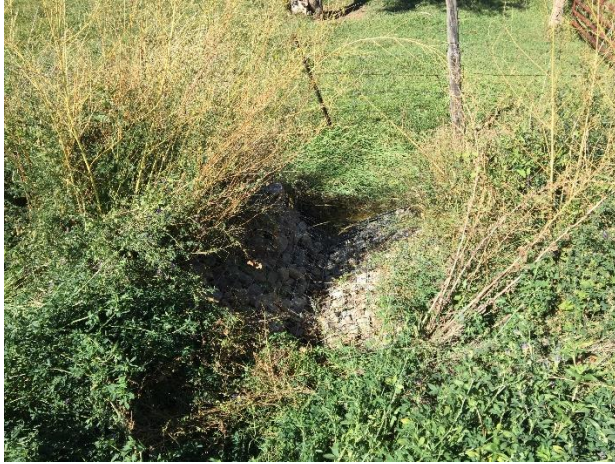
Photo 1 – Gabion Cage Sediment Control

The sediment control structure on the NW corner of the Morgan field was in working order. The rock gabion cage (photo 1) was in place along with the straw wattles. The vegetation on the field and on the embankments was thick and there were no signs of erosion. The Enstrom irrigation water was flowing around the field edge to the county culvert as designed.

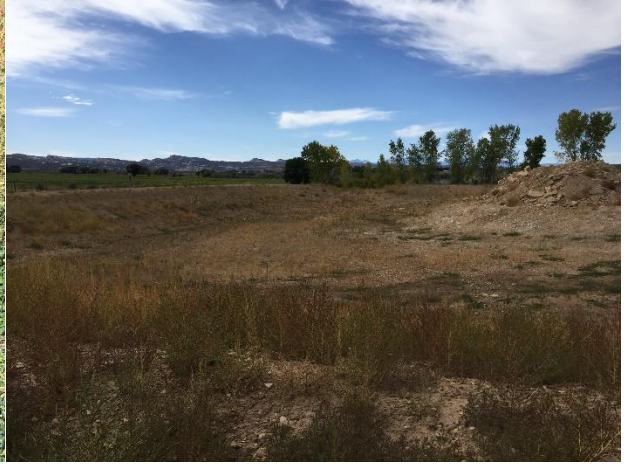
Photo 2 – Pond 18

Ponds 9, 16 and 18 (photo 2) did not contain water.
