**PERMIT INFORMATION**

| <b>Permit Number:</b> C-2010-089<br><b>Mine Name:</b> New Horizon North Mine<br><b>Operator:</b> Elk Ridge Mining and Reclamation, LLC<br><b>Operator Address:</b><br>Mr. Tony Tennyson<br>5731 State Highway 13<br>Meeker, CO 81641 | <b>County:</b> Montrose<br><b>Operation Type:</b> Surface<br><b>Permit Status:</b> Active<br><b>Ownership:</b> Private |

| <b>Inspection Start Date:</b> September 26, 2017<br><b>Inspection Start Time:</b> 13:00<br><b>Inspection End Date:</b> September 26, 2017<br><b>Inspection End Time:</b> 16:00 | <b>Inspection Type:</b> Coal Partial Inspection<br><b>Inspection Reason:</b> Normal I&E Program<br><b>Weather:</b> Clear |

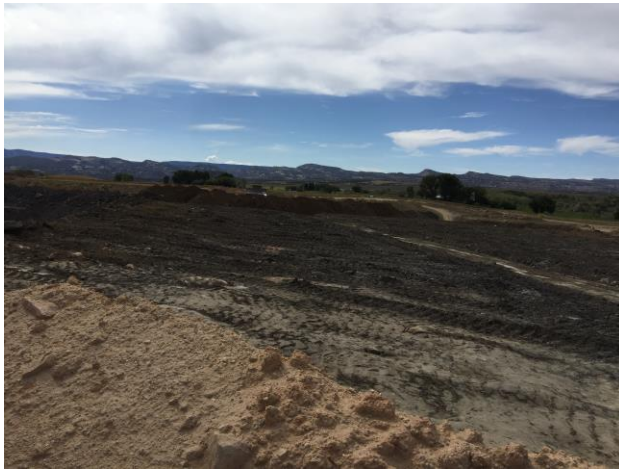
Photo 1 – Backfill in Center of Pit

The center of the pit was being backfilled first (photo 1). This is to accommodate the installation of the CCC Ditch pipeline sometime this fall/winter. The east side of the pit will get back filled after the coal stockpile is approved to be moved to NH2. The coal waste from the bottom of the coal stockpile will be placed in the bottom of the pit before it is backfilled.

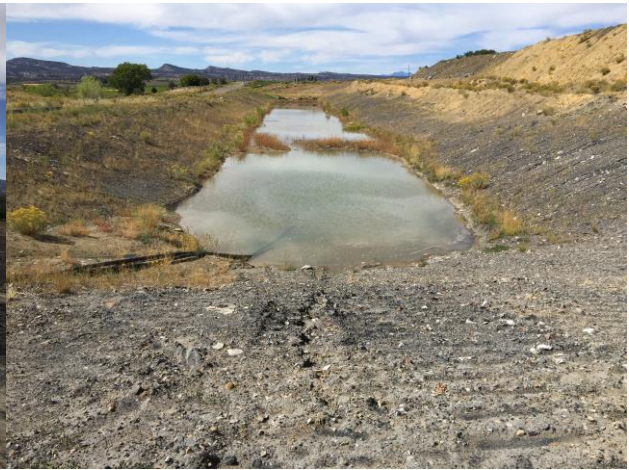
Photo 2 – Pond 001

Pond NHN-001 contained water but was not discharging (photo 1). The east ditch, between the pond and the service entrance was free and clear of obstructions.

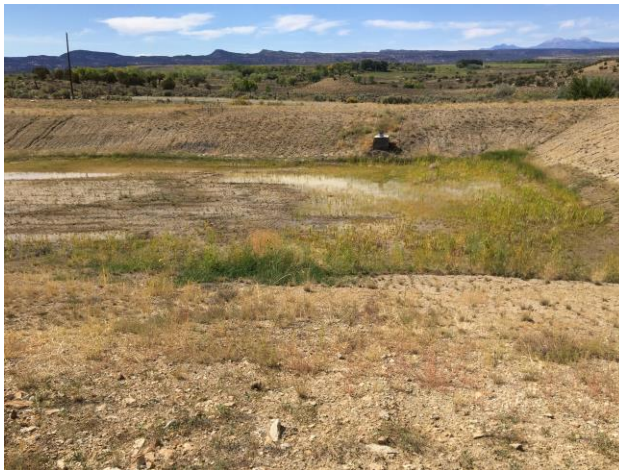
Photo 3 – Pond 002

Pond-002 contained a small puddle of water but was not discharging (photo 3). The south and north ditches were free and clear of obstructions.

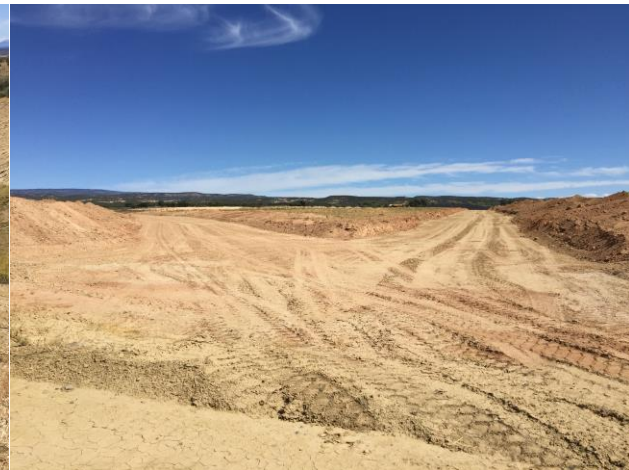
Photo 4 – Topsoil Moved for CCC Ditch Install

The topsoil was pushed aside on the west side of the Garvey property where the CCC Ditch will be installed (photo 4).
