## MINERALS PROGRAM INSPECTION REPORT

<b>MINE NAME:</b> Broken Spear Pit	<b>MINE/PROSPECTING ID#:</b> M-2000-050	<b>MINERAL:</b> Sand and gravel	<b>COUNTY:</b> Lincoln
<b>INSPECTION TYPE:</b> Monitoring	<b>INSPECTOR(S):</b> Timothy A. Cazier	<b>INSP. DATE:</b> August 24, 2015	<b>INSP. TIME:</b> 08:55
<b>OPERATOR:</b> Lincoln County	<b>OPERATOR REPRESENTATIVE:</b> Mark Bain	<b>TYPE OF OPERATION:</b> 110c - Construction Limited Impact	
<b>REASON FOR INSPECTION:</b> Normal I&E Program	<b>BOND CALCULATION TYPE:</b> None	<b>BOND AMOUNT:</b> \$10,000.00	
<b>DATE OF COMPLAINT:</b> NA	<b>POST INSP. CONTACTS:</b> None	<b>JOINT INSP. AGENCY:</b> None	
<b>WEATHER:</b> Clear	<b>INSPECTOR'S SIGNATURE:</b>

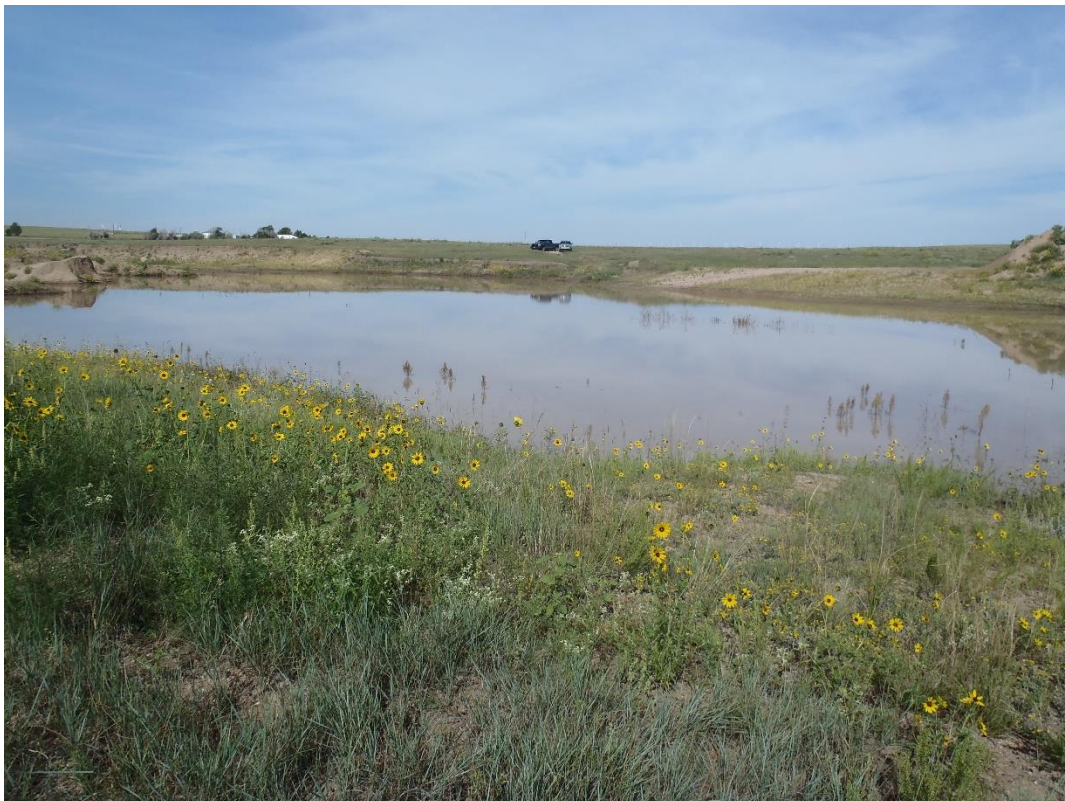
**Hydrologic Balance:** Standing water was observed in the pit (see **Photo 1**) pit and was determined to be stormwater from recent rains. No exposed groundwater was observed.

Photo 1. Standing water observed in the pit (looking SW).

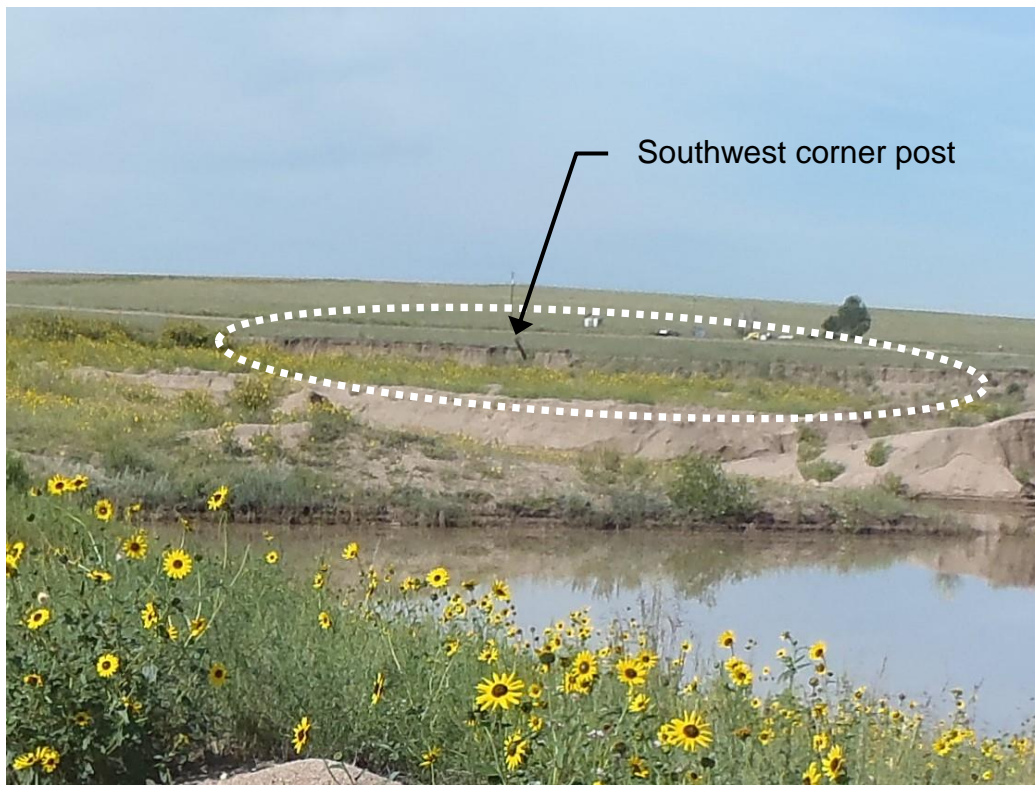
**Gen. Compliance with Mine Plan:** The operation appeared to be in compliance with the approved mine plan. The site is on the south bank of the ephemeral Arikaree River. Google Earth (September 2014 imagery) was used to measure the disturbed area, which was estimated to be approximately 3.25 acres. High walls were partially submerged. Mr. Bain estimated there might be as much as eight feet of highwall below the water line. The stability of the highwall was not able to be determined due to the presence of the water. It should be noted that another ephemeral stream (Currie Creek) enters the pit from the south and this stream is eroding the bank right at the permit boundary (see **Photo 2**).

Photo 2. Eroding west bank of Currie Creek & boundary marker (looking SW).

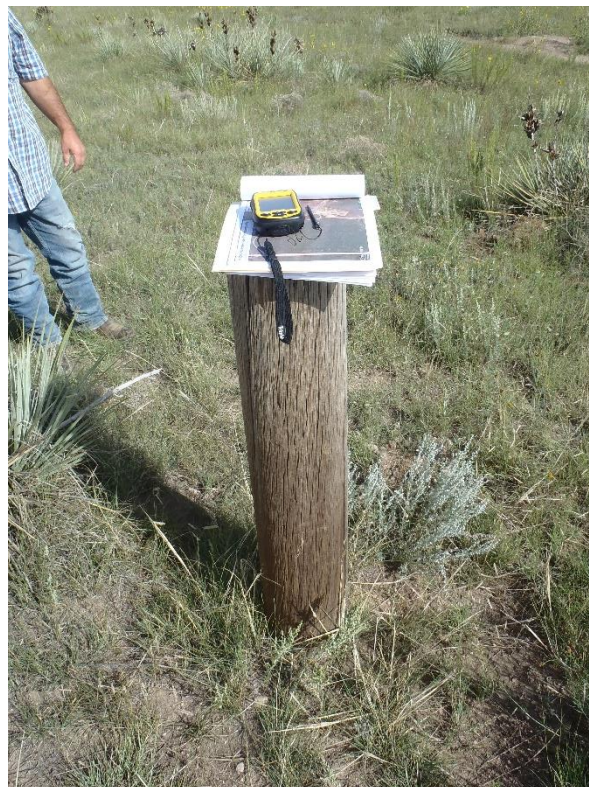
**Off-site Damage:** A hand held GPS unit (Trimble Juno 3B) was used to collect position data for each of the permit boundary corner markers (see **Photo 3**). Data processing for each collected point (wood corner post) confirmed a horizontal precision of between 5 and 6 feet. The operation was confirmed to be confined to the permit boundary (See **Figure 1**). However, a permit boundary was delineated using the GPS points for each marker and determined to be 10.4 acres (blue line on Figure 2) This is 0.5 acres greater than what is permitted, 9.9 acres; which is also the maximum allowed affected area for a 110c permit. In order to try to determine the source of the problem, an image of the permit boundary from the original application was used as an overlay in Google Earth (See **Figure 2**). This resulted in an area of 14.8 acres (see red line on **Figure 2**). There are potential errors in this assessment as only bearings, and no distances were provided for the two short segments on the south side of the "T" shaped boundary. The Division suggests moving wood posts 4 and 5 (**Figure 1**) to the northwest with the help of a professional surveyor to achieve the 9.9 acres limit and documenting the change in a technical revision submitted to the Division.

Photo 3. Trimble Juno 3B used to collect position of each permit boundary corner marker.

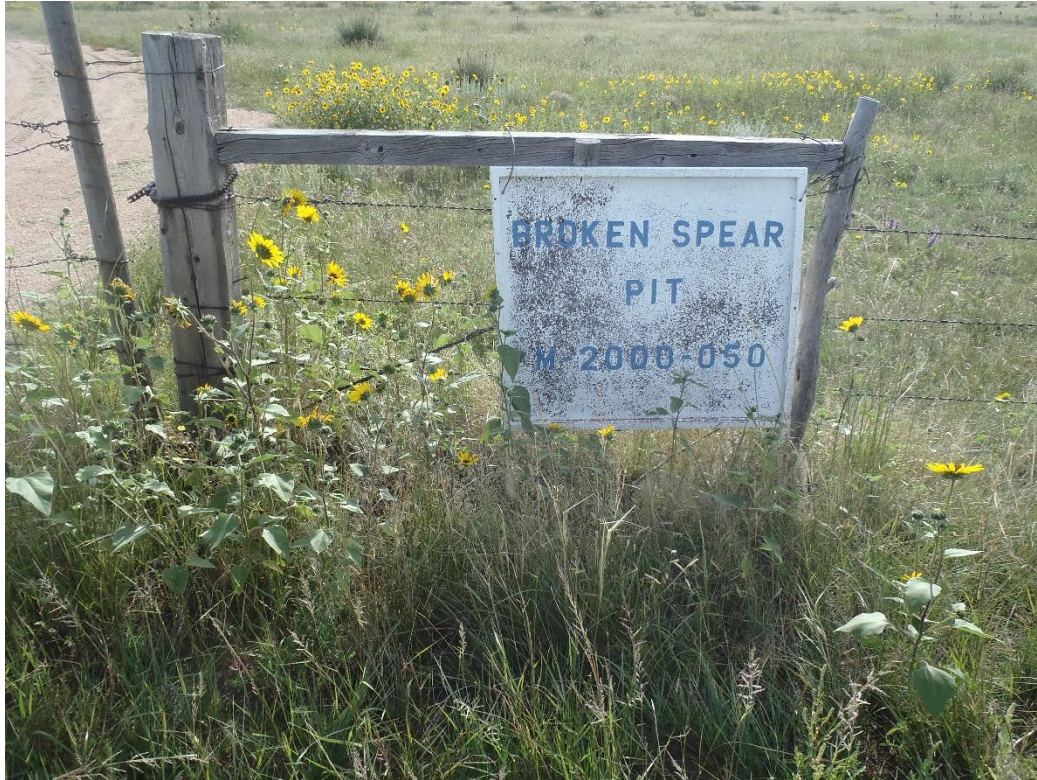
Photo 4. Permit sign properly posted.

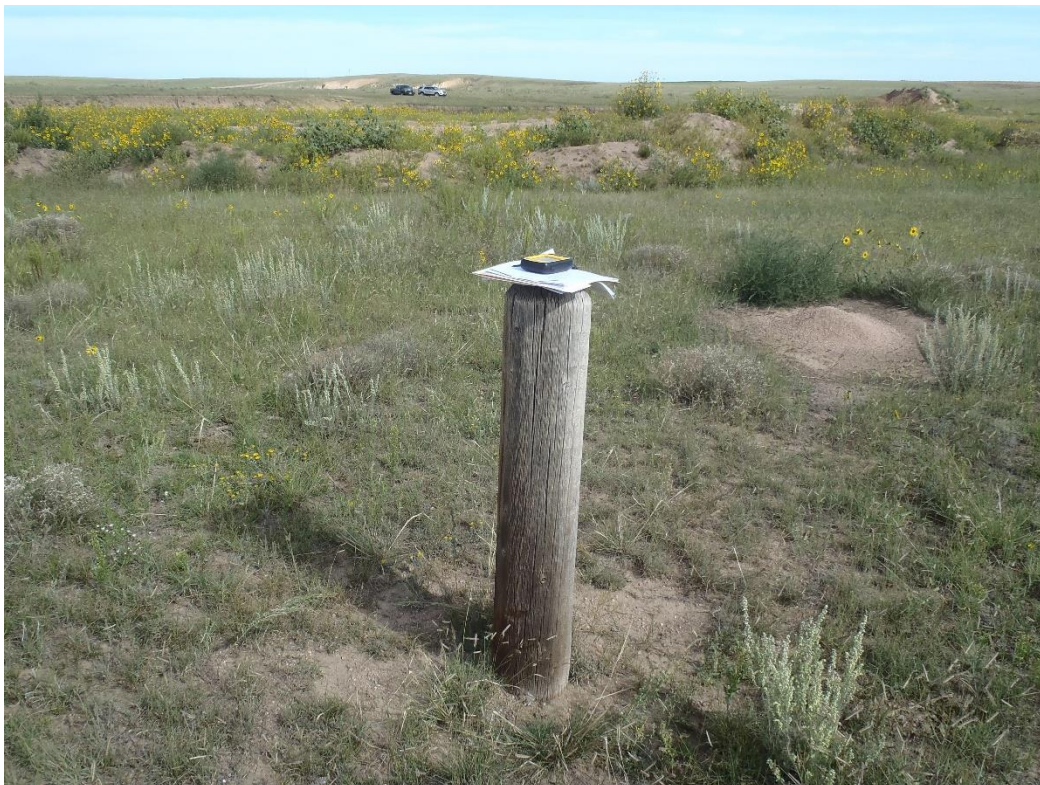
Signs and Markers: The permit sign was properly posted (see **Photo 4**) and boundary markers (wood posts) were observed to delineate the permit boundary (see **Photo 5**).

Photo 5. Typical boundary marker (wood post) used to delineate the permit boundary.

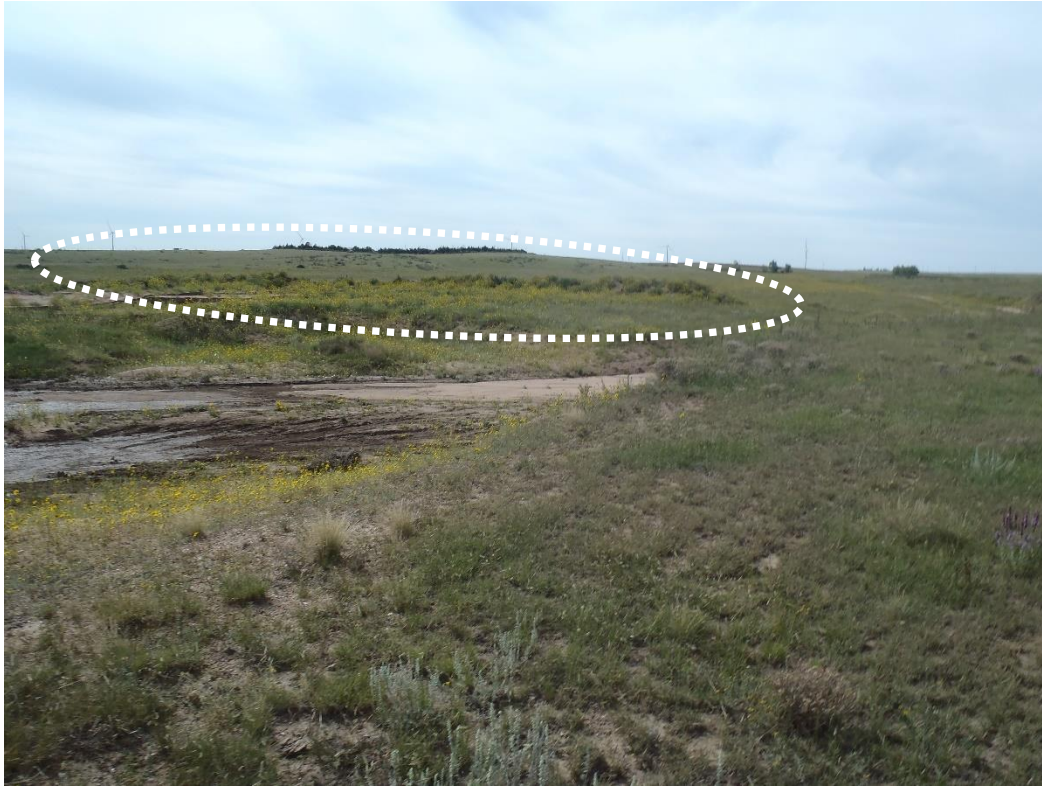
Topsoil: A topsoil stockpile is on the south side of the pit (see **Photo 6**).

Photo 6. Topsoil stockpile on south side of pit.

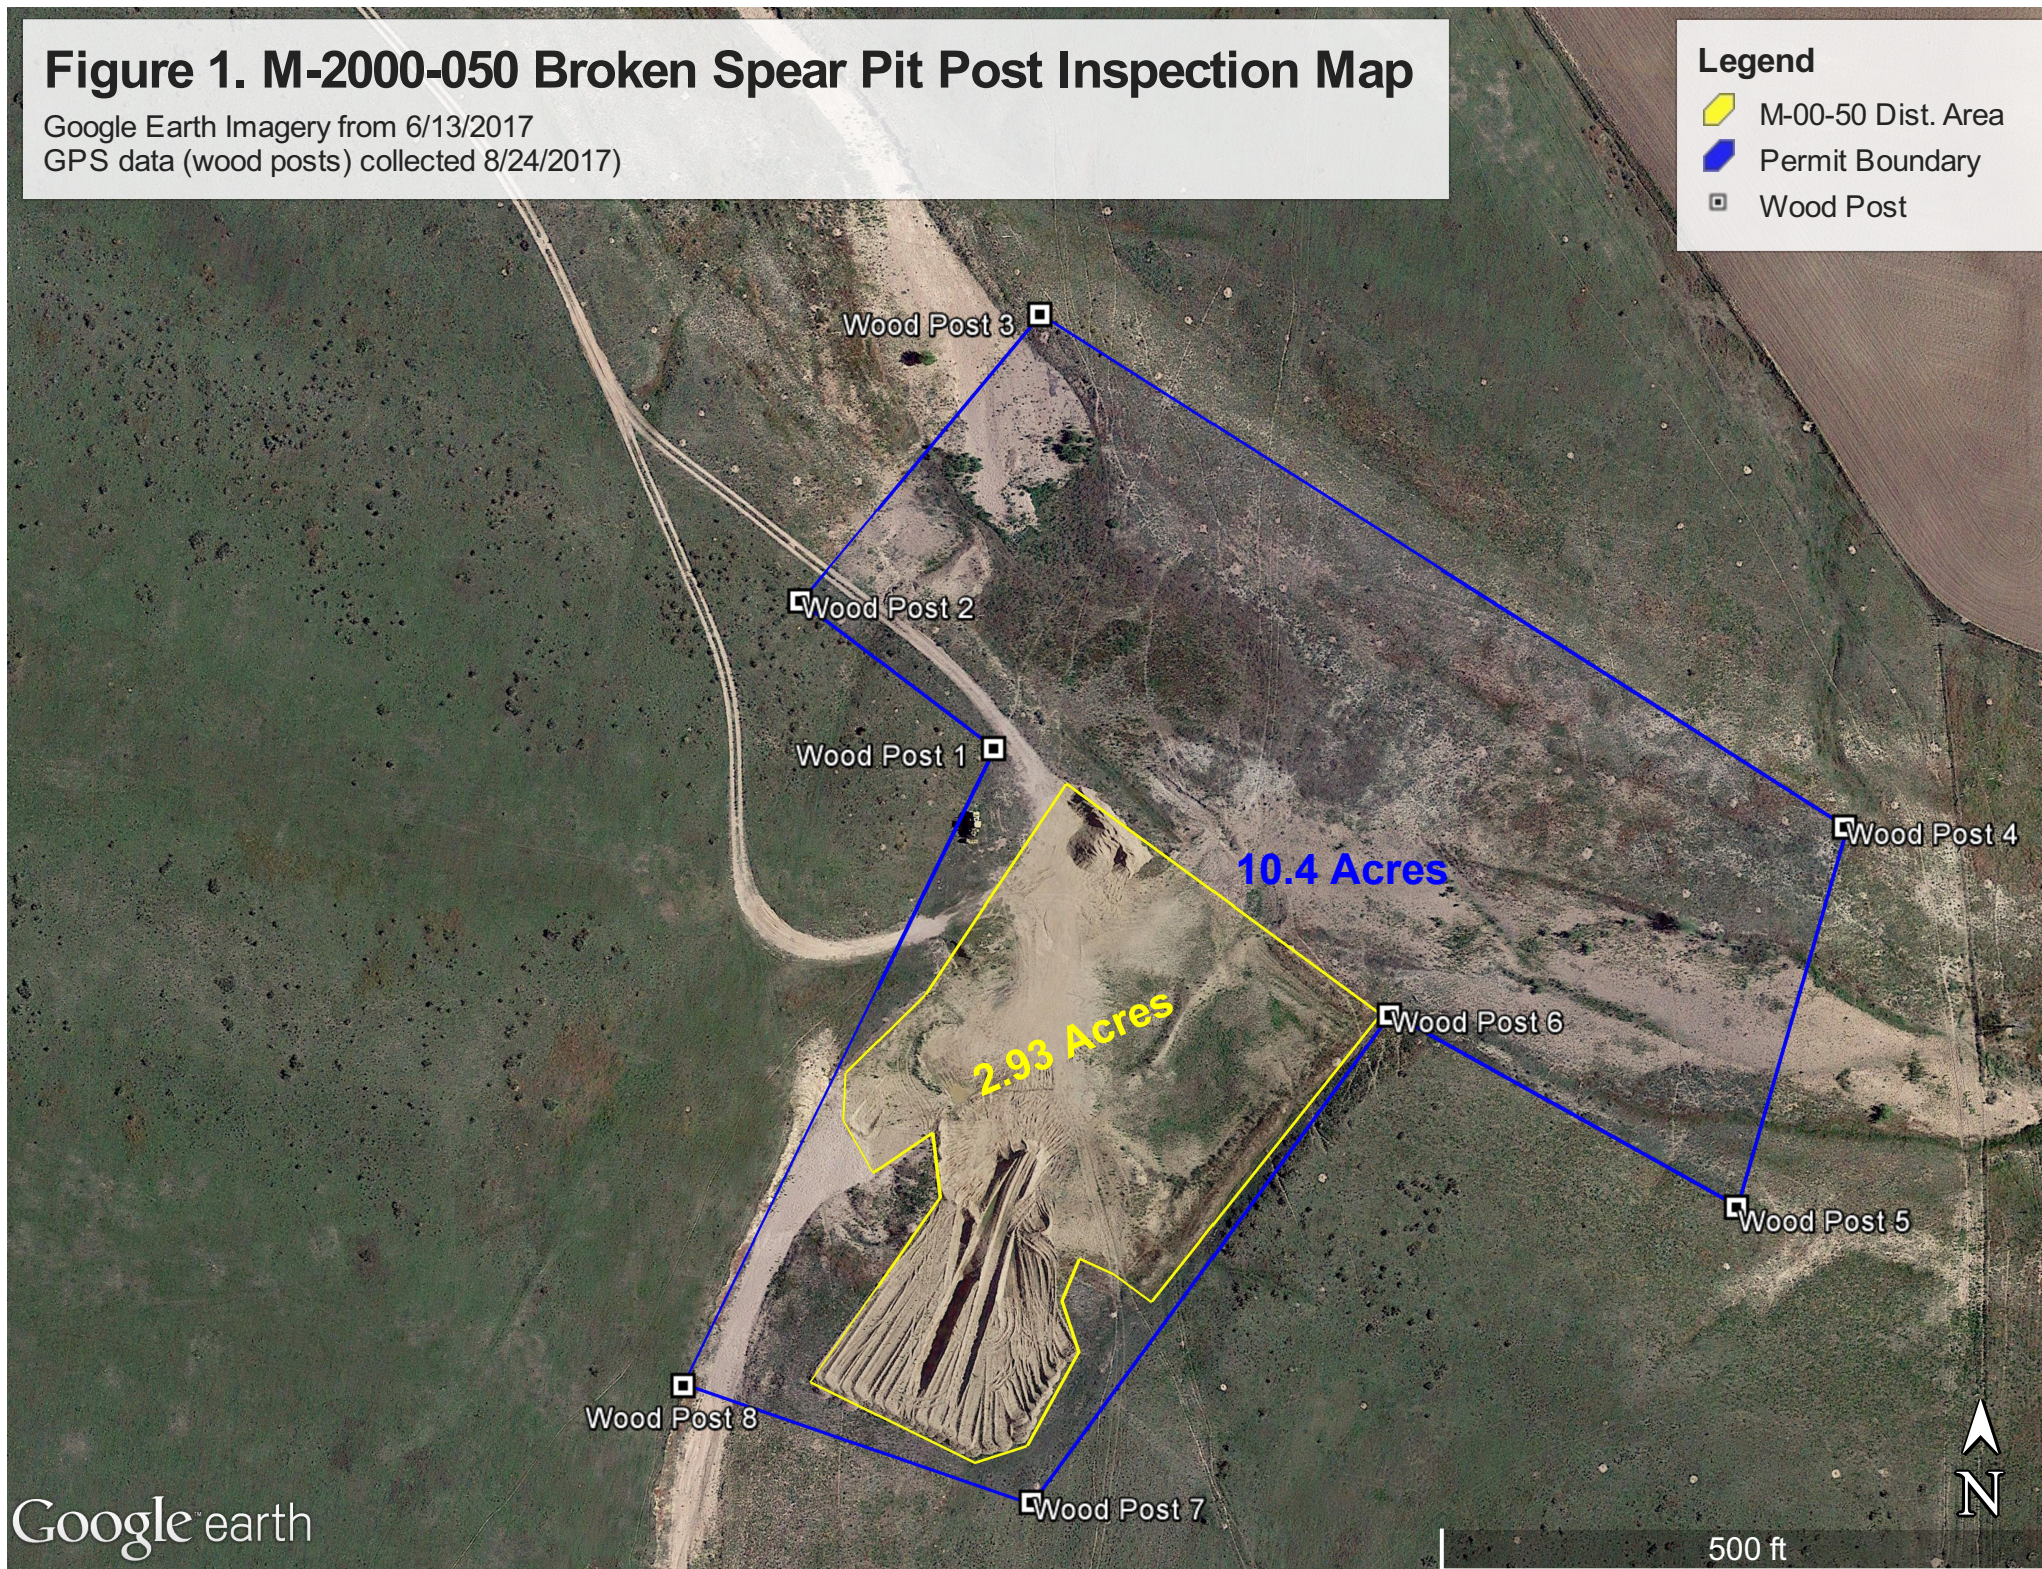
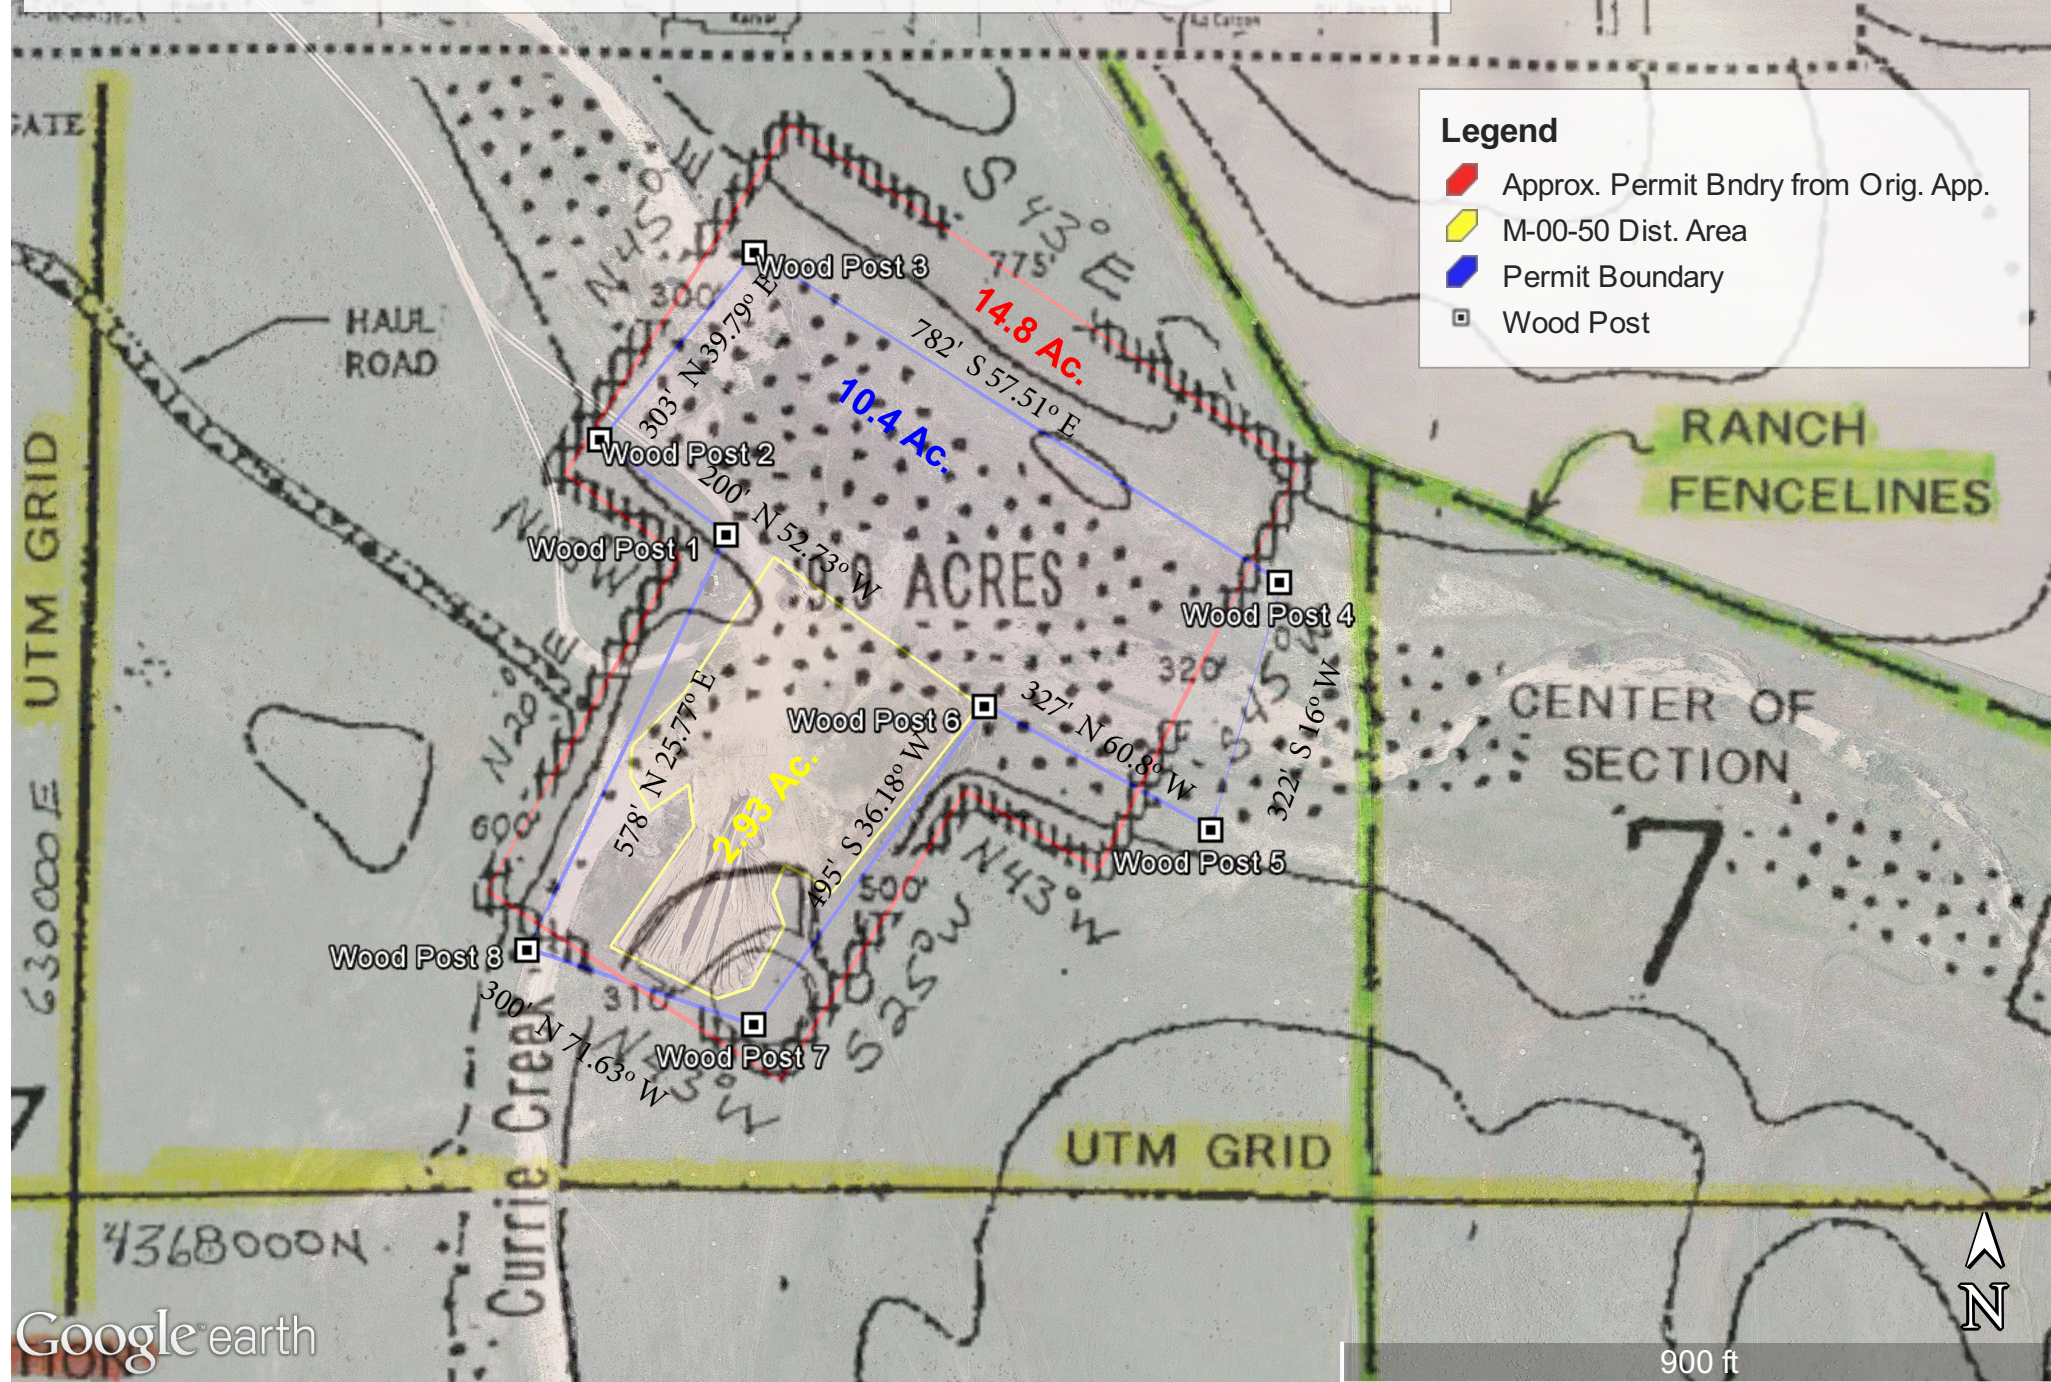
# Figure 1. M-2000-050 Broken Spear Pit Post Inspection Map

**PROBLEM/POSSIBLE VIOLATION:** Problem: Current boundary markers delineate 10.4 acres which is a half acre more than what is allowed by the permit.

**CORRECTIVE ACTIONS:** Adjust one or more boundary markers while keeping the current affected area inside the boundary to reduce the permit area to the approved 9.9 acres and submit a technical revision (along with the required \$216 fee) with a map and legal description to document the corrected permit area.
