MINERALS PROGRAM INSPECTION REPORT

| MINE NAME: Broken Spear Pit | MINE/PROSPECTING ID#: M-2000-050 | MINERAL: Sand and gravel | COUNTY: Lincoln |
| INSPECTION TYPE: Monitoring | INSPECTOR(S): Timothy A. Cazier | INSP. DATE: August 24, 2015 | INSP. TIME: 08:55 |

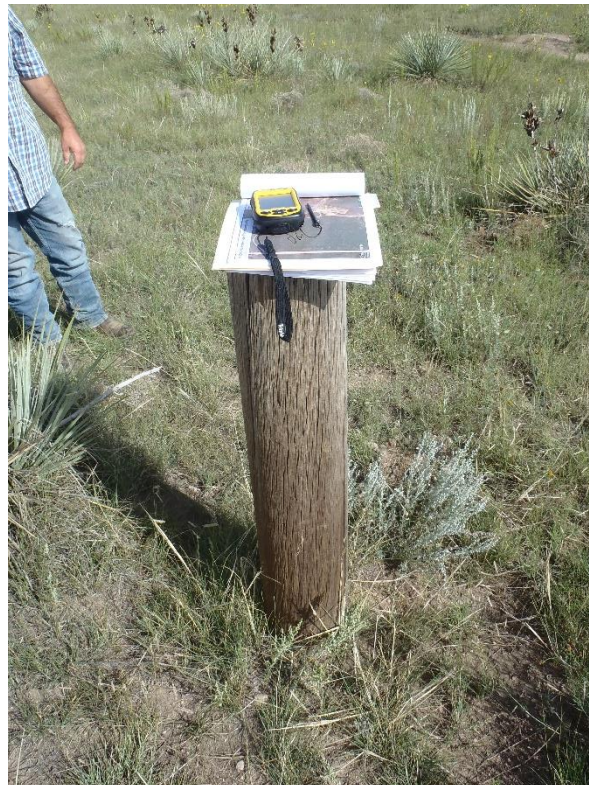
PROBLEM/POSSIBLE VIOLATION: Problem: Current boundary markers delineate 10.4 acres which is a half acre more than what is allowed by the permit.

Off-site Damage: A hand held GPS unit (Trimble Juno 3B) was used to collect position data for each of the permit boundary corner markers (see **Photo 3**). Data processing for each collected point (wood corner post) confirmed a horizontal precision of between 5 and 6 feet. The operation was confirmed to be confined to the permit boundary (See **Figure 1**). However, a permit boundary was delineated using the GPS points for each marker and determined to be 10.4 acres (blue line on Figure 2) This is 0.5 acres greater than what is permitted, 9.9 acres; which is also the maximum allowed affected area for a 110c permit. In order to try to determine the source of the problem, an image of the permit boundary from the original application was used as an overlay in Google Earth (See **Figure 2**). This resulted in an area of 14.8 acres (see red line on **Figure 2**). There are potential errors in this assessment as only bearings, and no distances were provided for the two short segments on the south side of the "T" shaped boundary. The Division suggests moving wood posts 4 and 5 (**Figure 1**) to the northwest with the help of a professional surveyor to achieve the 9.9 acres limit and documenting the change in a technical revision submitted to the Division.

Photo 3. Trimble Juno 3B used to collect position of each permit boundary corner marker.

CORRECTIVE ACTIONS: Adjust one or more boundary markers while keeping the current affected area inside the boundary to reduce the permit area to the approved 9.9 acres and submit a technical revision (along with the required \$216 fee) with a map and legal description to document the corrected permit area.

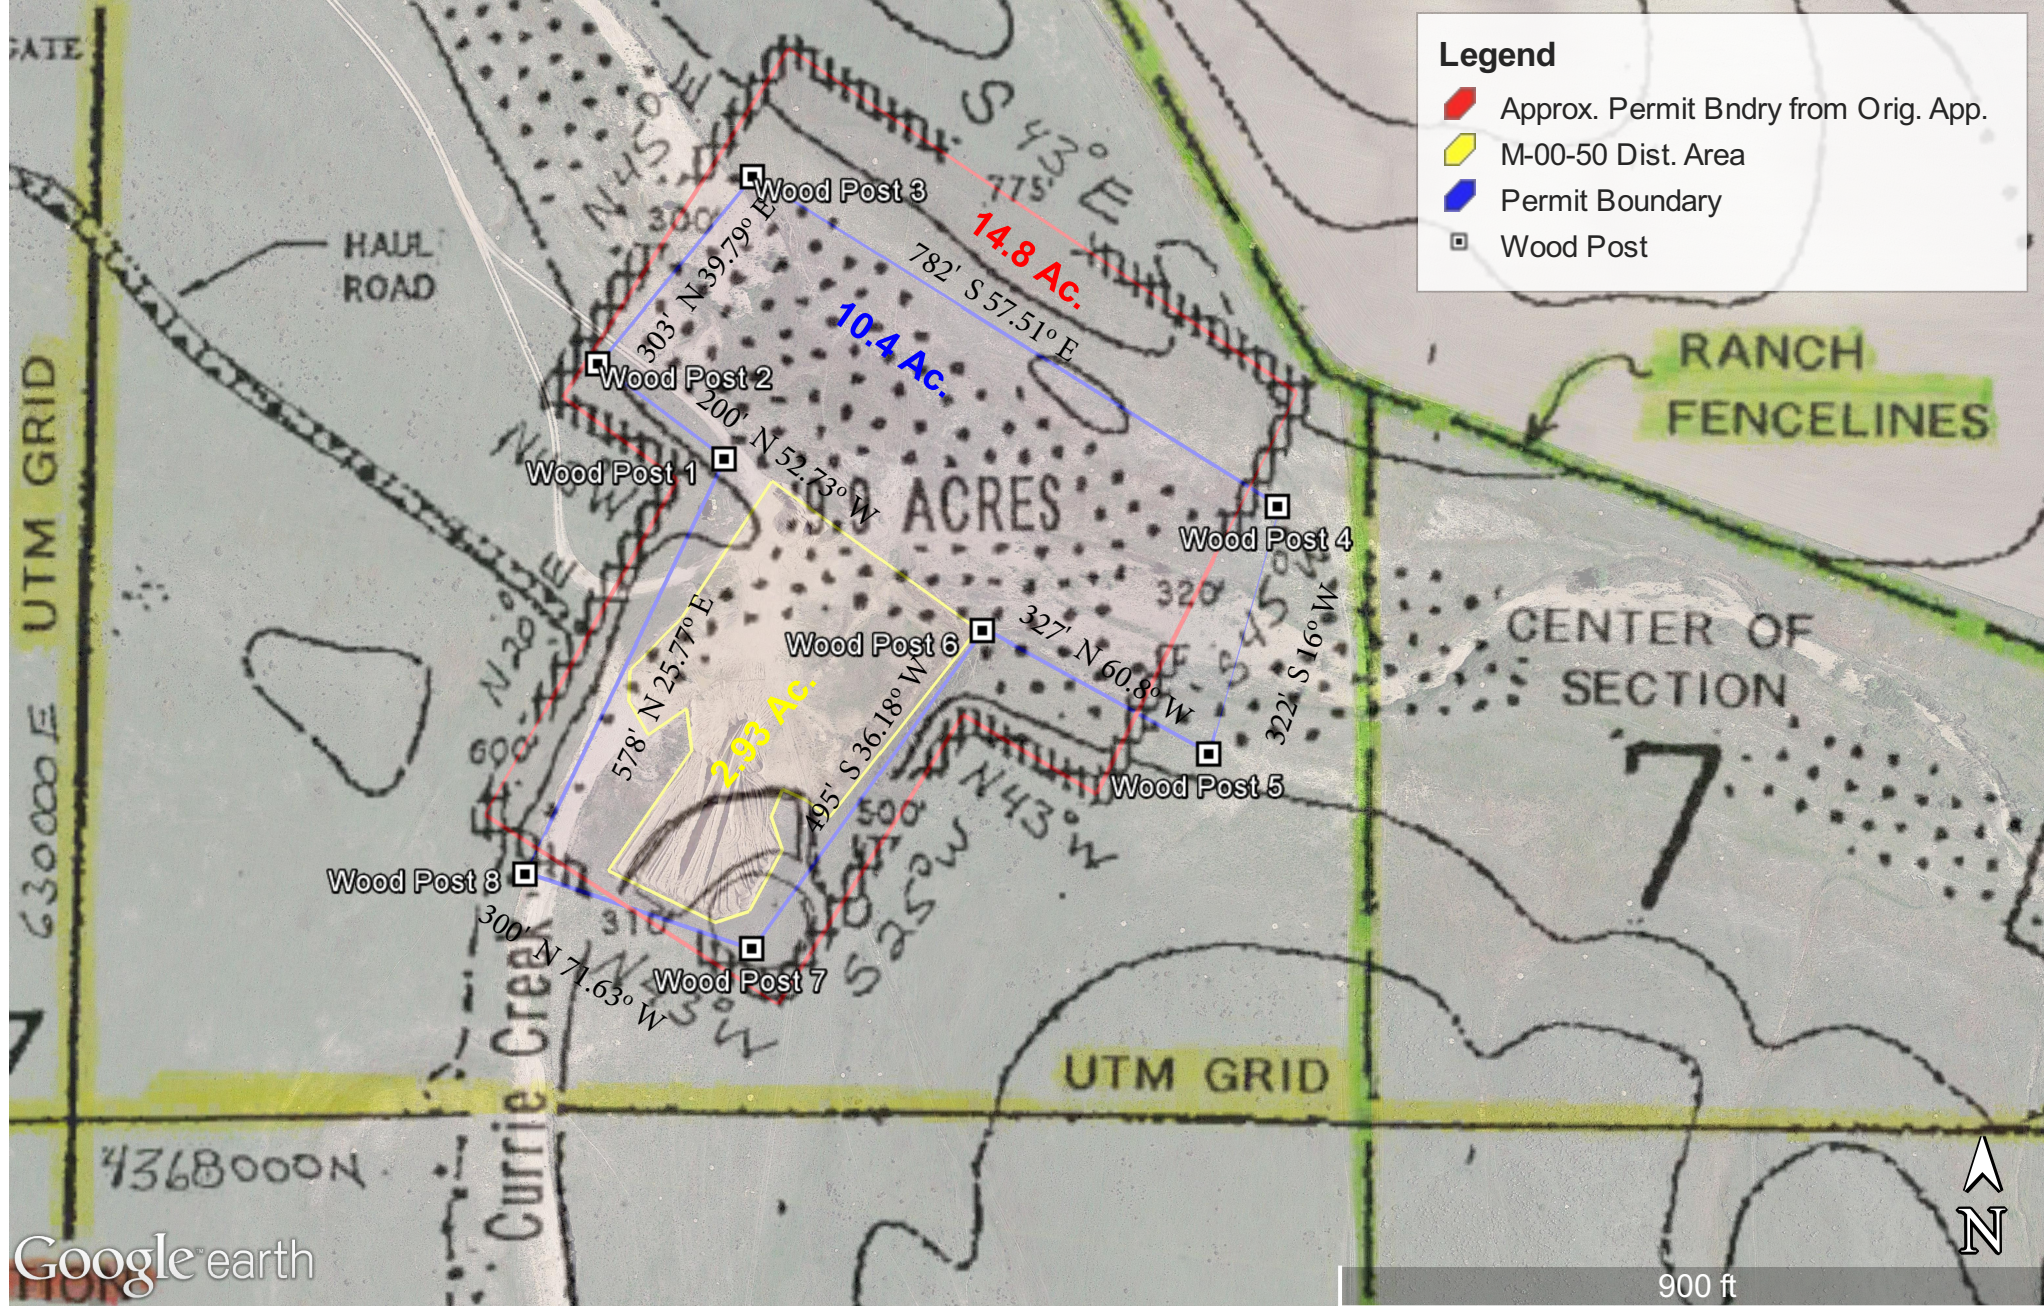
Figure 2. M-2000-050 Broken Spear Pit Post Inspection Map

Google Earth Imagery from 6/13/2017; GPS data collected 8/24/2017

Includes Image Overlay from Original Application (5/12/2000)
