MINERALS PROGRAM INSPECTION REPORT
PHONE: (303) 866-3567

| MINE NAME: Lofdahl | MINE/PROSPECTING ID#: M-2004-001 | MINERAL: Sand and gravel | COUNTY: Lincoln |
| INSPECTION TYPE: Monitoring | INSPECTOR(S): Timothy A. Cazier | INSP. DATE: August 23, 2017 | INSP. TIME: 14:20 |

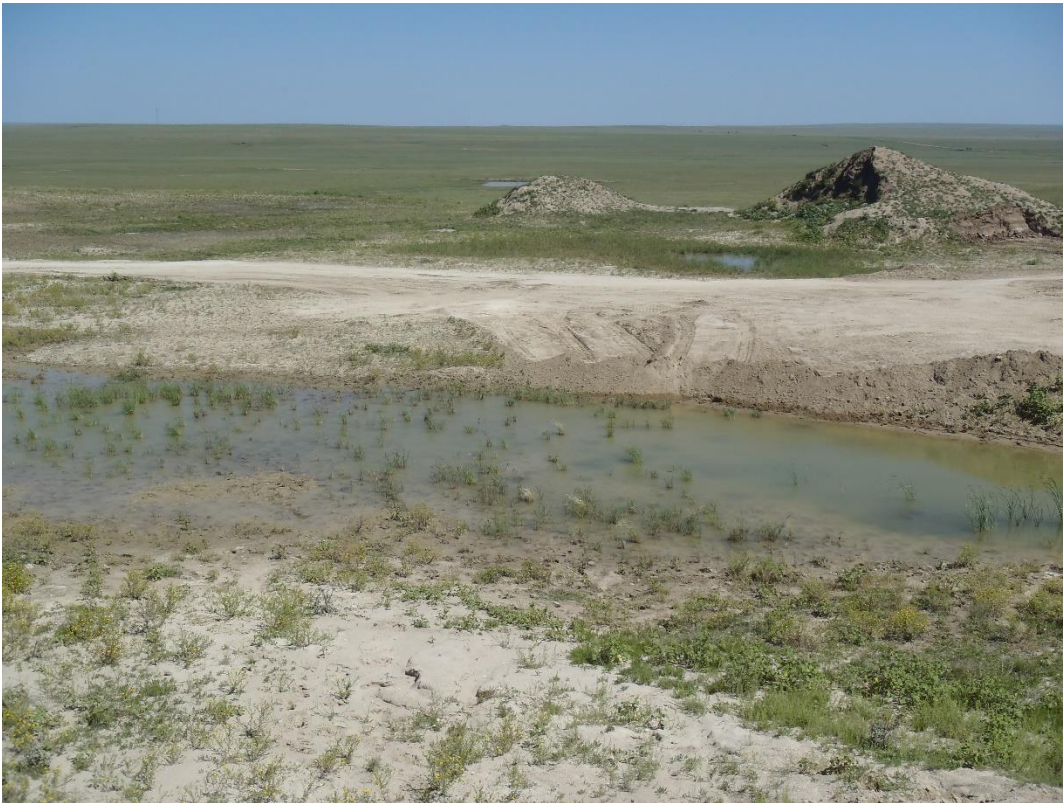
Hydrologic Balance: Some standing water was observed in the pit (see **Photo 1**) as a result of recent storms. It was determined not to be exposed groundwater.

Topsoil: A topsoil stockpile was observed on the uphill side of the pit (see **Photo 6**) and two on the east side (see **Photos 1** and **7**) . All appeared stable.

Photo 1. Standing water observed in the pit & south topsoil stockpile on right (looking SE).

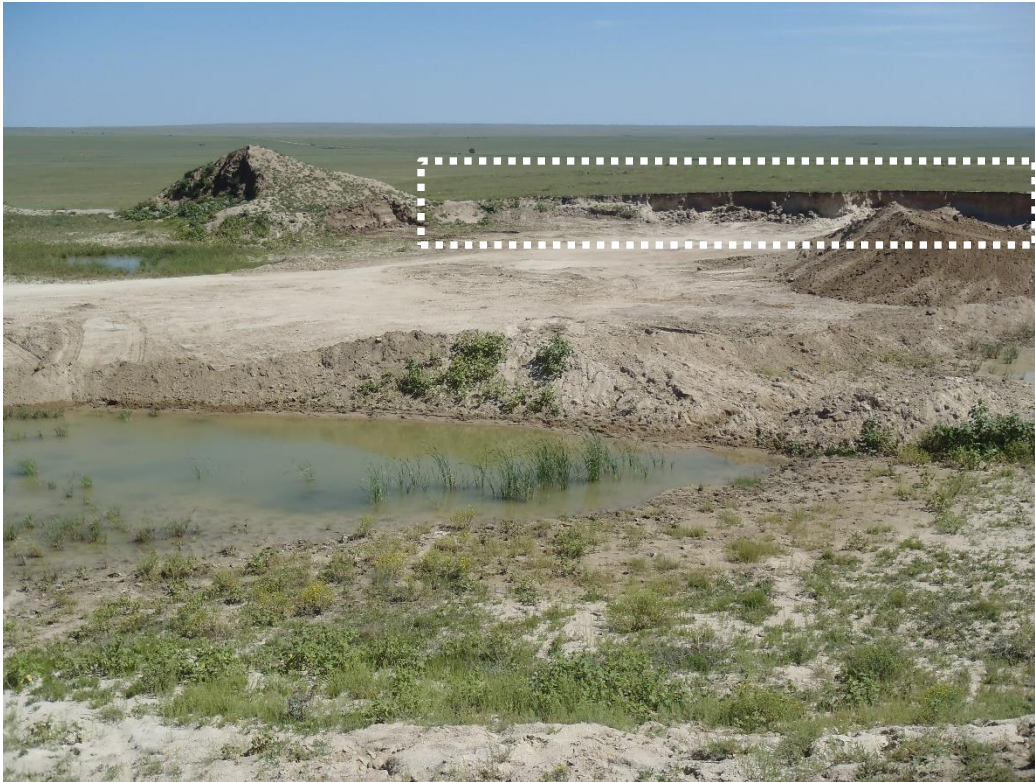
Gen. Compliance with Mine Plan: The operation appeared to be in compliance with the approved mine plan. Google Earth was used to measure the disturbed area, which was estimated to be approximately 8 acres (based on 2014 imagery). The maximum affected area allowed by the approved permit is 28.2 acres. Highwalls were estimated to vary between 6 and 10 feet in height and appeared stable (see **Photo 2**). Mr. James indicated future mining would be towards the south.

Photo 2. Highwalls estimated to vary between 6 and 10 feet in height.

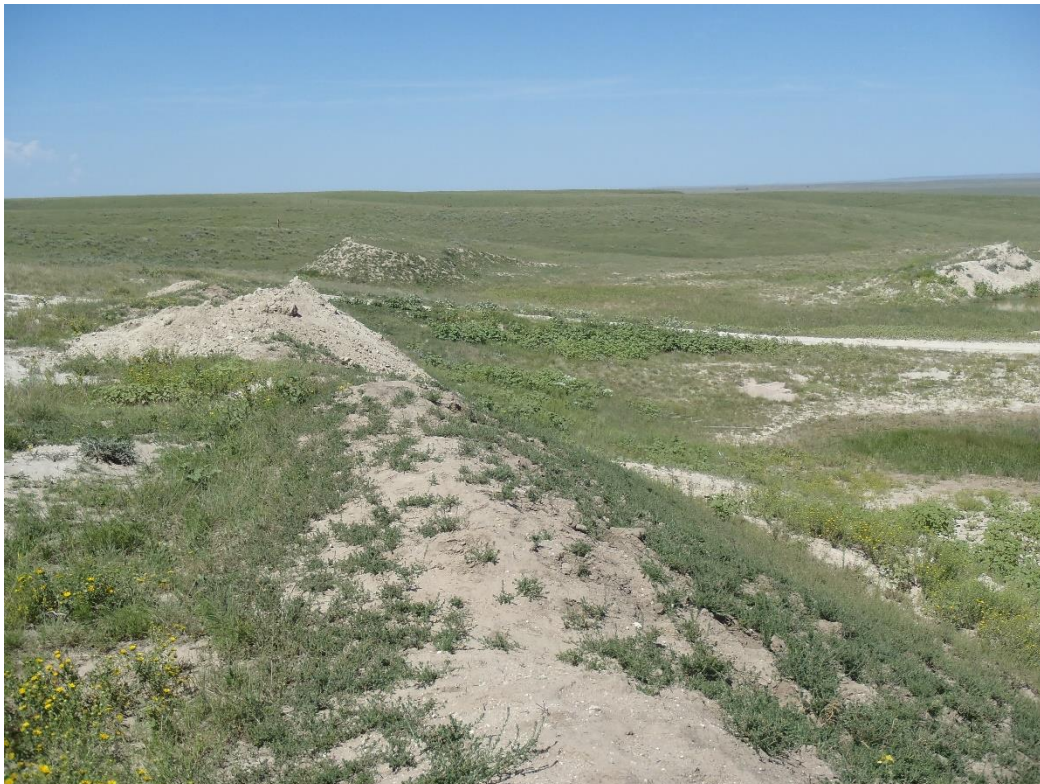
Revegetation: Revegetation was observed to be proceeding well on the northwest slope (see **Photo 3**). No noxious weeds were observed.

Photo 3. Revegetation observed to be proceeding well on northwest slope (looking north).

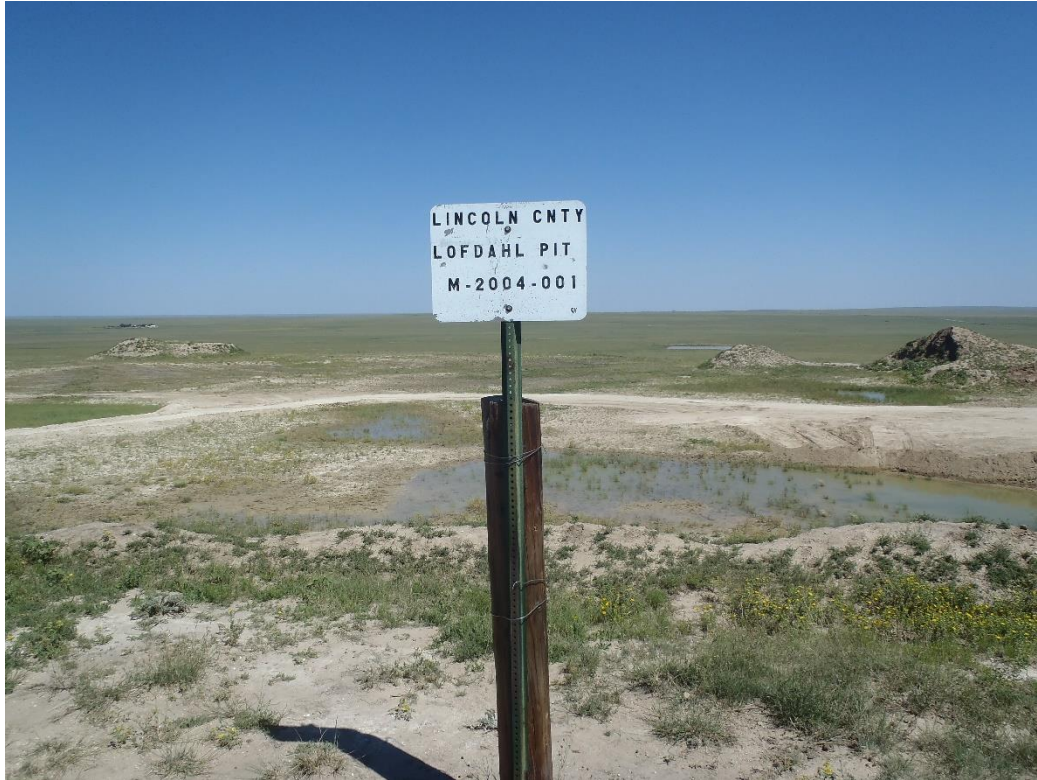
Signs and Markers: The permit sign was properly posted (see **Photo 4**) and wood boundary marker posts were observed to delineate the permit boundary (see **Photo 5**).

Photo 4. Permit sign at entrance.

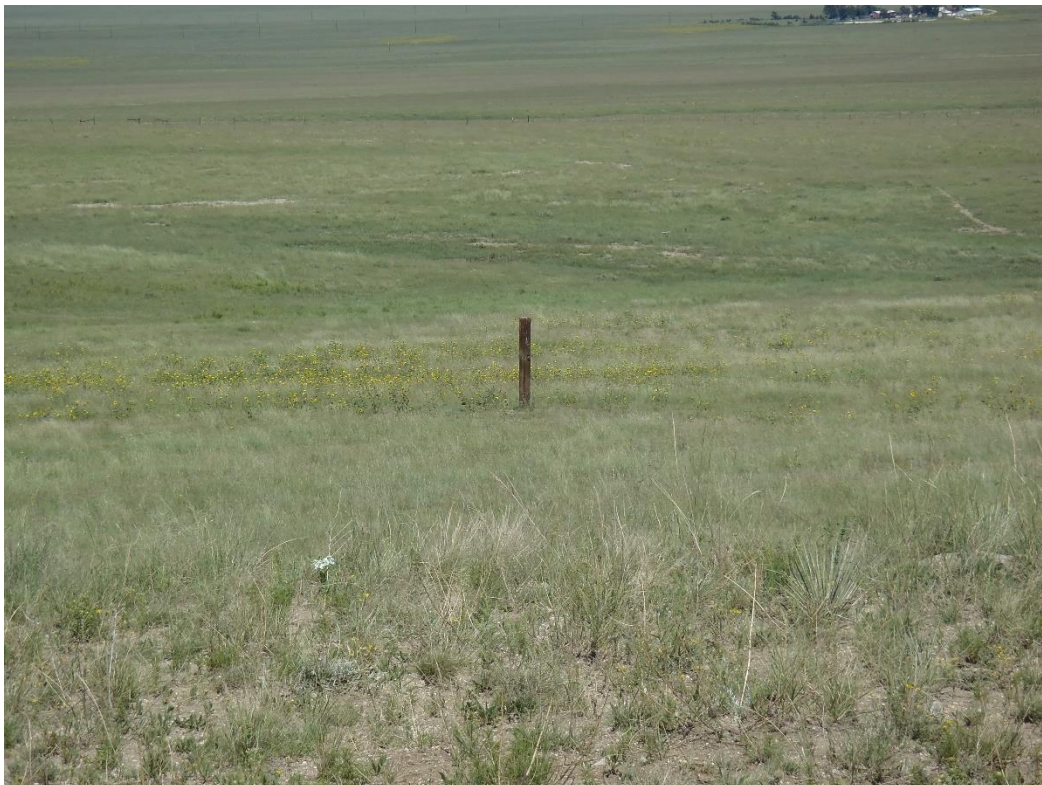
Photo 5. Typical wood post boundary marker (NE corner).

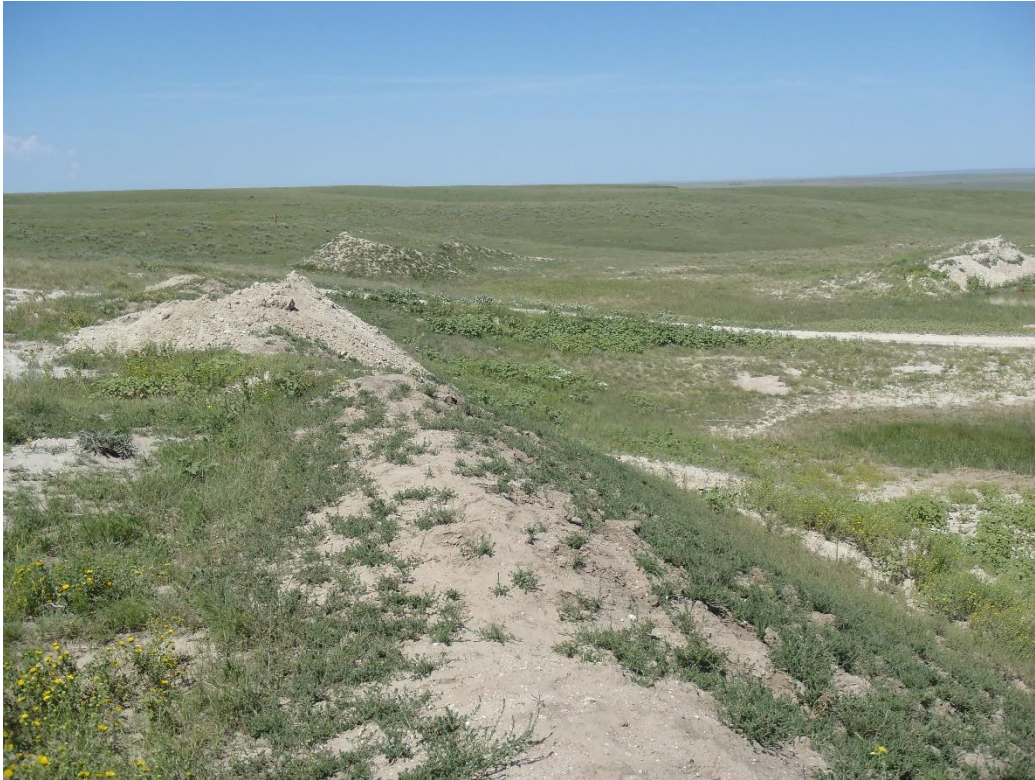
Photo 6. Topsoil stockpile observed on uphill side of pit (looking north).

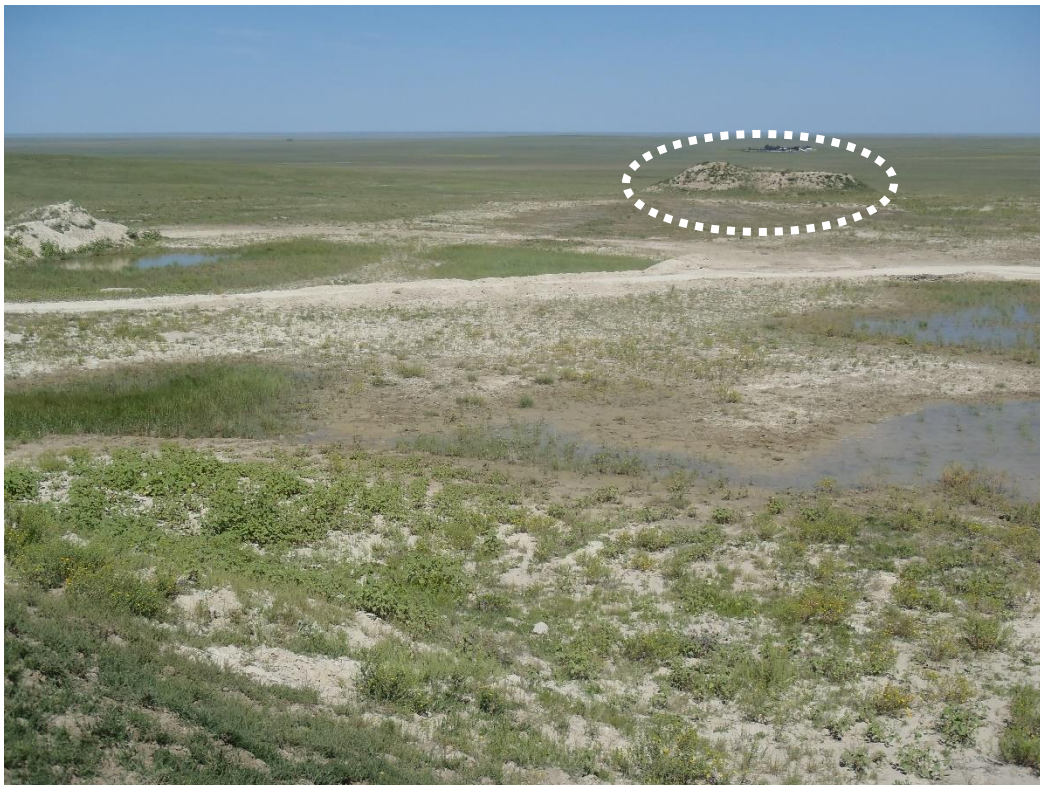
Photo 7. North topsoil stockpile (east side).
