**MINERALS PROGRAM INSPECTION REPORT**  
**PHONE: (303) 866-3567**

<b>MINE NAME:</b> Ravenkamp Pit No 1	<b>MINE/PROSPECTING ID#:</b> M-1991-060	<b>MINERAL:</b> Gravel	<b>COUNTY:</b> Lincoln
<b>INSPECTION TYPE:</b> Monitoring	<b>INSPECTOR(S):</b> Timothy A. Cazier	<b>INSP. DATE:</b> August 23, 2017	<b>INSP. TIME:</b> 12:40
<b>OPERATOR:</b> Lincoln County	<b>OPERATOR REPRESENTATIVE:</b> Trey James & Chris Monk	<b>TYPE OF OPERATION:</b> 112c - Construction Regular Operation	
<b>REASON FOR INSPECTION:</b> Normal I&E Program	<b>BOND CALCULATION TYPE:</b> None	<b>BOND AMOUNT:</b> \$0.00	
<b>DATE OF COMPLAINT:</b> NA	<b>POST INSP. CONTACTS:</b> None	<b>JOINT INSP. AGENCY:</b> None	
<b>WEATHER:</b> Clear	<b>INSPECTOR'S SIGNATURE:</b>

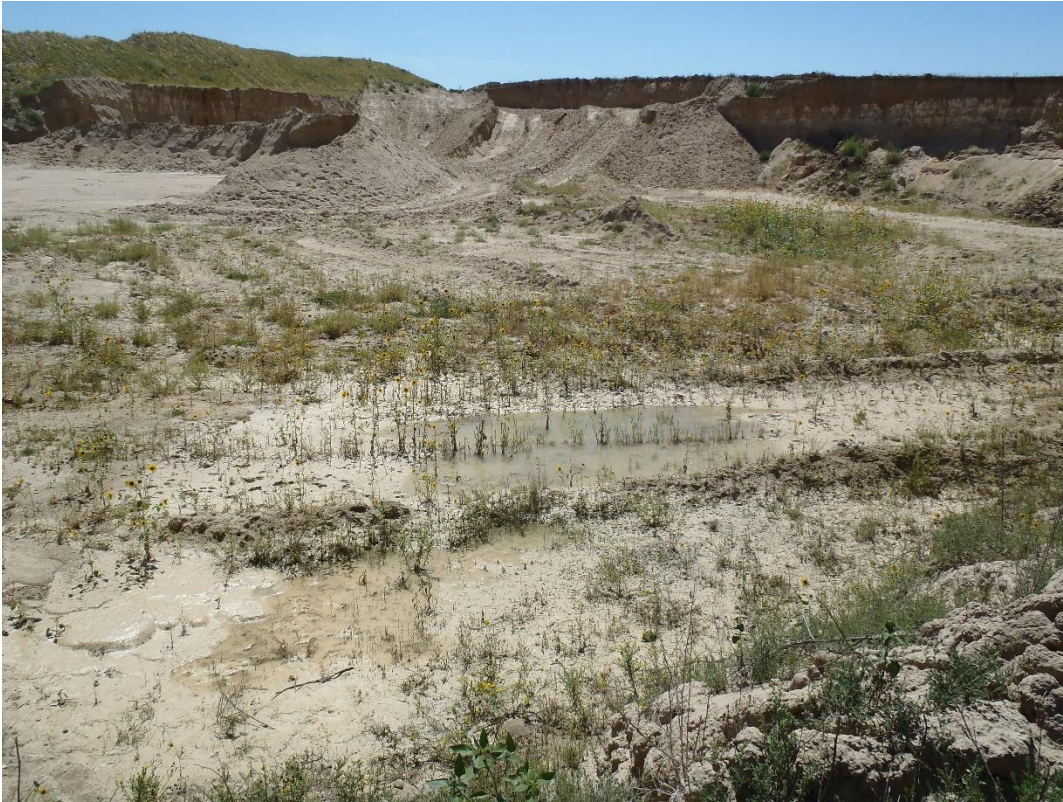
Hydrologic Balance: A small amount standing water was observed in the pit (see **Photo 1**) as a result of recent storms. It was determined not to be exposed groundwater. Mr. Monks indicated groundwater is close to the pit floor.

Photo 1. Standing water observed in the pit (looking SE).

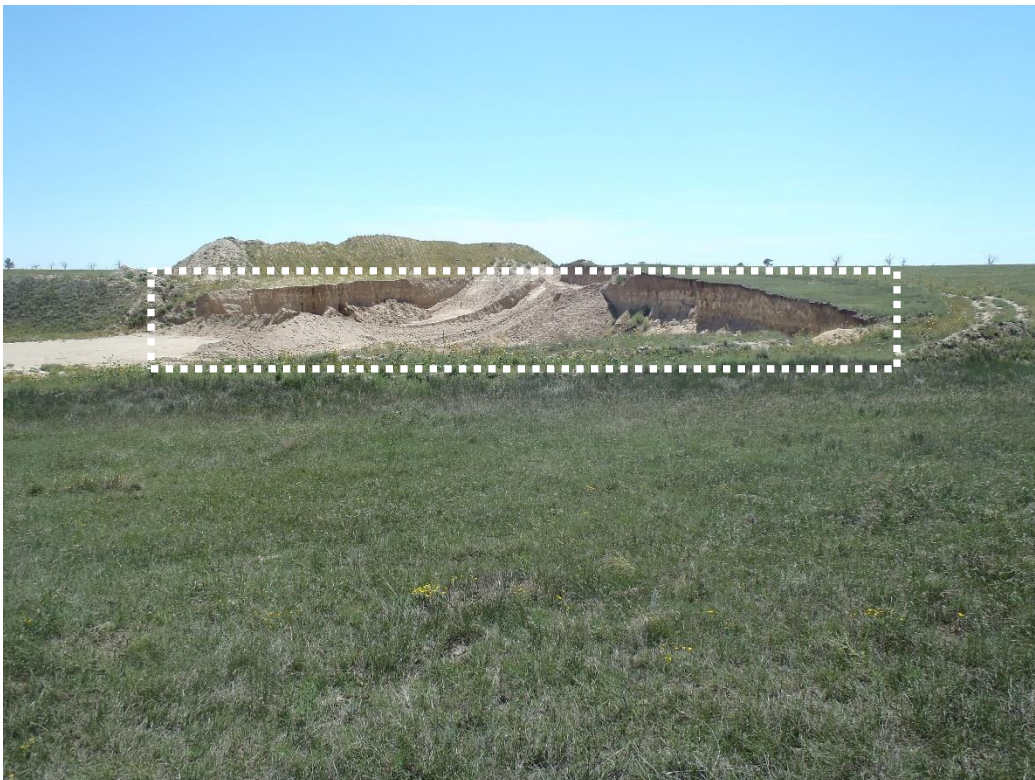
Photo 2. Highwalls estimated to vary between 8 and 16 feet in height.

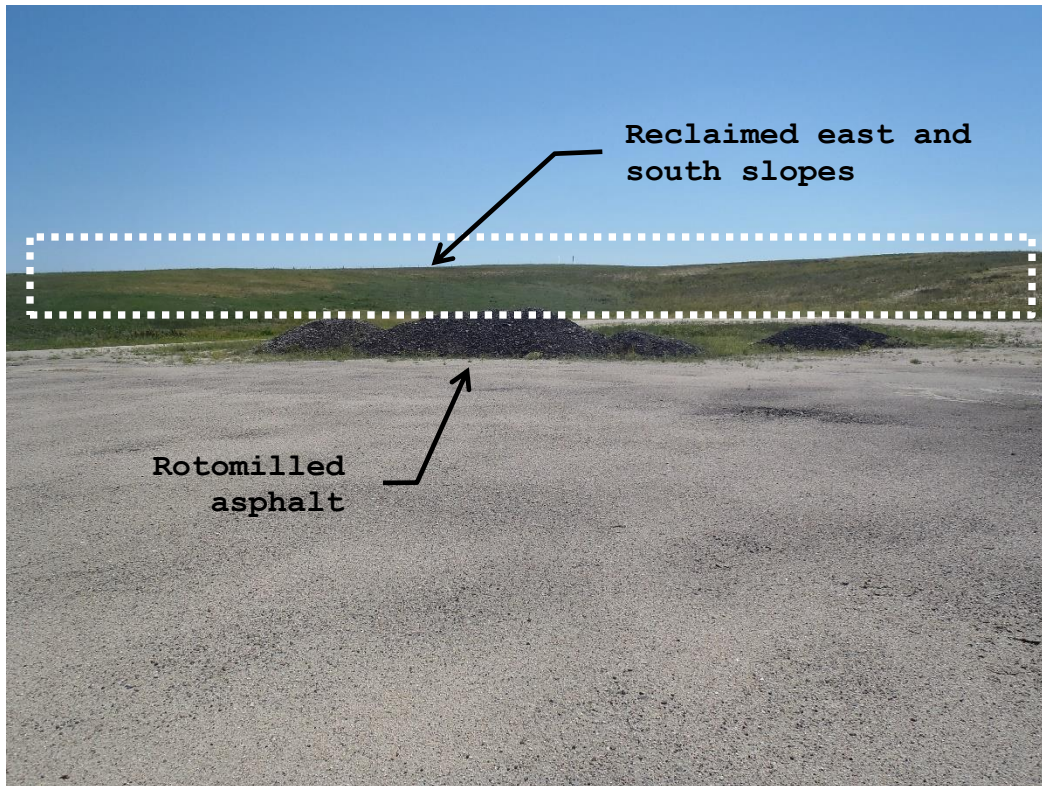
Processing Waste: None observed. The County had stored some milled asphalt (see **Photo 3**) in the northeast area of the permit, which is allowed under TR-03.

Reclamation Success: The east side had been graded to 3H:1V or flatter, topsoiled and seeded (see **Photo 3**) as per the approved reclamation plan. If the county does not intend to re-disturb this area, they may want to consider requesting an acreage release for the reclaimed area.

Revegetation: Revegetation was observed to be proceeding well on the east side (see **Photo 3**). No noxious weeds were observed.

Photo 3. Reclaimed area and rotomilled asphalt (looking SE).

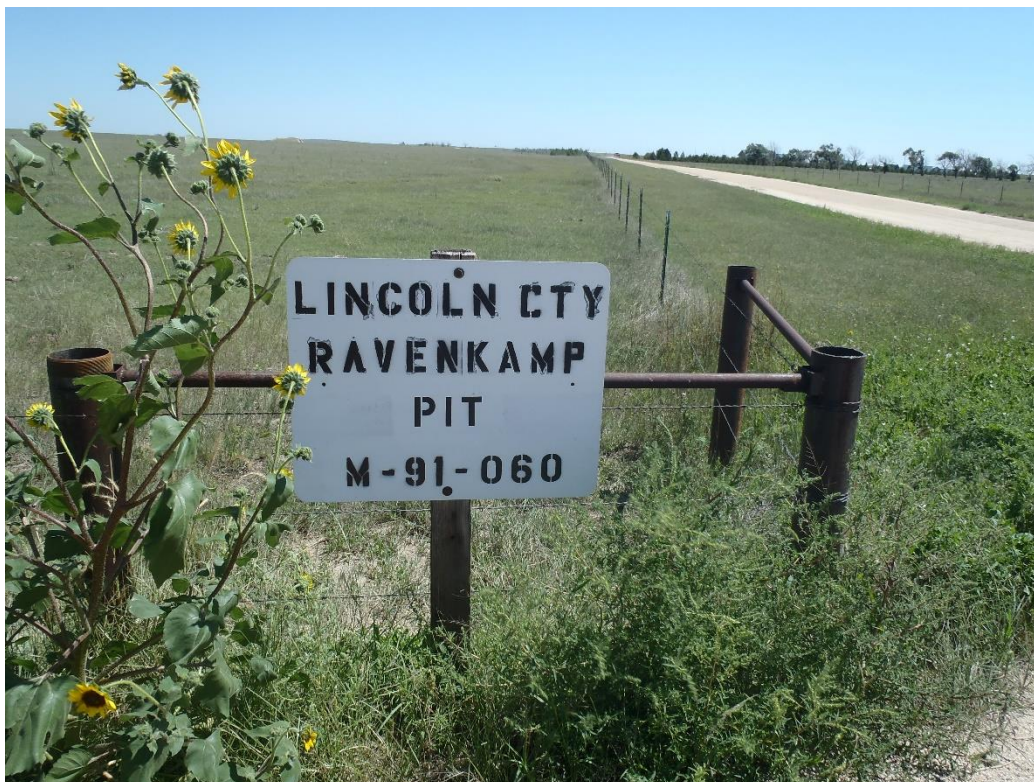
Signs and Markers: The permit sign was properly posted (see **Photo 4**) and T-post boundary marker posts were observed to delineate the permit boundary.

Photo 4. Permit sign at entrance (off County Rd 26).

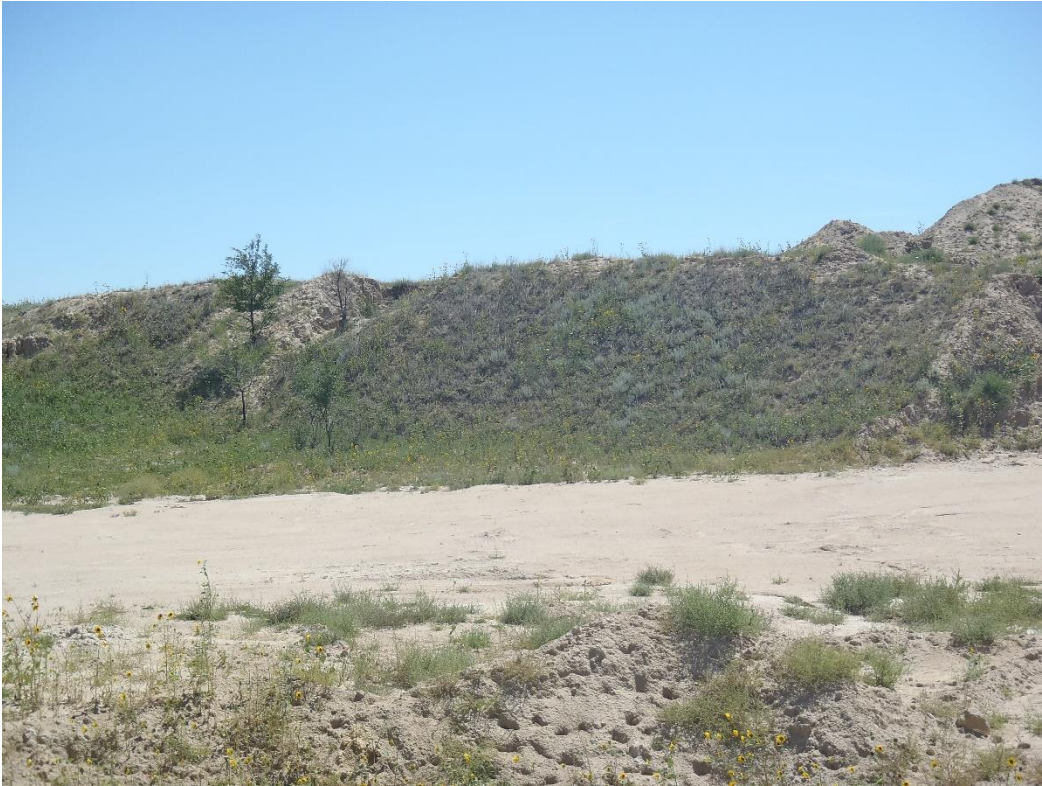
Topsoil: A topsoil stockpile was observed on the uphill side of the pit (see **Photo 5**) and appeared stable.

Photo 5. Topsoil stockpile (Near haul road).
