**COLORADO**Division of Reclamation,  
Mining and Safety

**MINERALS PROGRAM INSPECTION REPORT****PHONE: (303) 866-3567**

<b>MINE NAME:</b> Climax Mine	<b>MINE/PROSPECTING ID#:</b> M-1977-493	<b>MINERAL:</b> Molybdenum	<b>COUNTY:</b> Summit
<b>INSPECTION TYPE:</b> Monitoring	<b>INSPECTOR(S):</b> Lucas J. West	<b>INSP. DATE:</b> September 27, 2017	<b>INSP. TIME:</b> 10:00
<b>OPERATOR:</b> Climax Molybdenum Company	<b>OPERATOR REPRESENTATIVE:</b> James Haag, Aaron Hilshorst	<b>TYPE OF OPERATION:</b> 112d-3 - Designated Mining Operation	
<b>REASON FOR INSPECTION:</b> Normal I&E Program	<b>BOND CALCULATION TYPE:</b> None	<b>BOND AMOUNT:</b> \$78,246,088.00	
<b>DATE OF COMPLAINT:</b> NA	<b>POST INSP. CONTACTS:</b> None	<b>JOINT INSP. AGENCY:</b> None	
<b>WEATHER:</b> Clear	<b>INSPECTOR'S SIGNATURE:</b>

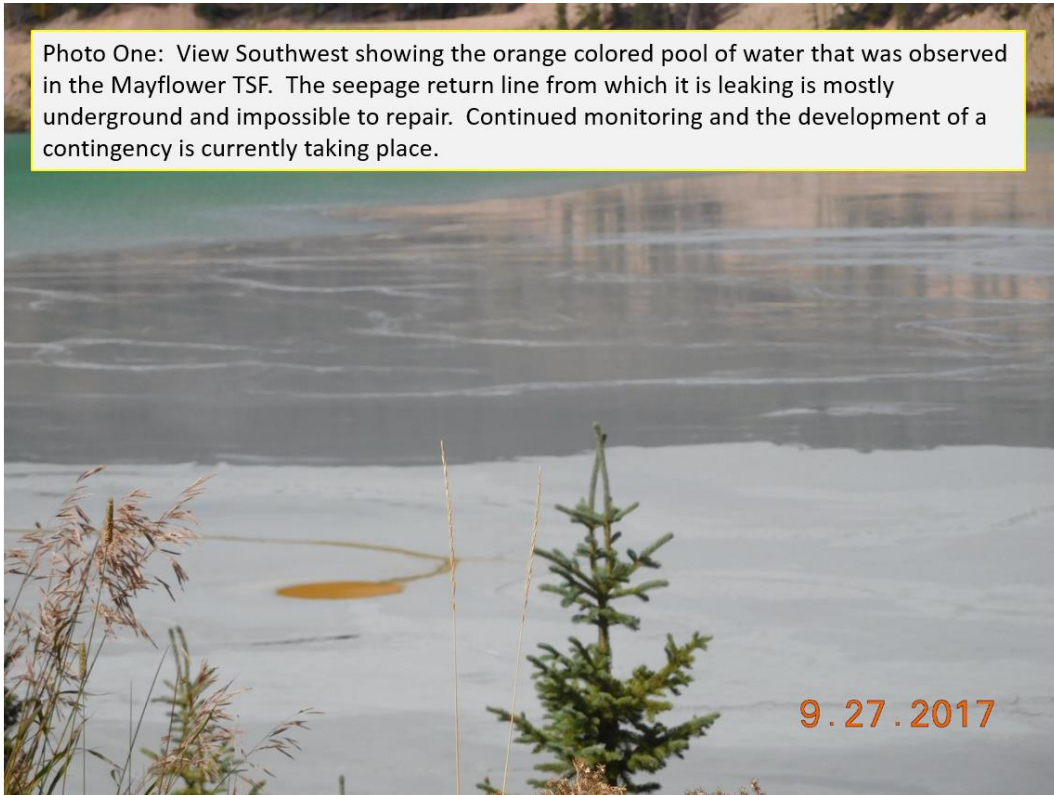
The site was active during the inspection, and the main purpose of this inspection was to discuss and observe the recently discovered leak in the Seepage Return Line from the 5 Dam pup station to the 3 Dam pump station. On approximately September 6, 2017 the Division received notification that a leak in the seepage return line had been discovered. The leak in the line is contained within the larger Mayflower Tailings Storage Facility (TSF) where it is effectively contained. There is no concern of loss of containment from the Tailings Storage Facility at this time. The leak was discovered when the orange colored water was observed pooling in the normally grey colored tailings. Photo One shows the small pool located in the Mayflower TSF. The pool is approximately 1500 Feet away from the tailings dam and does not pose a threat to the stability of the dam itself. The estimated rate of the leak is approximately 200-250 GPM and is being closely monitored by the Operator. As of now the leak is not a major concern as approximately 75% of the flow within the seepage return line is functioning as normal, and small portion that is leaking is contained within the TSF. On site discussions with the Operator included a potential contingency plan that includes opening the ¼ valve in the seepage return line and allowing the entire flow to enter, and be contained within the TSF, however the system will continue to operate as normal until the contingency becomes absolutely necessary. The Operator has been advised that when the contingency becomes necessary and the details of that plan are finalized they will need to be addressed through the Technical Revision Process.

Photo One: View Southwest showing the orange colored pool of water that was observed in the Mayflower TSF. The seepage return line from which it is leaking is mostly underground and impossible to repair. Continued monitoring and the development of a contingency is currently taking place.

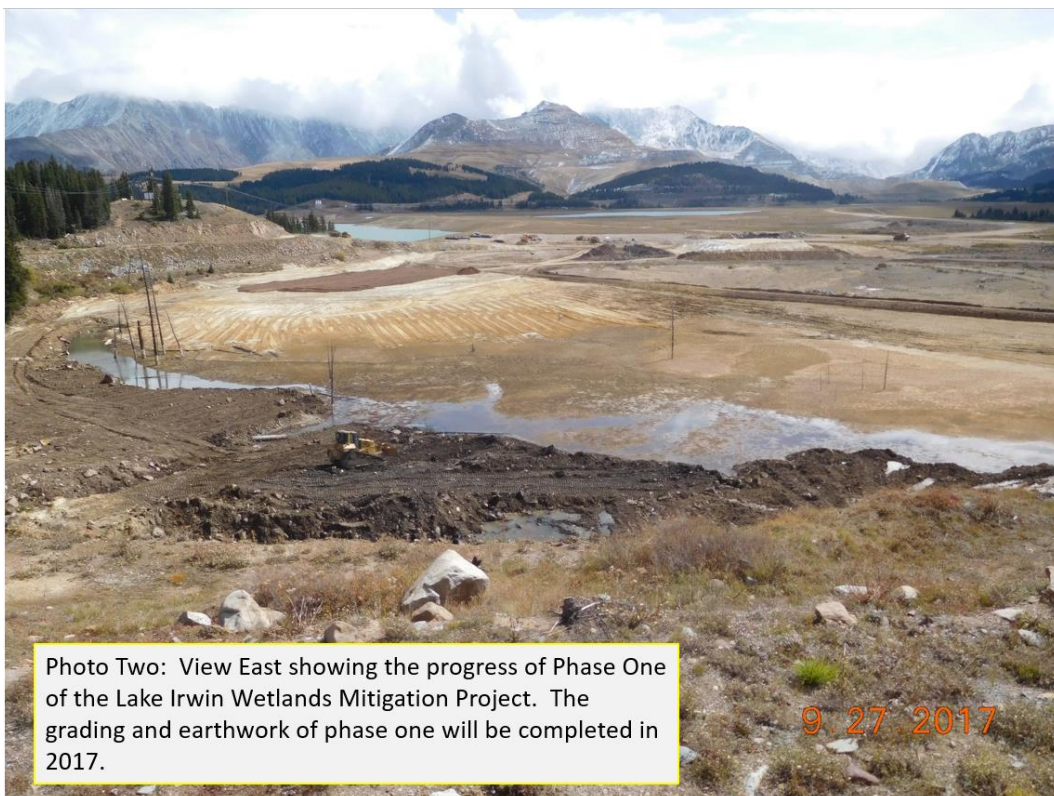
The Division recently approved TR's 25 and 26 which addressed the McNulty Gulch Overburden Storage Facility (OSF) and the Lake Irwin Wetlands Mitigation Project. Both projects have commenced and are currently underway. Vegetation clearing and very minimal topsoil stripping has begun in the McNulty area, and the major earthwork will not commence until spring of 2018. The construction of the Lake Irwin Wetlands area has begun and can be seen in Photo Two. The construction of the Wetlands will be completed in phases that coincide with the phases of the construction of the McNulty OSF. The grading of subsoil in Phase One of the project will be completed in 2017 and the addition of topsoil and vegetation will take place in 2018.

Photo Two: View East showing the progress of Phase One of the Lake Irwin Wetlands Mitigation Project. The grading and earthwork of phase one will be completed in 2017.
