MINERALS PROGRAM INSPECTION REPORT

MINE NAME: Ellis Allen Pit	MINE/PROSPECTING ID#: M-1984-185	MINERAL: Sand and gravel	COUNTY: Lincoln
INSPECTION TYPE: Monitoring	INSPECTOR(S): Timothy A. Cazier	INSP. DATE: August 24, 2017	INSP. TIME: 10:15
OPERATOR: Lincoln County	OPERATOR REPRESENTATIVE: None	TYPE OF OPERATION: 110c - Construction Limited Impact	
REASON FOR INSPECTION: Normal I&E Program	BOND CALCULATION TYPE: None	BOND AMOUNT: \$0.00	
DATE OF COMPLAINT: NA	POST INSP. CONTACTS: None	JOINT INSP. AGENCY: None	
WEATHER: Cloudy	INSPECTOR'S SIGNATURE:

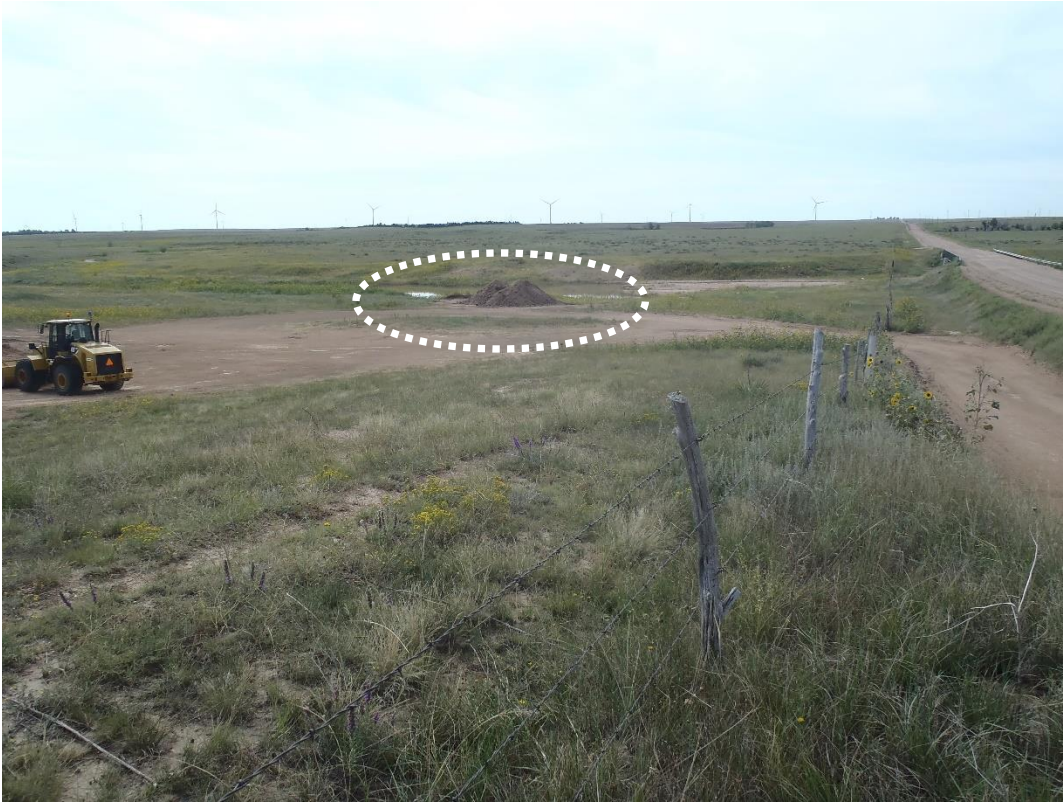
Hydrologic Balance: Some standing water was observed in or near the Arikaree River (see **Photo 1**), likely a result of the recent heavy rain. No known exposed groundwater was observed.

Photo 1. Standing water observed in or near the Arikaree River (looking south).

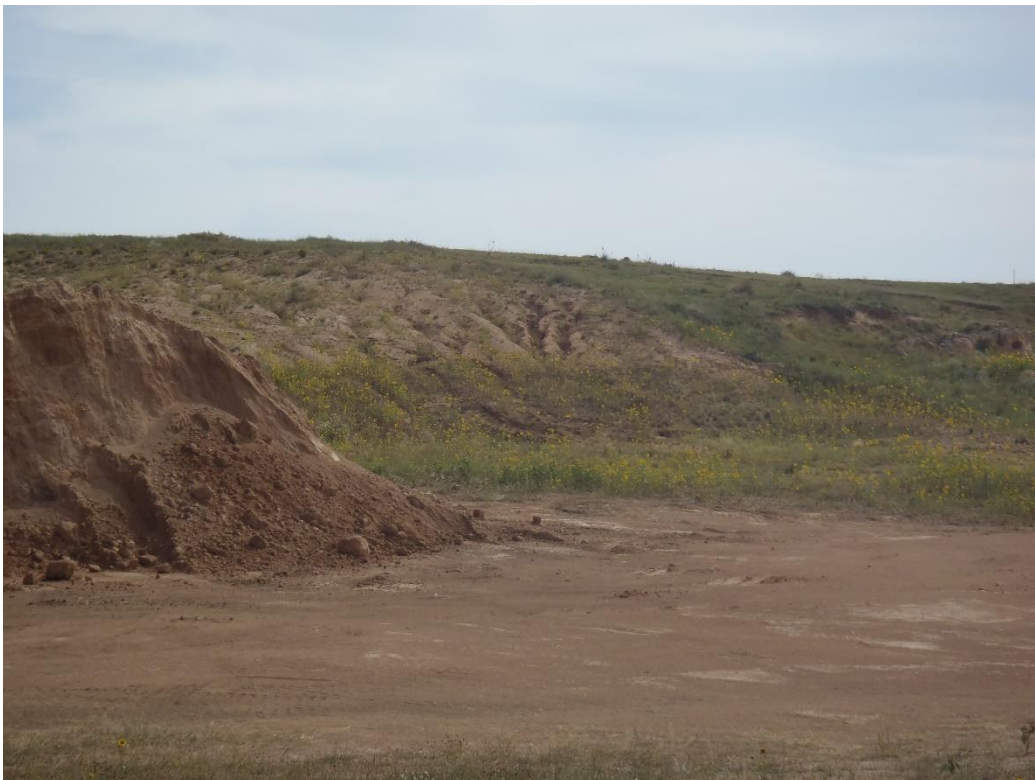
Sediment Control: Erosion rills and gullies observed and noted in the December 2015 inspection have apparently grown (see **Photo 2**). Lincoln County should address these erosion features and apply best management practices (BMPs) before these erosion problems migrate/head cut offsite.

Photo 2. Erosion gullies on northeast slope.

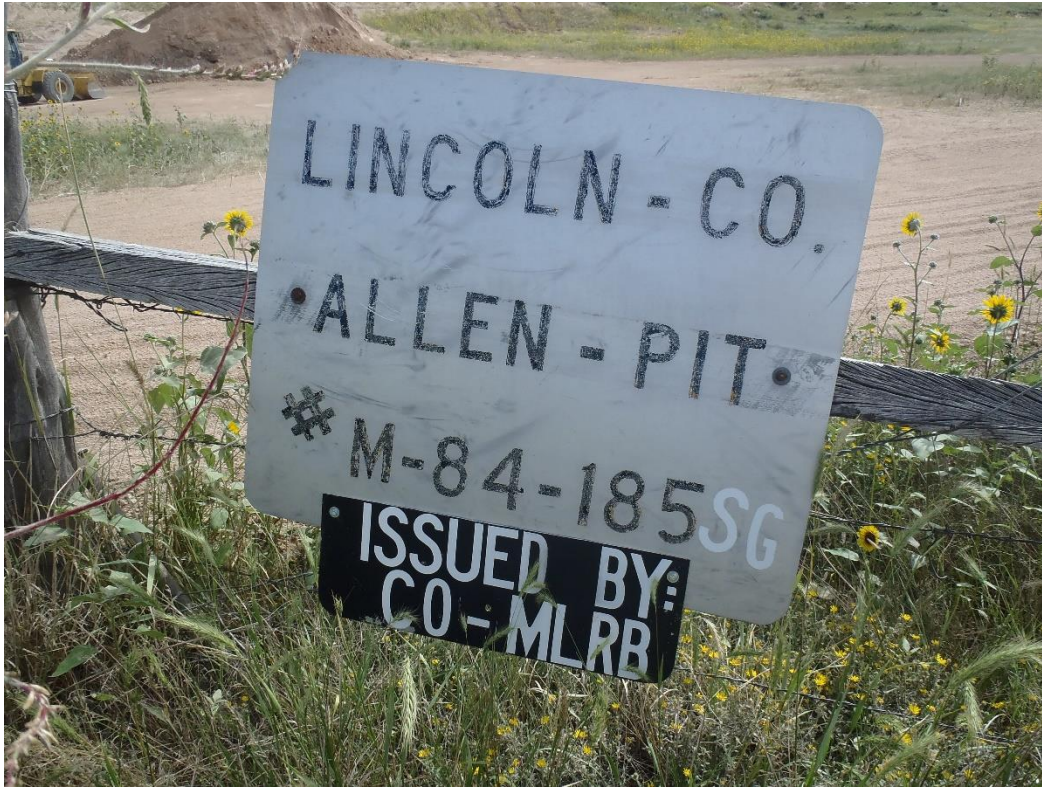
Signs and Markers: The permit sign was properly posted (see **Photo 3**). Boundary markers were not checked. However the west side of the pit is fenced.

Photo 3. Permit sign (at entrance).
