**COLORADO**Division of Reclamation,  
Mining and Safety

**MINERALS PROGRAM INSPECTION REPORT****PHONE: (303) 866-3567**

| <b>MINE NAME:</b><br>Golden Wonder Mine | <b>MINE/PROSPECTING ID#:</b><br>M-1978-091-UG | <b>MINERAL:</b><br>Gold | <b>COUNTY:</b><br>Hinsdale |
| <b>INSPECTION TYPE:</b><br>Monitoring | <b>INSPECTOR(S):</b><br>Travis H. Marshall | <b>INSP. DATE:</b><br>September 19, 2017 | <b>INSP. TIME:</b><br>10:00 |

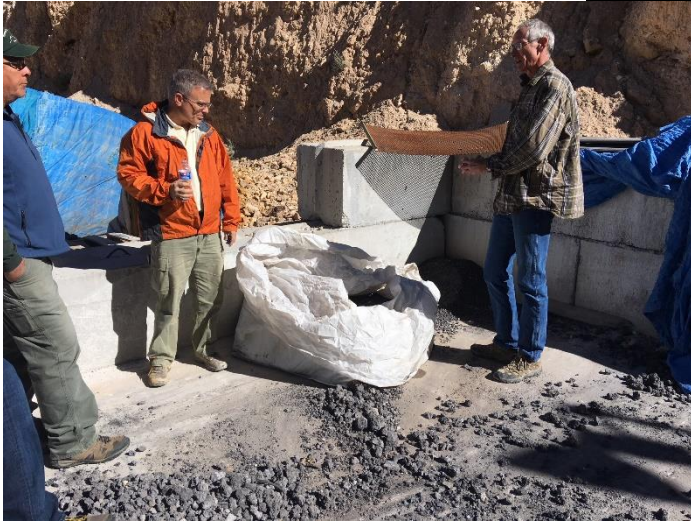
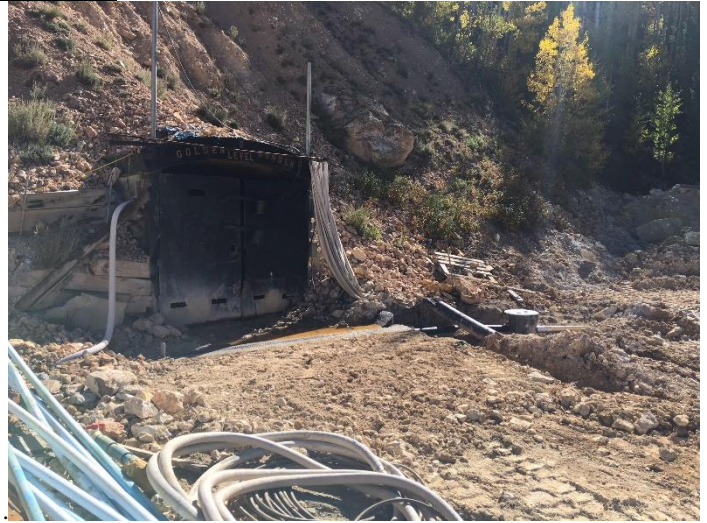
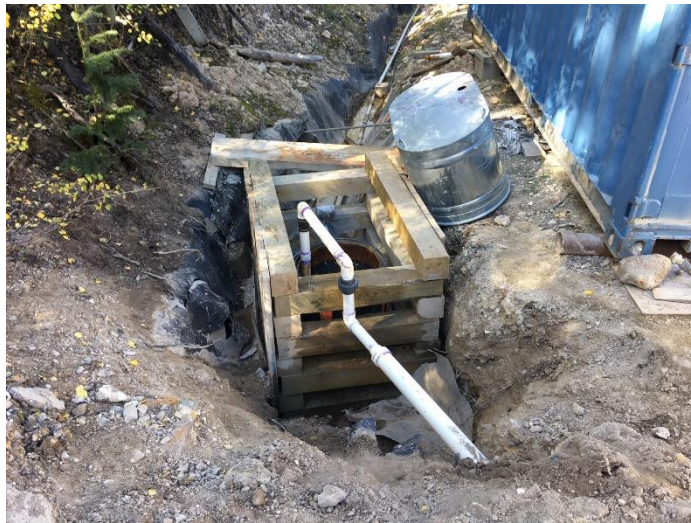
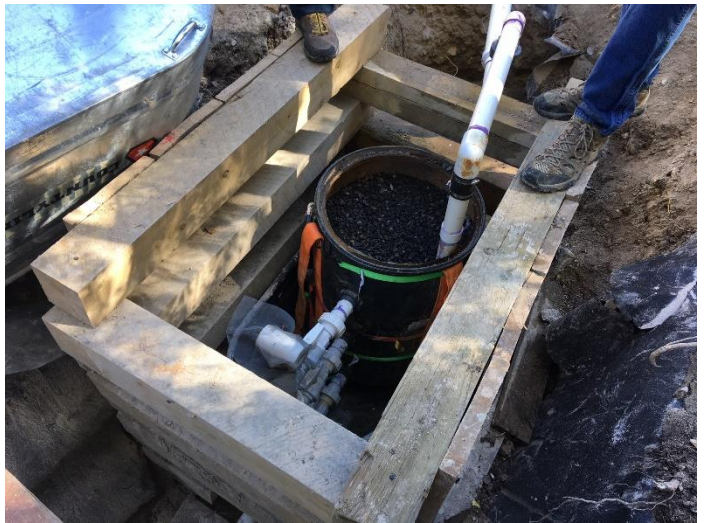
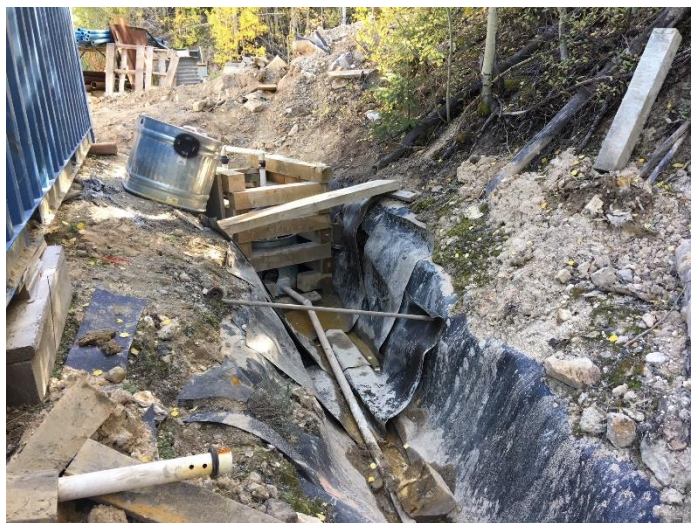
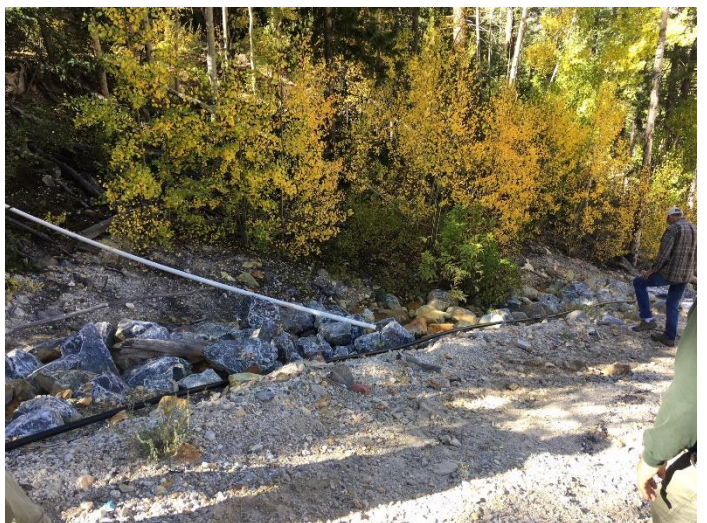
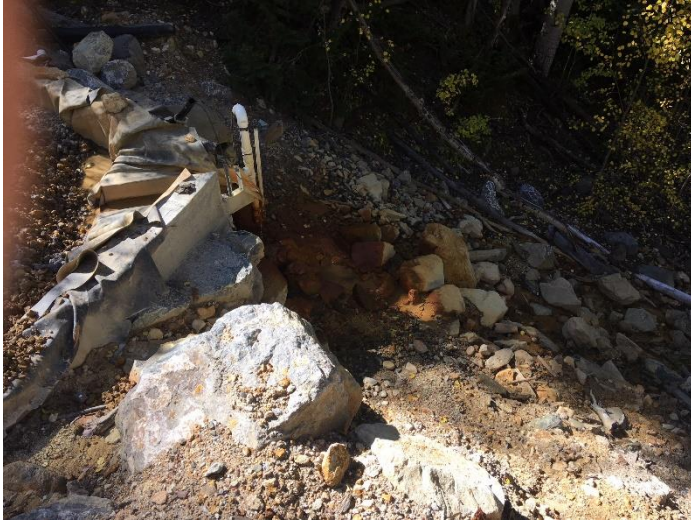
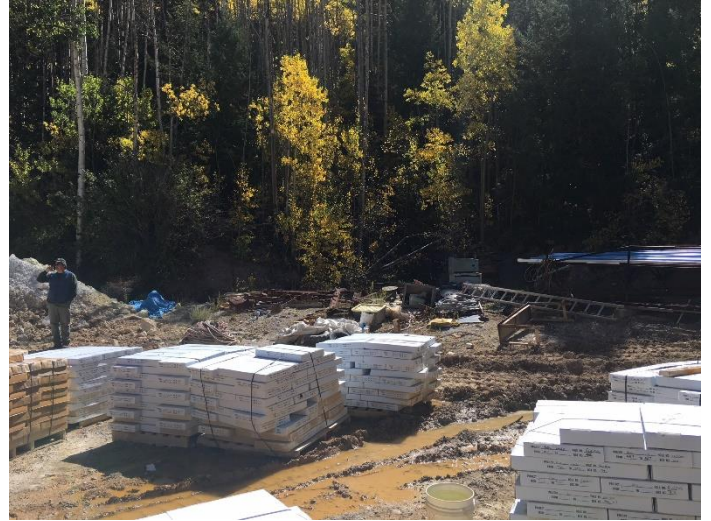
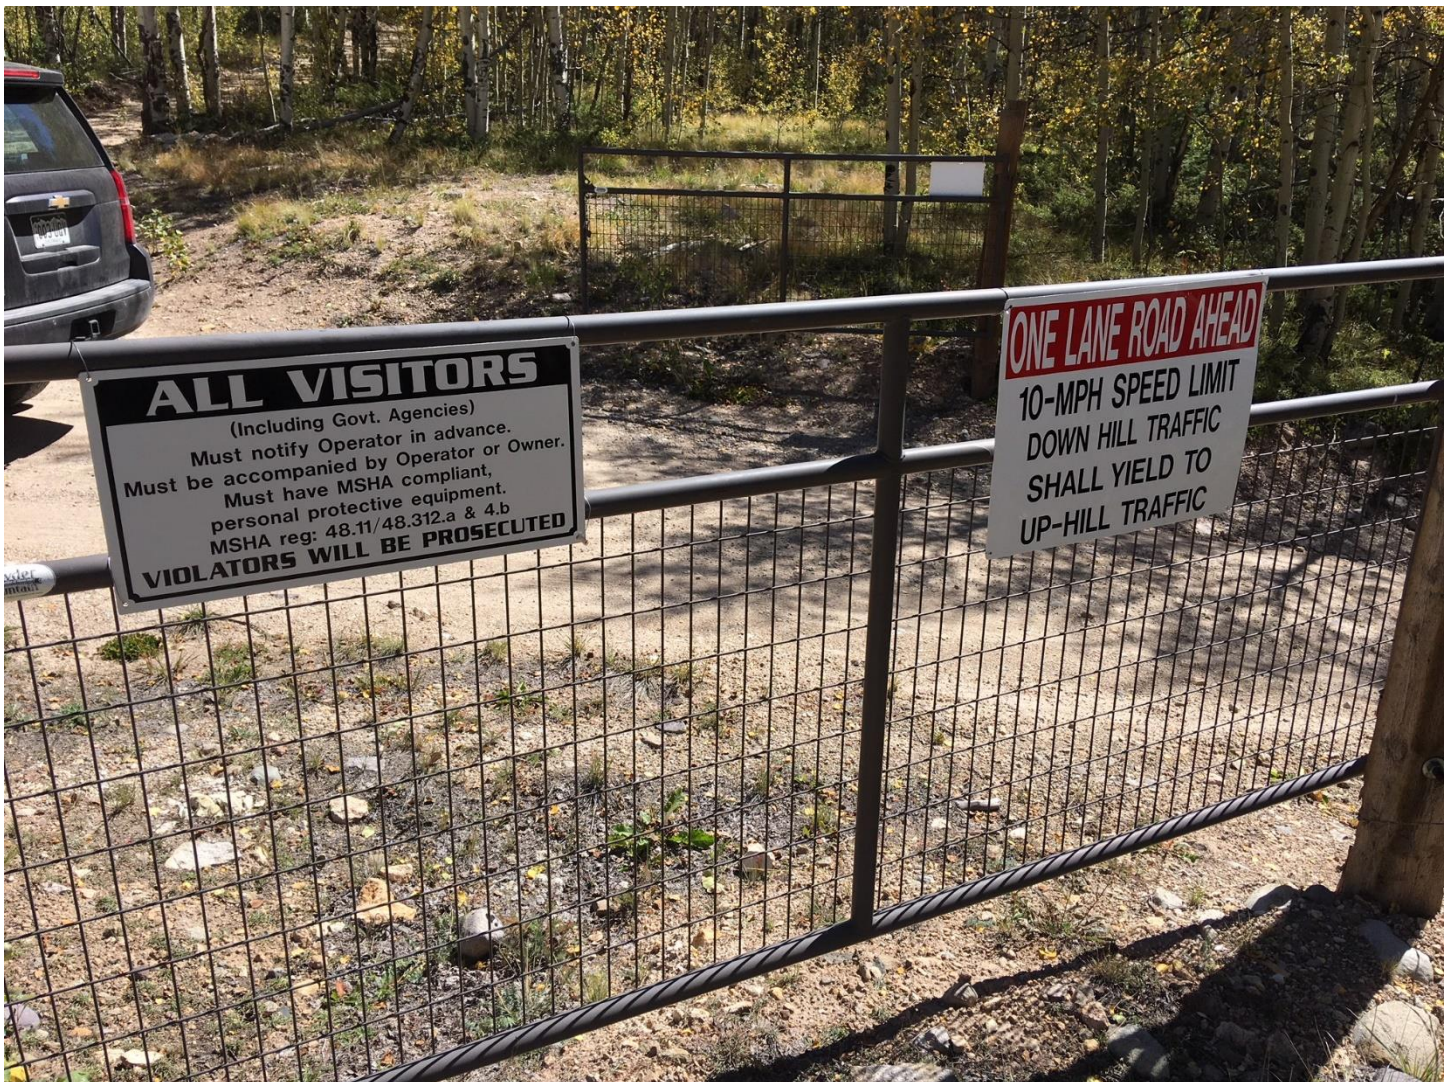
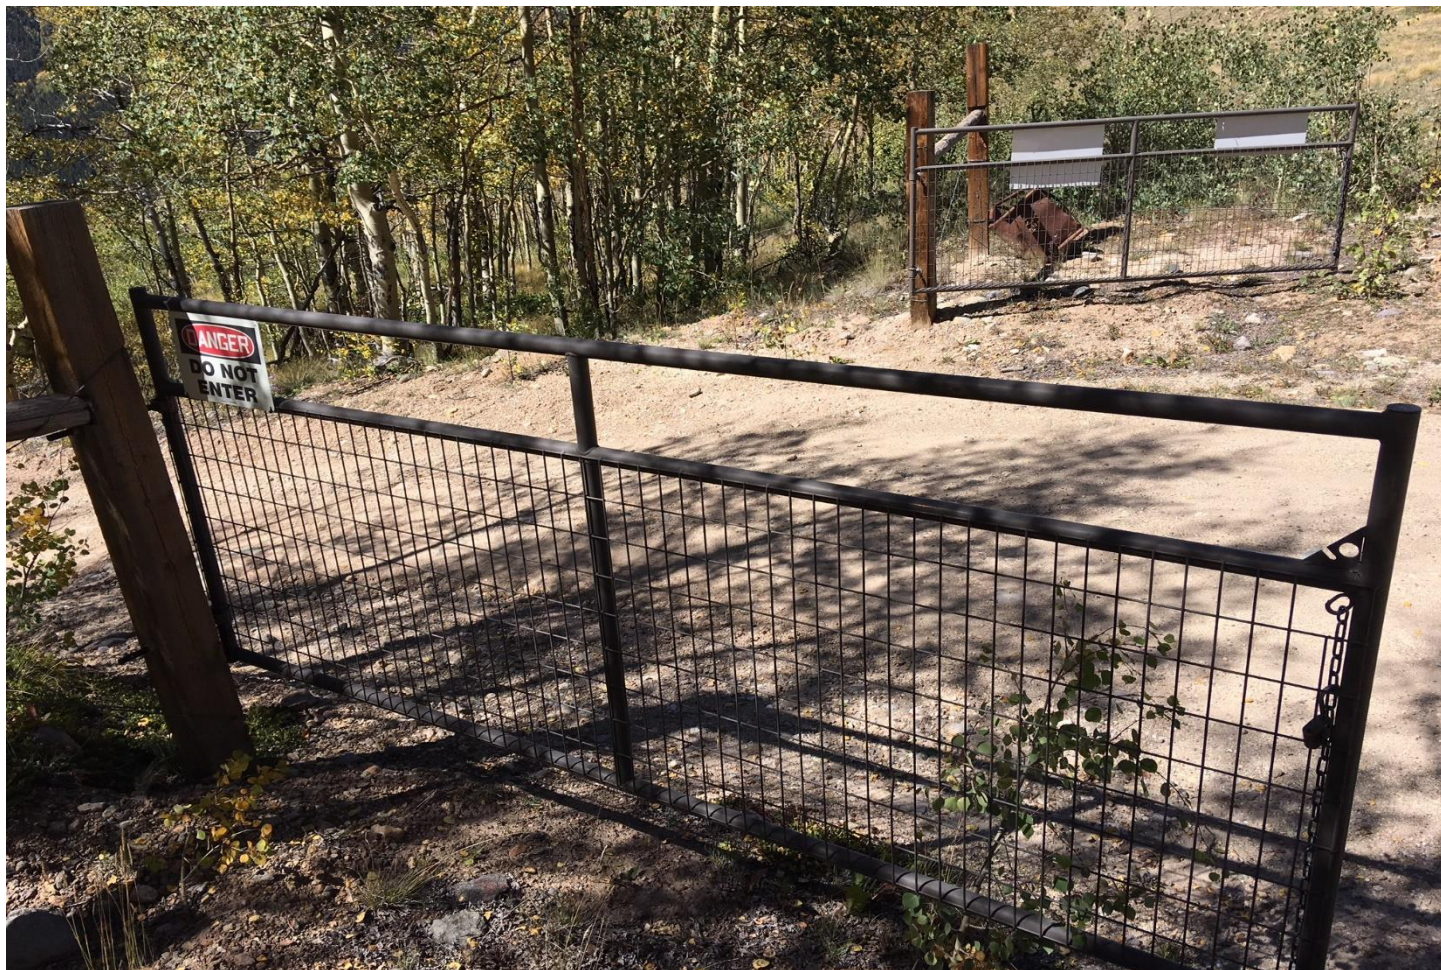
The mine identification sign was not observed at the entrance to the mine site and is not in compliance with Rule 3.1.12. This is noted as a problem and the operator must provide photo documentation that demonstrates a sign has been placed at the main entrance no later than the corrective action date of November 30, 2017.

No active mining was observed during the inspection. A mini excavator was observed replacing limestone with metal slag at the toe of the mine dump. An orange colored mine water discharge was observed exiting the portal which was observed during prior inspections. The discharge was collected into piping that directed the water into the passive metal slag treatment system. The flow is still estimated to be 0.1 gpm. The treatment system was near a final configuration during the inspection. The operator may need to change minor components of the current configuration to adjust residence time of water in the system to obtain desired water quality parameters. If any major changes to the system occur the operator must submit a new technical revision and gain Division approval. Division staff has not received results of the mine discharge water to date. **Please provide water quality results within 30 days to avoid potential enforcement action.**

Miscellaneous mining debris / trash was observed along the eastern portion of the mine bench. The materials appeared disorganized and out of place. The conditions observed are not considered problem but poor housekeeping and is noted in this inspection report to be used as a tool to monitor future site conditions.

**CORRECTIVE ACTIONS:** The operator shall, at the entrance of the mine site, post a sign which shall be clearly visible from the access road with the following: the name of the operator, a statement that a reclamation permit for the operation has been issued by the Colorado Mined Land Reclamation Board; and the permit number. The operator shall submit photo documentation that a proper sign has been posted by the corrective action date.
