COLORADO
Division of Reclamation,
Mining and Safety
Department of Natural Resources

Permit Number: C-1981-035 Mine Name: King Coal Mine Operator: GCC Energy, LLC Operator Address: Mr. Tom Bird 6473 County Road 120 Hesperus, CO 81326	County: La Plata Operation Type: Underground Permit Status: Active Ownership: Federal
	Operator Representative Present: M. McFarland, Tom Bird
Operator Representative Signature: (Field Issuance Only)

Inspection Start Date: October 24, 2017 Inspection Start Time: 14:15 Inspection End Date: October 25, 2017 Inspection End Time: 14:30		Inspection Type: Coal Complete Inspection Inspection Reason: Normal I&E Program Weather: Clear	
Joint Inspection Agency: None		Joint Inspection Contacts: 	
Post Inspection Agency: None		Post Inspection Contacts: 	
Inspector(s): Robert D. Zuber, P.E.	Inspector's Signature:

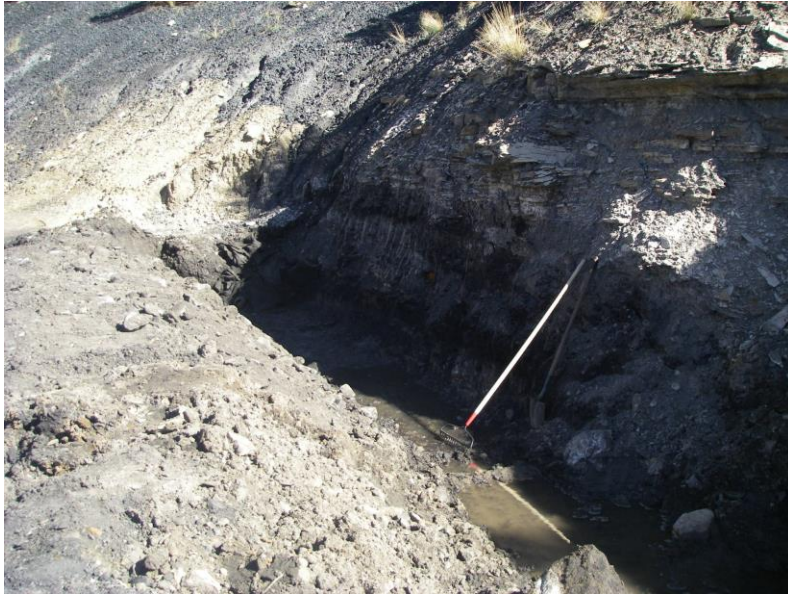
The channel below the rock underdrain has been better defined. Water was seen in the channel below the rock underdrain, but no stains were present on the soil. It appears that the underdrain allows water from above the refuse to seep under the Refuse Pile, but there is no sign that water is infiltrating through the pile and causing dissolution of metals that end up in the discharge below the pile.

Channel below Refuse Pile underdrain

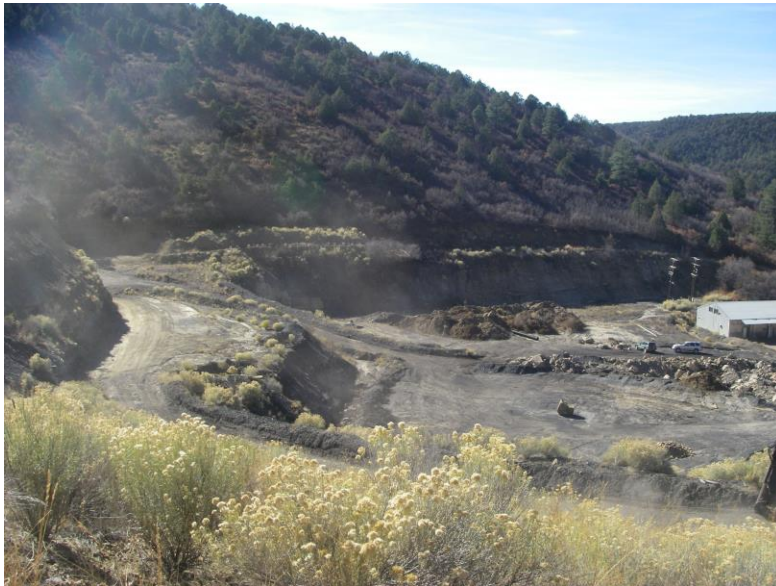
The King I entrance area is still being used as a staging area for the road improvement project (CR 120). During the inspection, a truck dumped refuse at King I, near the toe of the Refuse Pile.

King I: road to Refuse Pile, material from County road construction, and portal walls

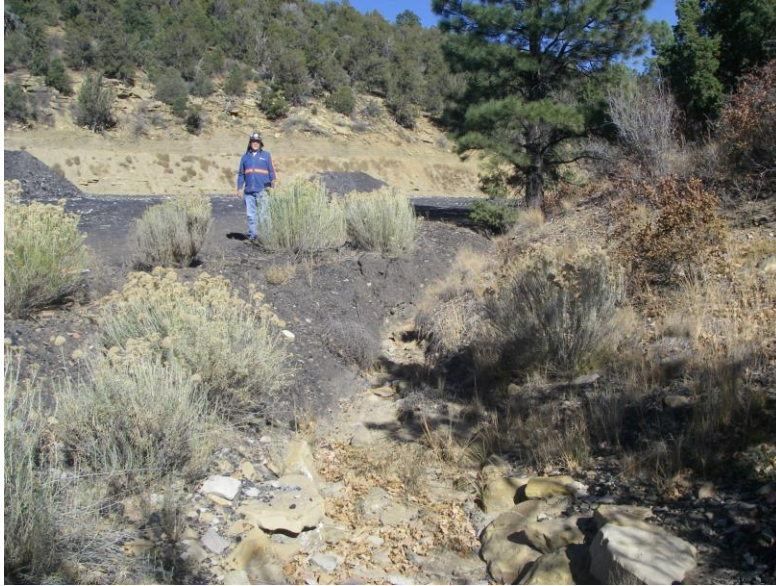
- *At the lower end of Reach 3, additional repairs have been performed on the exposed pipe, although GCC staff suggested that pipe replacement may be performed.
- * Reach 10 (near the southwest corner of the Refuse Pile) has eroded, and riprap improvements are recommended. Related to this, the Division suggests that runoff from the active portion of the Refuse Pile be diverted (with a swale) into this ditch, rather than letting it drain into the roadside ditch, where erosion has occurred.
- * The culvert in Reach 10 (across the road on the Refuse Pile) was clear, and the hillside below the culvert appeared stable.

Erosion in Reach 10 near top of road to Refuse Pile

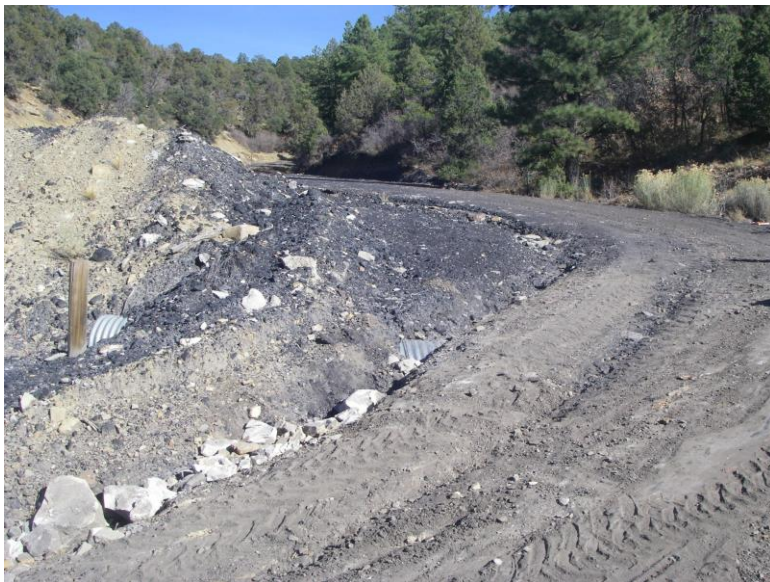
Exposed culvert pipe near top of road to Refuse Pile (was later covered by end of inspection)

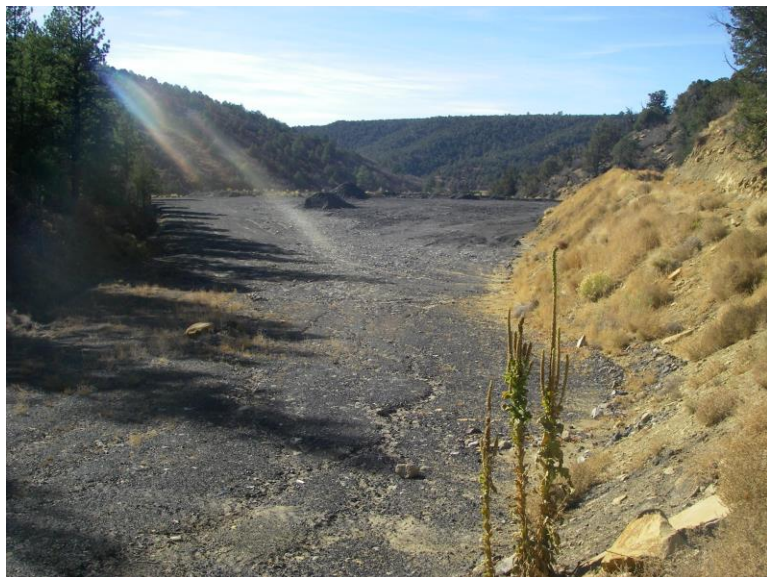
The un-reclaimed portion of the Refuse Pile (upper portion) needs to be graded to spread the large piles of waste rock and to repair rills. This is not yet an urgent matter but should be done as soon as practical. Very little trash was seen in the recently graded area, and almost no large rocks (bigger than 18 inches in length) were seen. No puddles were seen on the surface of the Refuse Pile.

Upper end of Refuse Pile

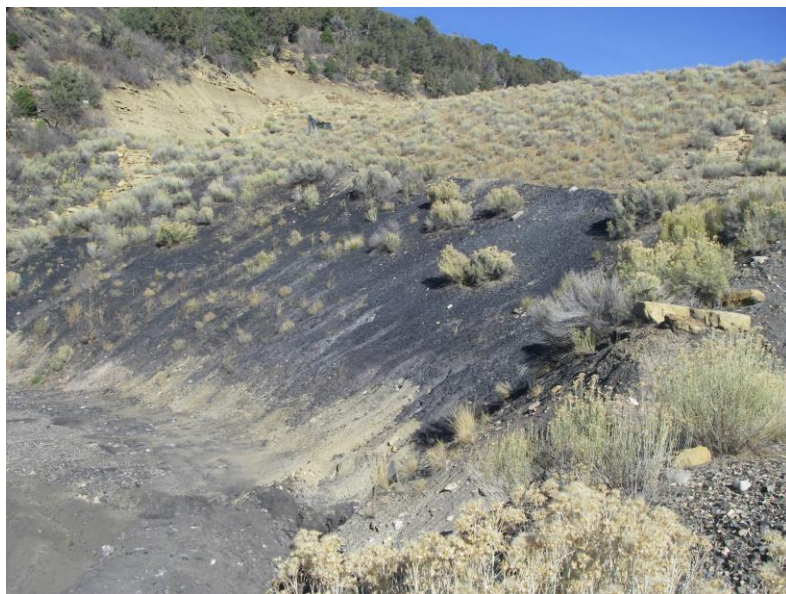
It appeared that in recent months no material has been added to the lower portion of the Refuse Pile. Round rock for the extension of the underdrain was staged on site. It is uncertain if this quantity will suffice or if more rock will have to be brought to the site. At this point, the lower portion of the Refuse Pile appears stable, despite the

steep grade and lack of vegetation.

Toe of Refuse Pile

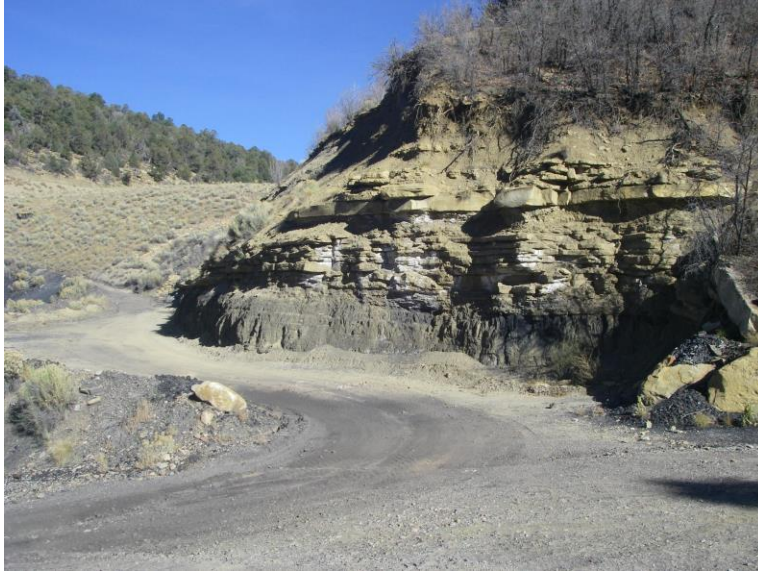
The primary cut slopes at the mine appear to be stable. This includes the King I facilities area (where portals were located) and the King II portal areas.

Road cut (former shop bench at King I)

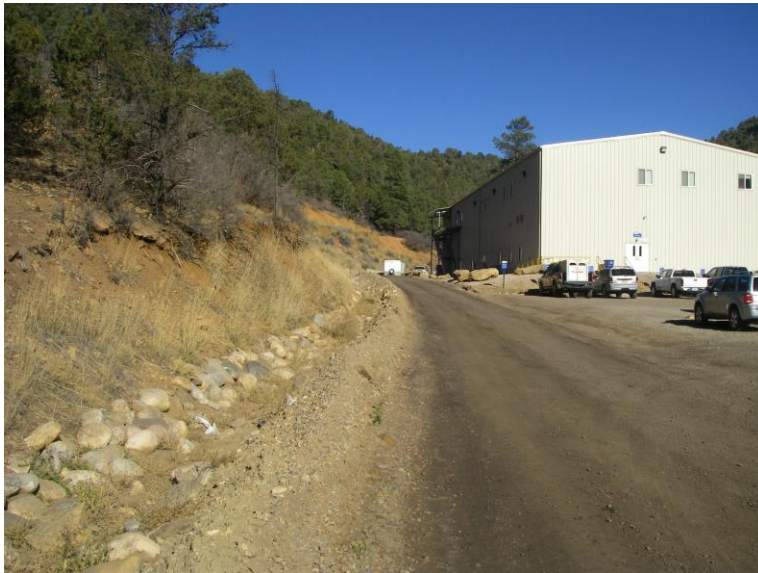
The East Clearwater Ditch at King II (CWD-2) was found to be generally in good shape. The West Clearwater Ditch at King II (CWD-1) was also found to be generally in good shape. The BMPs below this ditch (sumps at the King II entrance) appear to be functioning well.

King II road and West Clearwater Ditch, near office

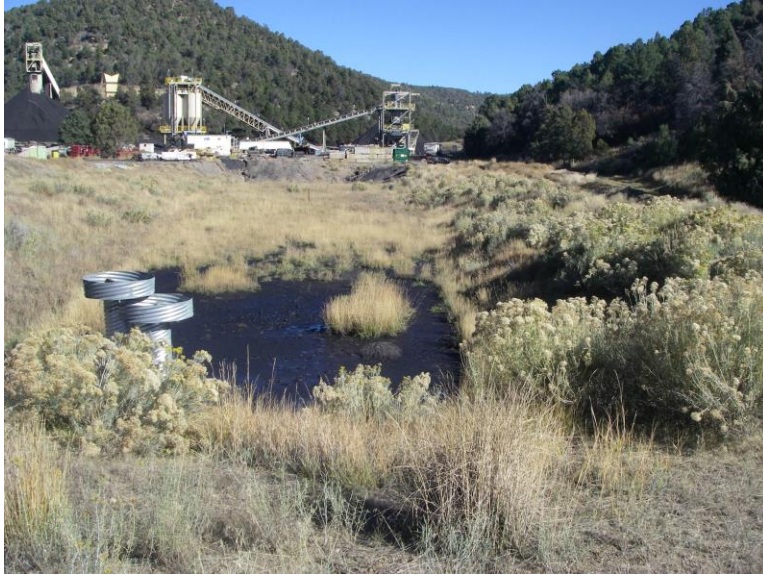
Only a small amount of water was in the King II pond, and no problems were seen with the structures.

King II pond

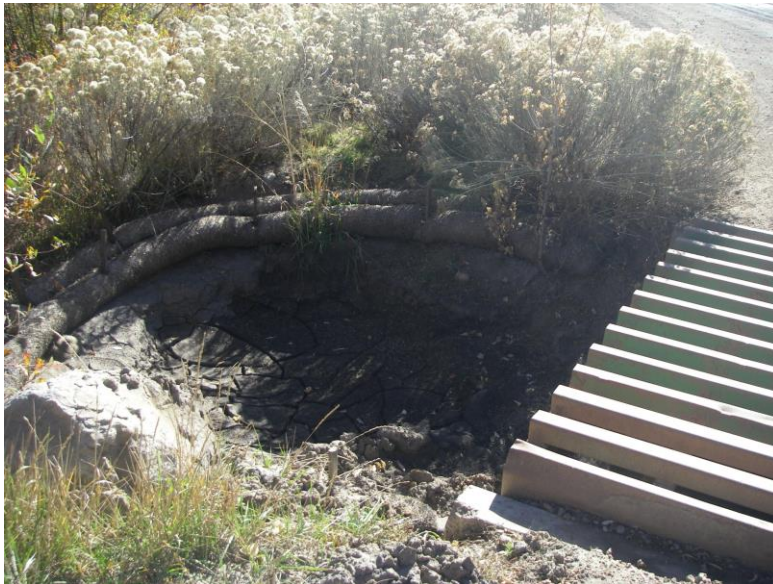
Sediment sump at King II entrance

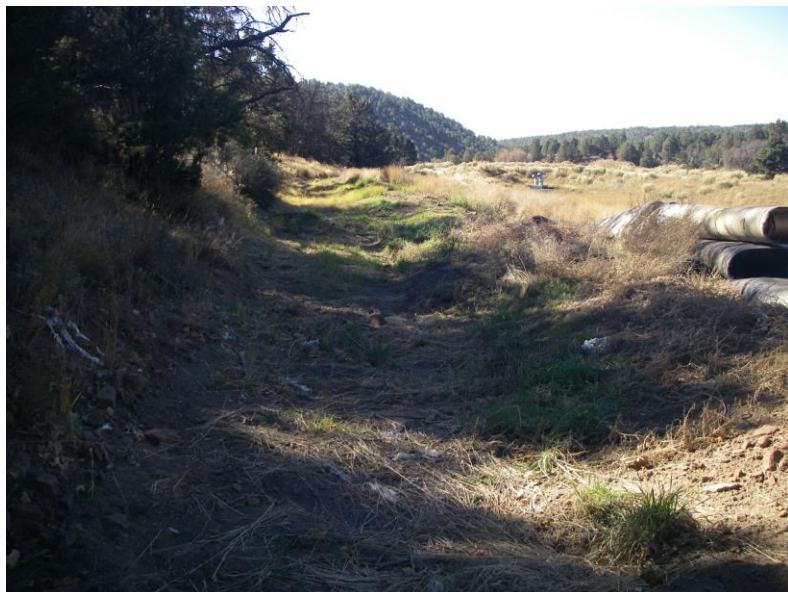
East Clearwater Ditch near King II pond

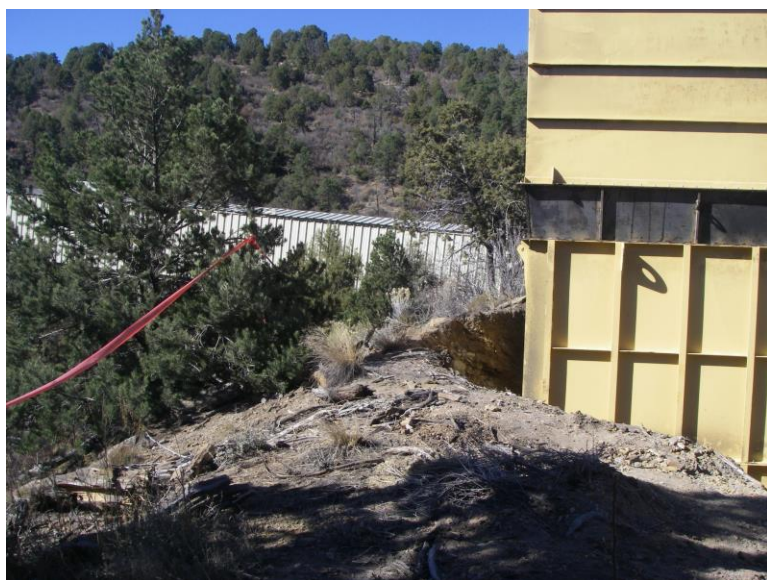
Construction of the new fan appears to be nearing completion. No problems were seen with erosion or sediment loading onto the hill below the fan. Under the conveyor, next to the new fan construction, wattle maintenance is needed.

Top of hill next to new fan

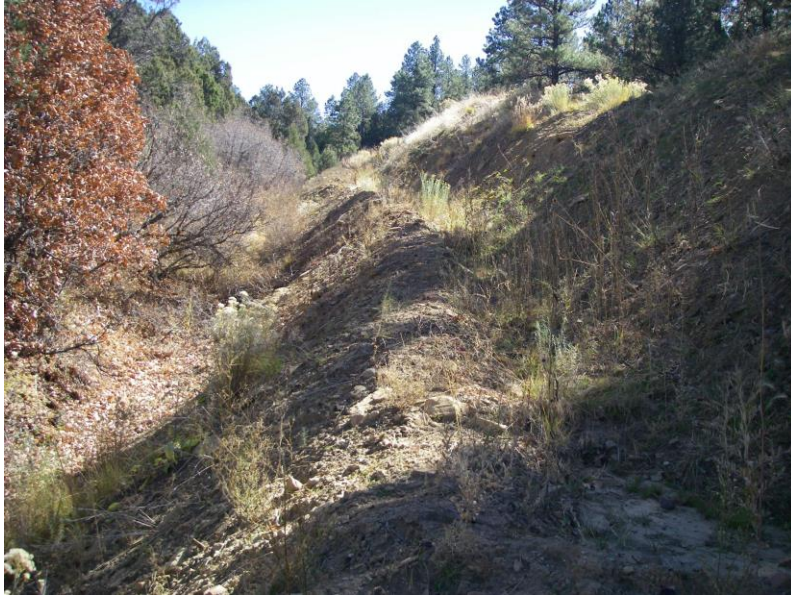
At King I, no significant problems were identified with the Plant Growth Medium Storage Areas, although vegetation on the piles is lacking in places. No sign of erosion or sediment transport off the piles was seen.

Ditch on north side of Plant Growth Medium Storage Area (above Refuse Pile)

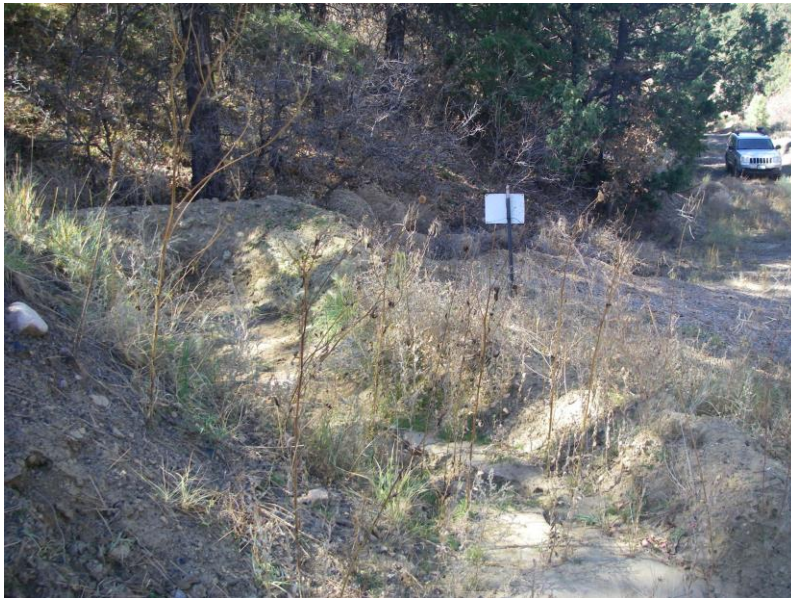
**Ditch on low end of Plant Growth Medium Storage Area
(vehicle on right is directly above Refuse Pile)**
