**COLORADO**Division of Reclamation,
Mining and Safety

MINERALS PROGRAM INSPECTION REPORT**PHONE: (303) 866-3567**

MINE NAME: Portland Limestone Quarry	MINE/PROSPECTING ID#: M-1977-344	MINERAL: Limestone (general)	COUNTY: Fremont
INSPECTION TYPE: Monitoring	INSPECTOR(S): Timothy A. Cazier	INSP. DATE: April 26, 2017	INSP. TIME: 12:45
OPERATOR: Holcim (US) Inc.	OPERATOR REPRESENTATIVE: Nick Bellino	TYPE OF OPERATION: 112c - Construction Regular Operation	
REASON FOR INSPECTION: Normal I&E Program	BOND CALCULATION TYPE: Partial Bond	BOND AMOUNT: \$5,268,550.00	
DATE OF COMPLAINT: NA	POST INSP. CONTACTS: None	JOINT INSP. AGENCY: None	
WEATHER: Cloudy	INSPECTOR'S SIGNATURE:

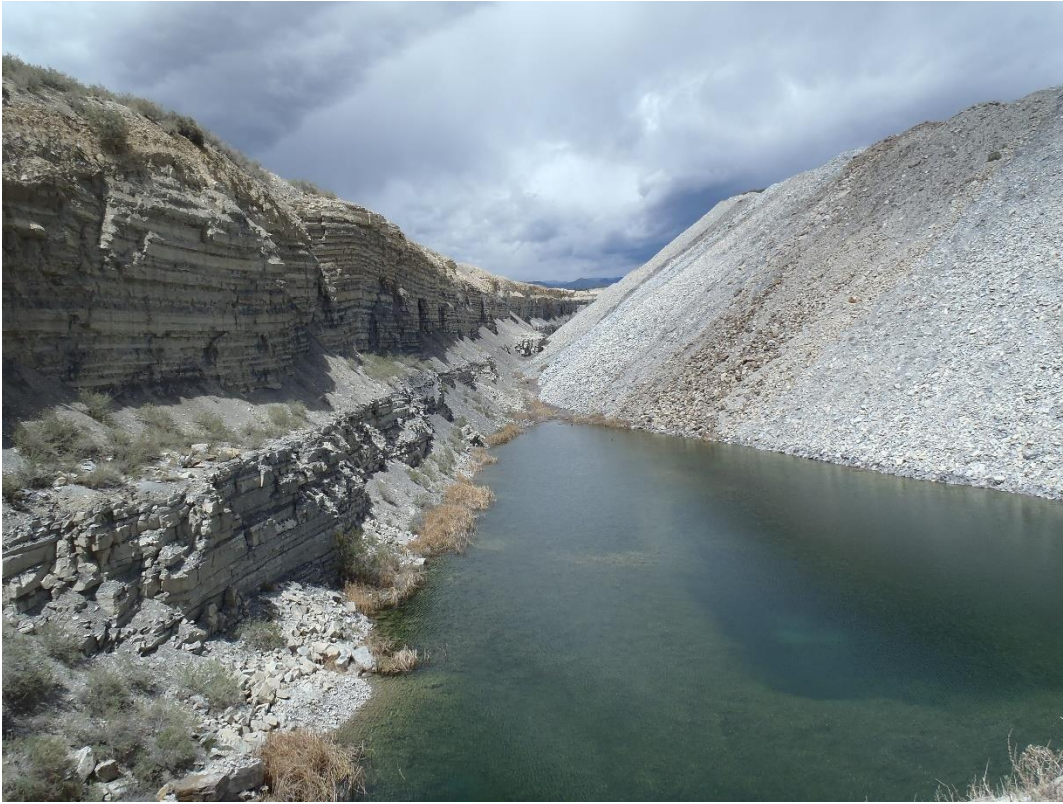
Hydrologic Balance: Mr. Bellino stated they had received over a half inch of rain the night before the inspection. Standing water was observed in different areas of the pit. Some of this appeared to have a significant groundwater component, if not all groundwater: North Pond (see **Photo 1**) and the million dollar hole (see **Photo 2**). Mr. Bellino explained the million dollar hole receives water pumped out of the active pit for the purpose of dewatering, then is pumped to an Arkansas River discharge point. As stated above, a records review indicates the SWSP expired on December 31, 2014. **The absence of a valid SWSP is cited as a problem on page 1 of this report.**

Photo 1. North Pond (looking north).

PROBLEM/POSSIBLE VIOLATION: Problem: The Division has no evidence that the operator has a valid well permit, substitute water supply plan, or approved water augmentation plan for the exposed groundwater at the site. This is a problem related to 34-32.5-116(4)(h) of the Colorado Revised Statutes and 3.1.6(1)(a) of the Construction Materials Rules and Regulations governing injury to existing water rights.

CORRECTIVE ACTIONS: The operator shall demonstrate that the operation is in compliance with the Office of the State Engineer, show evidence that the operator is taking measures to bring the site into compliance with the SEO, or backfill the pits to at least two feet above the groundwater surface by the corrective action date specified.

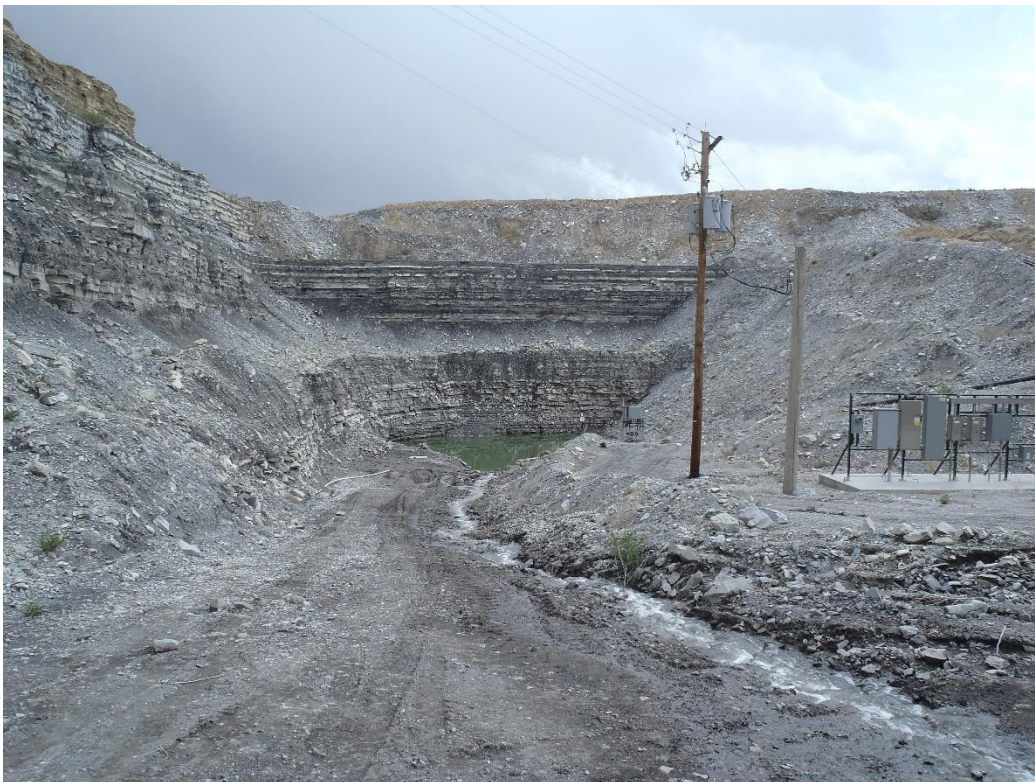
Photo 2. Million dollar hole pond receives water from pit dewatering (looking south).

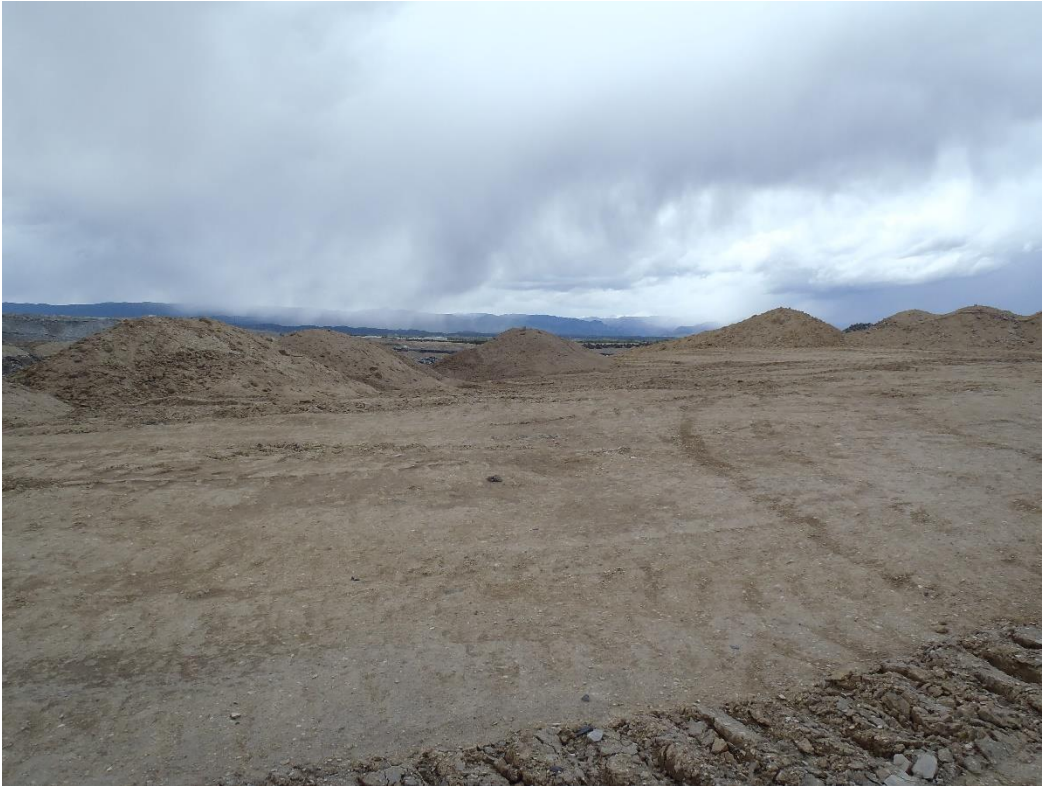
Reclamation Success: Reclamation efforts have been initiated in the southeast corner of the mine Grading to 3H:1V or flatter had been completed. Topsoiling was in process near the million dollar pit (see **Photo 3**), but no seeding had taken place at the time of the inspection.

Photo 3. Spreading topsoil near million dollar hole (looking SW).

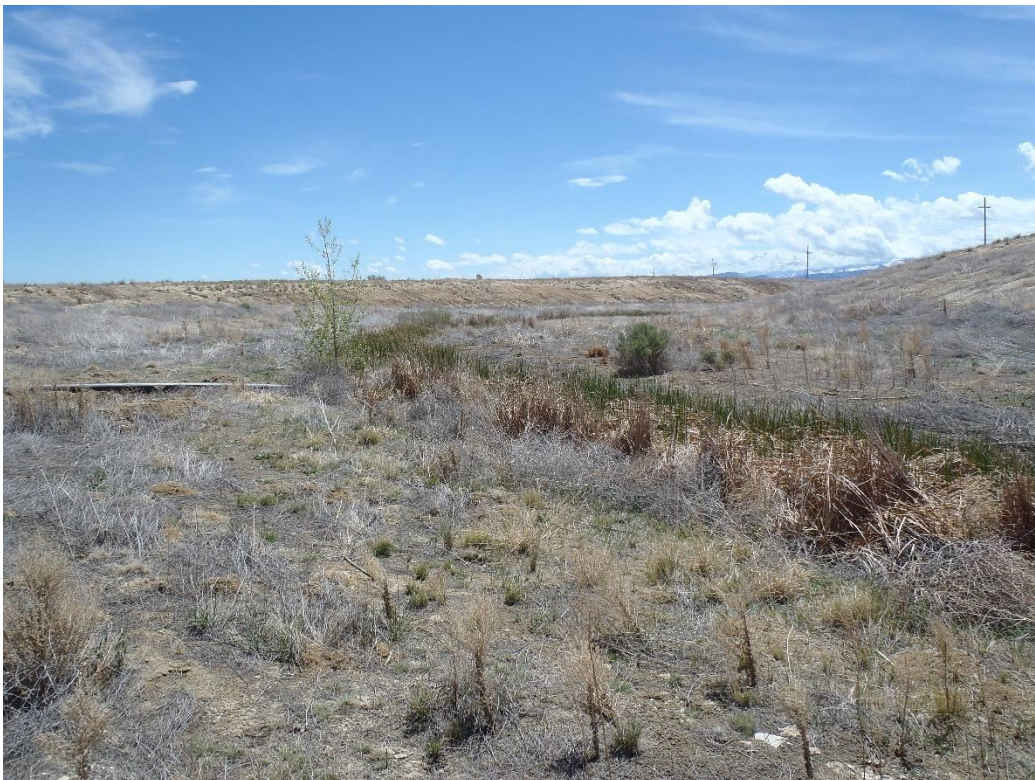
Revegetation: Mr. Bellino indicated no revegetation efforts had been initiated. Willows and cattails appeared well established along the lower banks of the Bear Creek Diversion (see **Photos 4 and 5**). However, the upper banks could benefit from more focused revegetation efforts. No noxious weeds were observed.

Photo 4. Cattails along the lower banks of the Bear Creek Diversion (looking north).

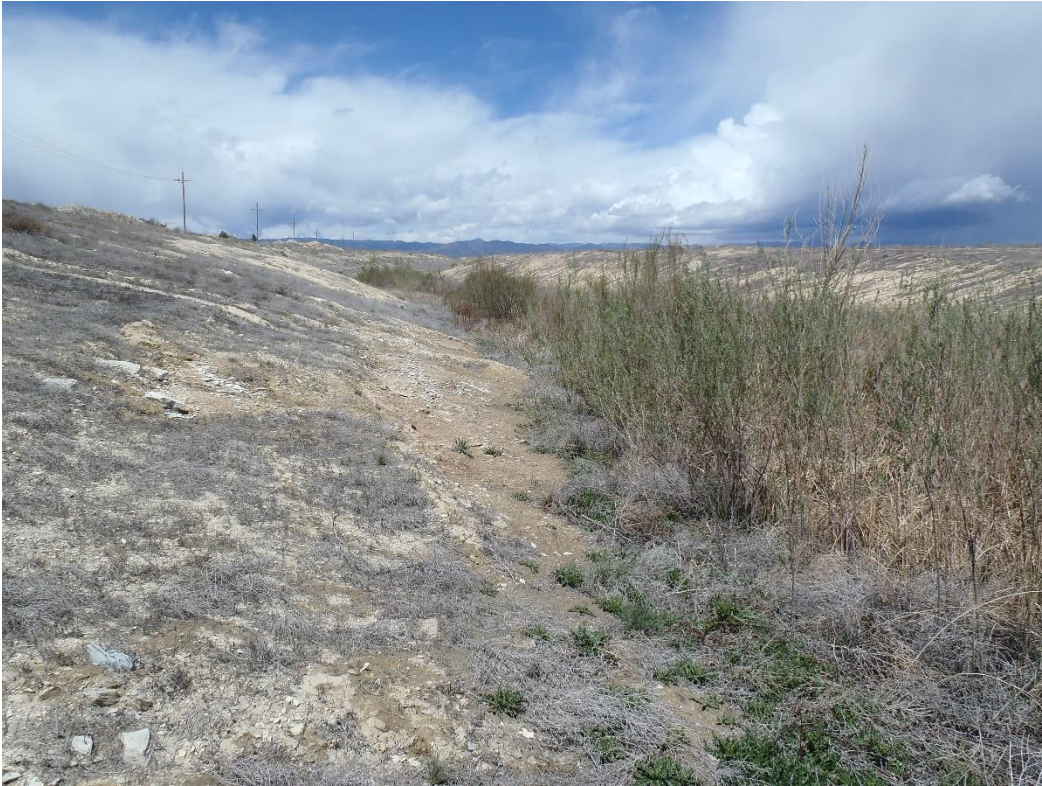
Photo 5. Willows along the lower banks of the Bear Creek Diversion (looking north).

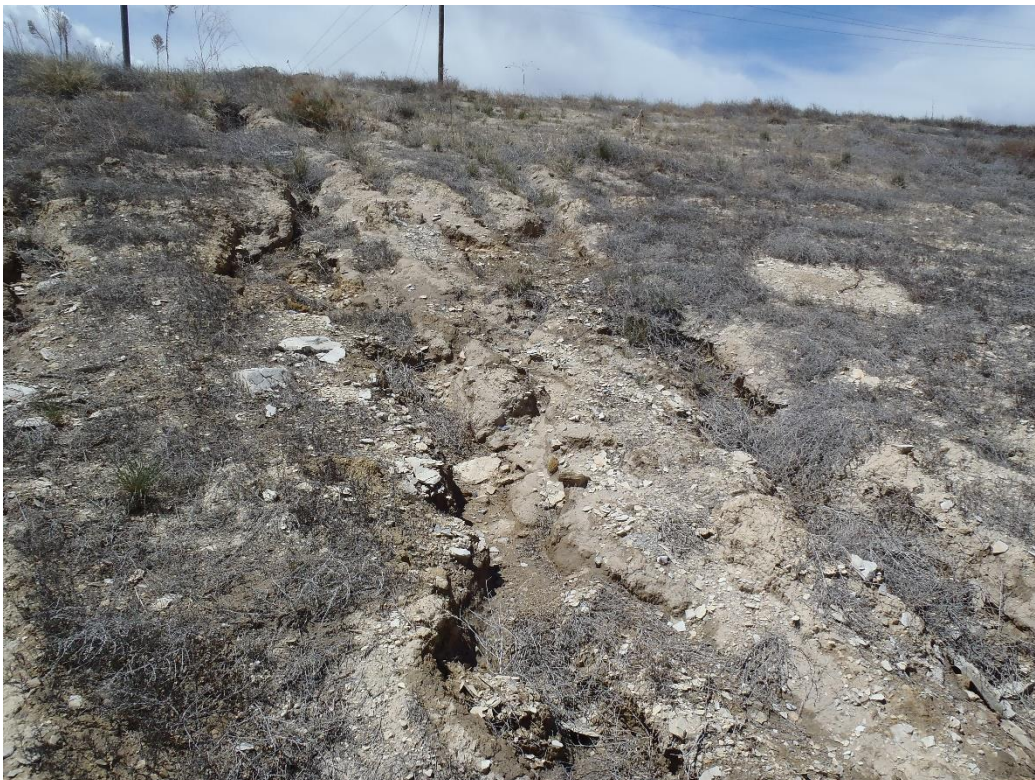
Photo 6. Erosion rilling and gulying observed along the Bear Creek realignment.

Sediment Control: Some erosion rilling and gulying were observed along the Bear Creek realignment (see **Photos 6 and 7**). The Division recommends implementing best management practices (BMPs) such as straw wattles and/or erosion control blankets to control erosion until the vegetation is established.

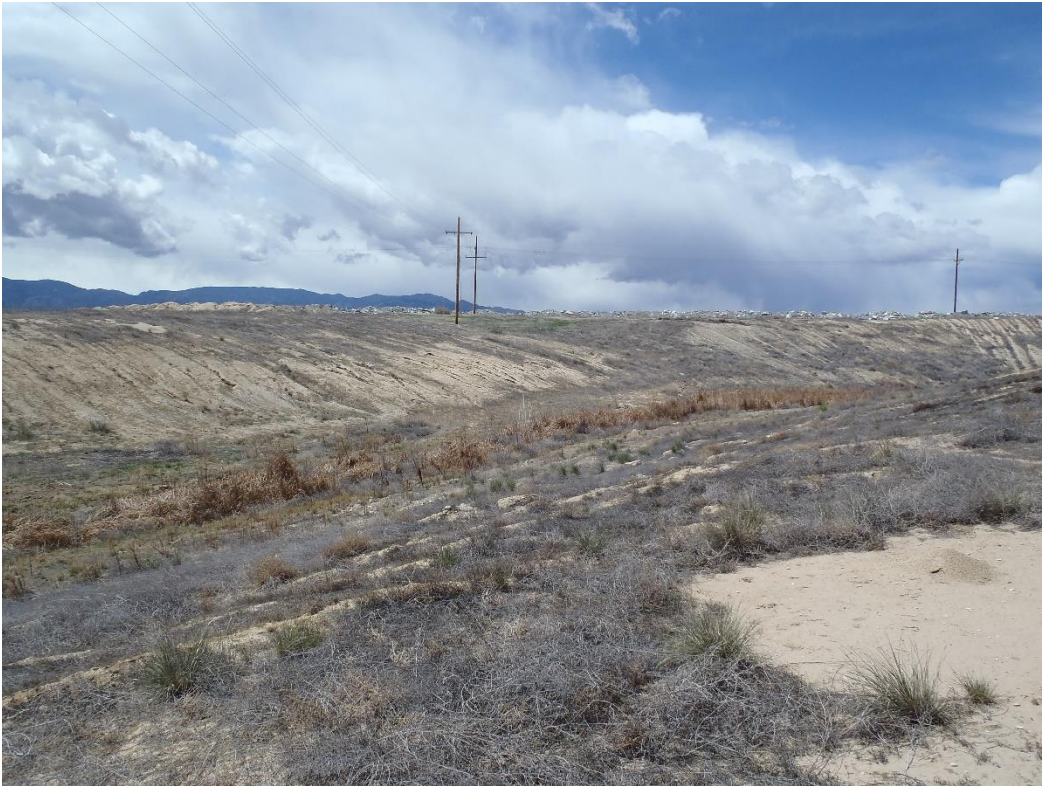
Photo 7. Erosion rilling / gullying observed along Bear Creek realignment (looking NW).

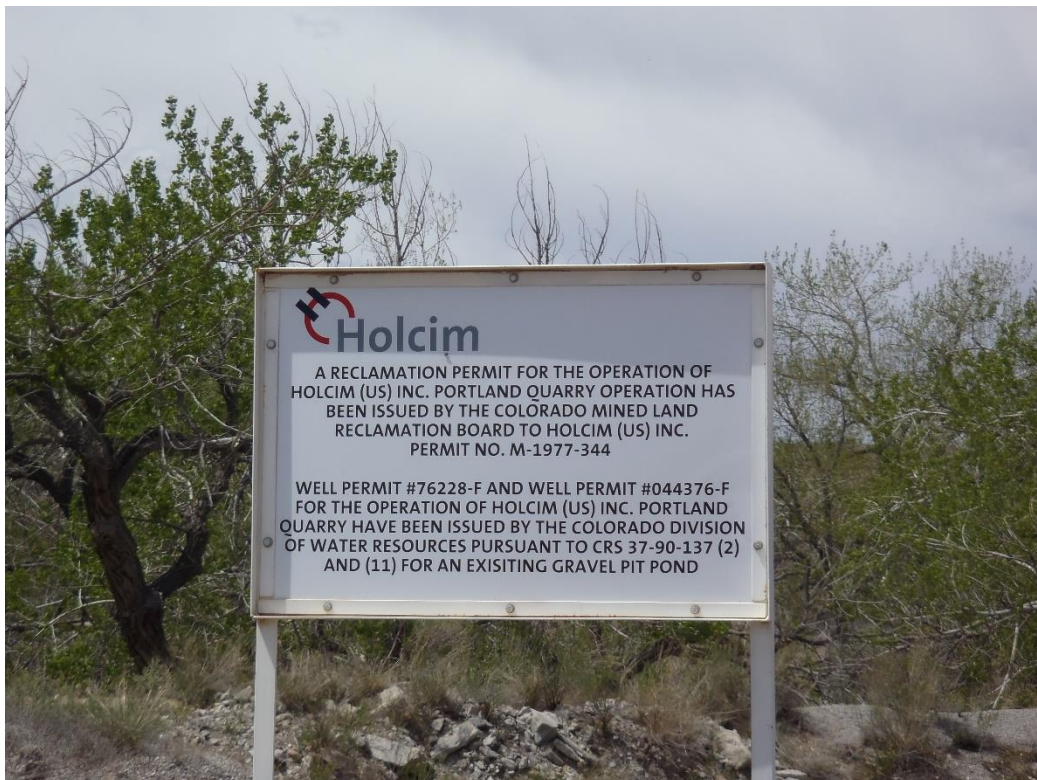
Signs and Markers: The permit sign was properly posted (see **Photo 8**) and boundaries are generally marked with fences.

Photo 8. Permit sign at entrance.

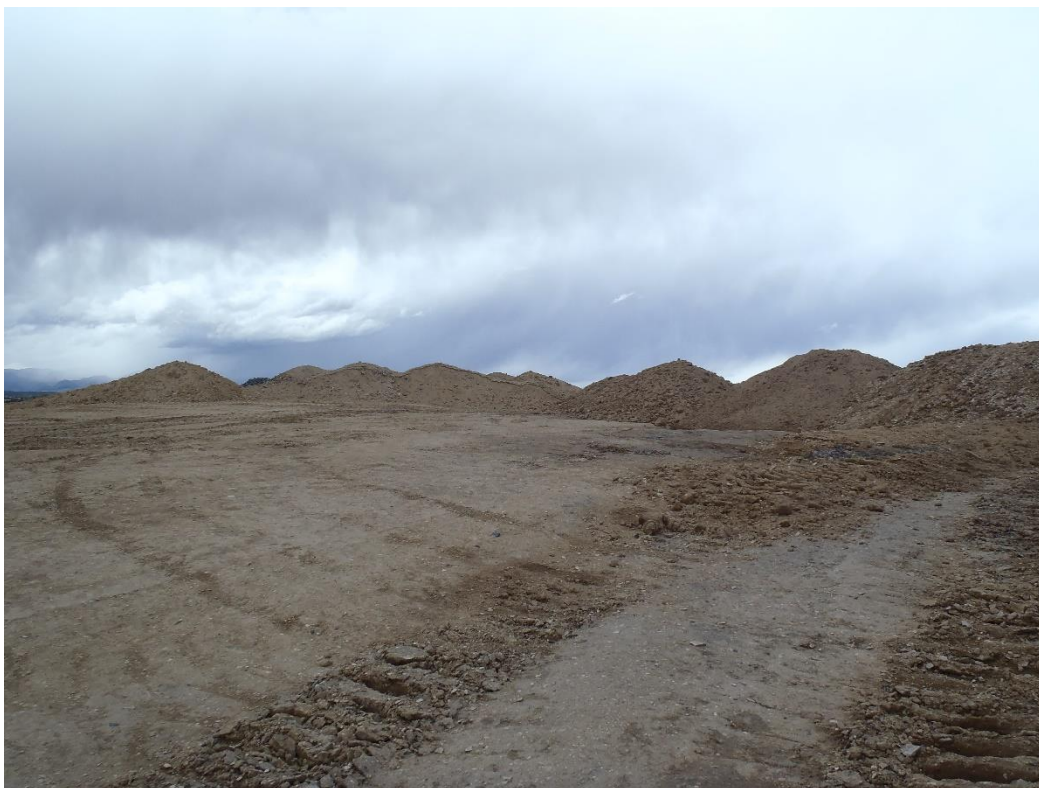
Topsoil: The mine has been stripping topsoil and salvaging it for reclamation (see **Photo 9**).

Photo 9. Topsoil stockpiles (near million dollar hole, SE area of permit).
