MINERALS PROGRAM INSPECTION REPORT
PHONE: (303) 866-3567

MINE NAME: Hukill Gulch Millsite	MINE/PROSPECTING ID#: M-2009-076	MINERAL: Silver and gold	COUNTY: Clear Creek
INSPECTION TYPE: Monitoring	INSPECTOR(S): Michael A. Cunningham	INSP. DATE: October 26, 2017	INSP. TIME: 09:30
OPERATOR: Venture Resources, Inc.	OPERATOR REPRESENTATIVE: Patrick Maher, Mason Drake, Jim Beck	TYPE OF OPERATION: 110d - Designated Limited Impact	
REASON FOR INSPECTION: Normal I&E Program	BOND CALCULATION TYPE: None	BOND AMOUNT: \$96,827.69	
DATE OF COMPLAINT: NA	POST INSP. CONTACTS: None	JOINT INSP. AGENCY: None	
WEATHER: Clear	INSPECTOR'S SIGNATURE:

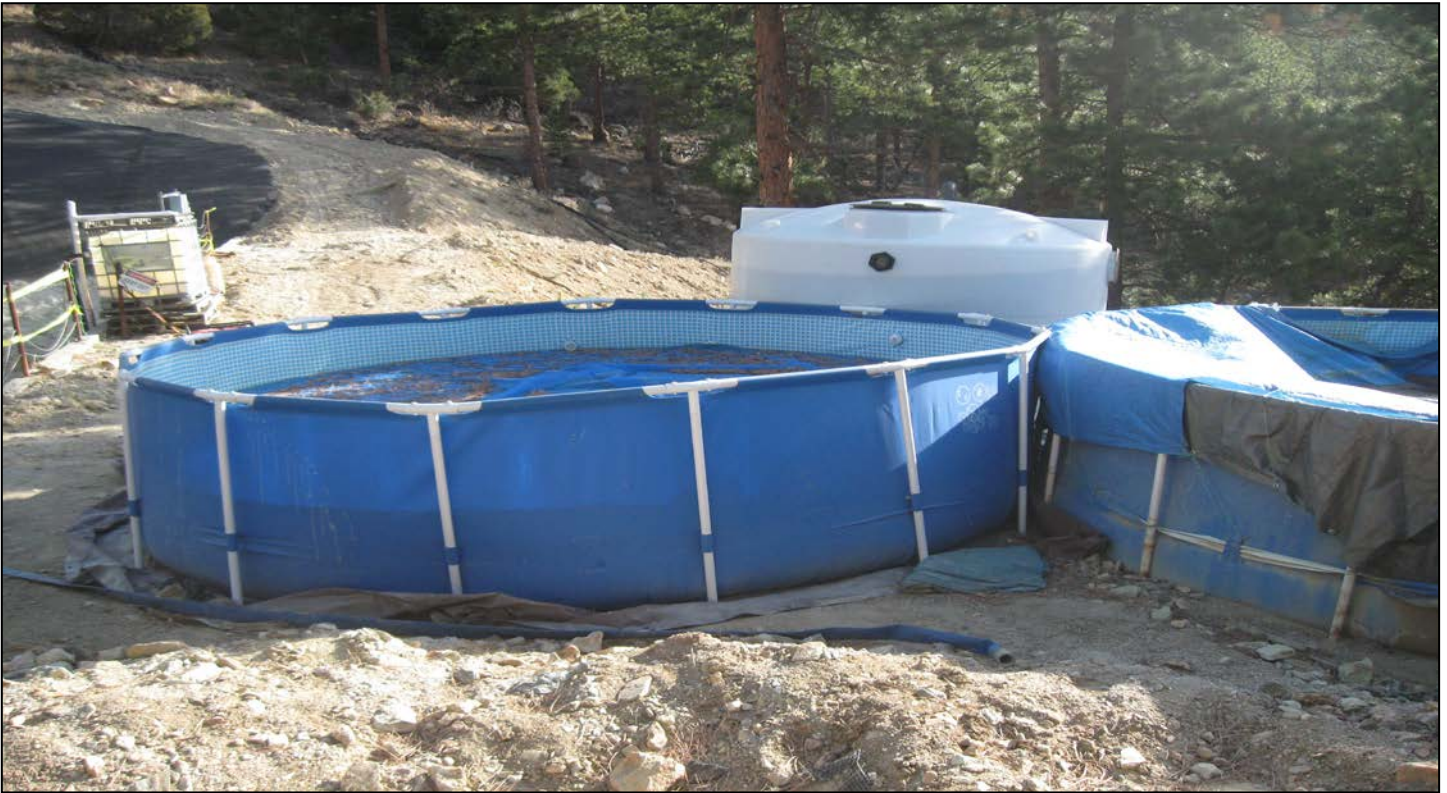
During the inspection, the Division observed 3 tanks adjacent to the concrete cut-off wall. The tanks contained approximately 10,500 gallons of liquids pumped from the tailings impoundment. The Operator has requested authorization to return the liquids back into the tailings impoundment. Upon review of the Corrective Action Completion Report and visual assessment of the repaired composite liner, the Division authorizes the Operator to proceed with transferring the liquids back into the tailings impoundment. The Operator has estimated it will take one day to complete this task.

1. Storage of liquids pumped from tailings impoundment.

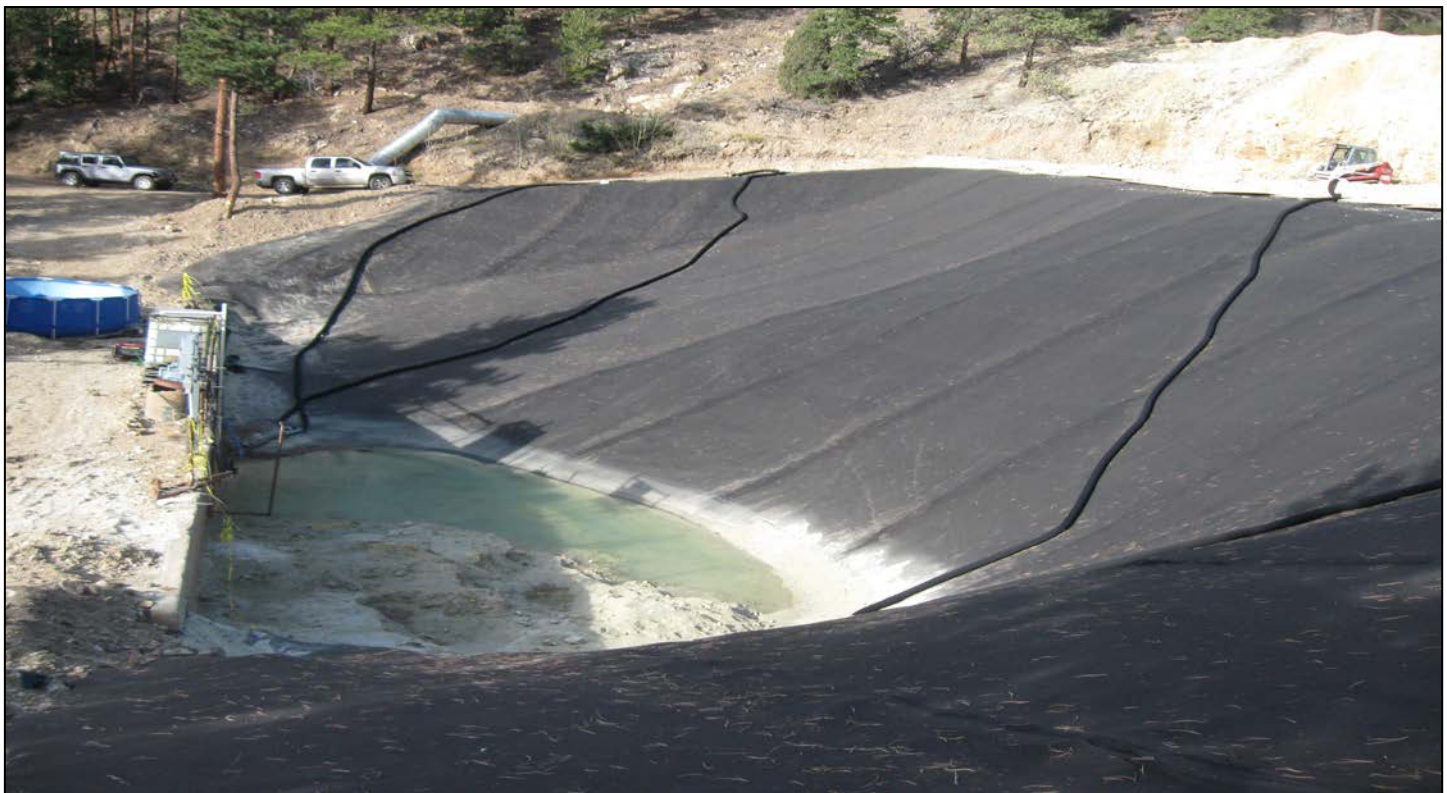
2. Overview of tailings impoundment, photo taken facing west.

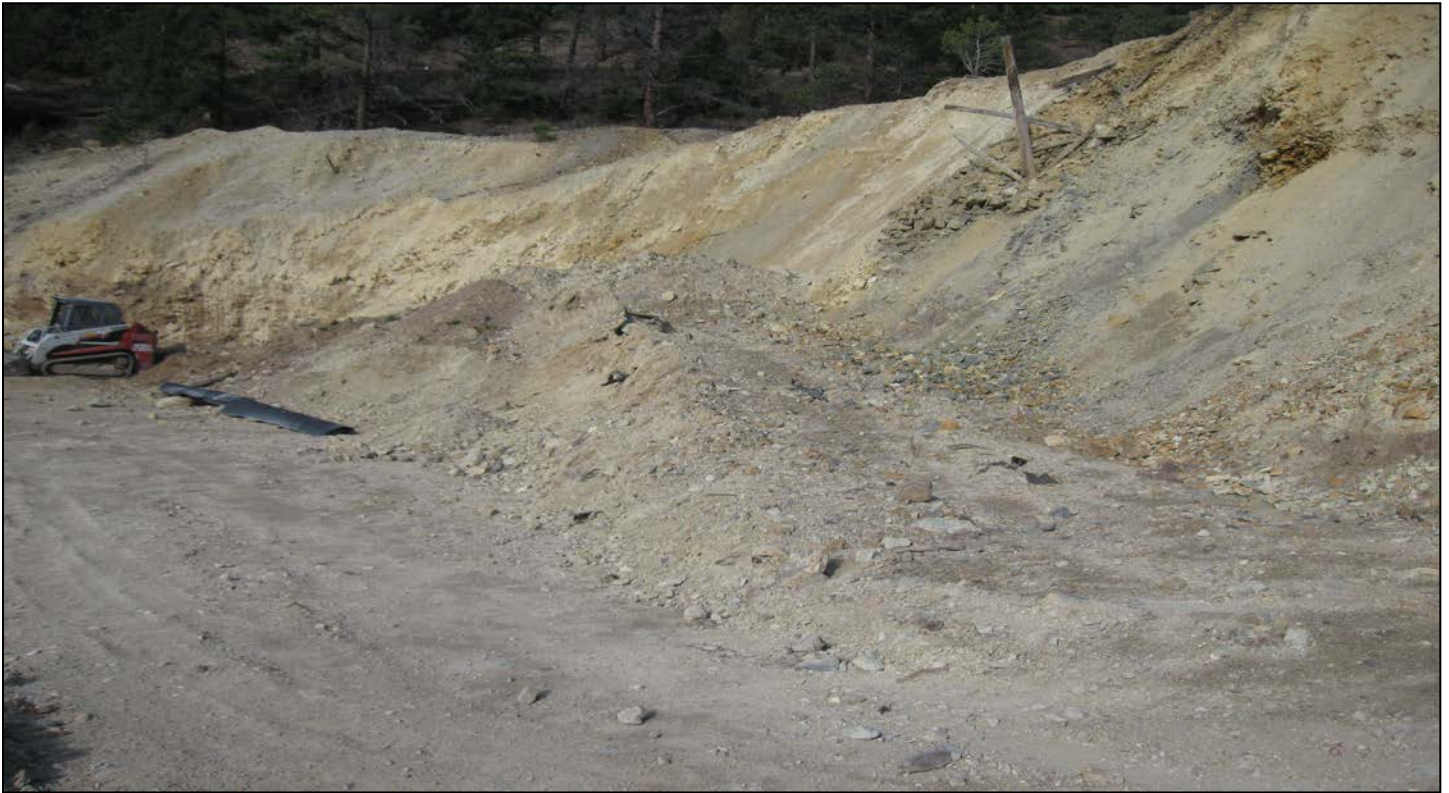
The waste rock which had been placed within the tailings impoundment has been relocated to the bench immediately above the impoundment. The waste rock will be run through the mill when active milling operations resume. In addition to the waste rock, the Operator removed and segregated bank run material which had been placed in the tailings impoundment. The bank run material will be utilized as a supplemental growth medium during reclamation. The Operator also replaced the 4" drain pipes within the tailings impoundment. The drain pipes are covered in a geotextile filter sock and are designed to facilitate additional drainage within the tailings impoundment.

3. Waste rock removed from tailings impoundment.

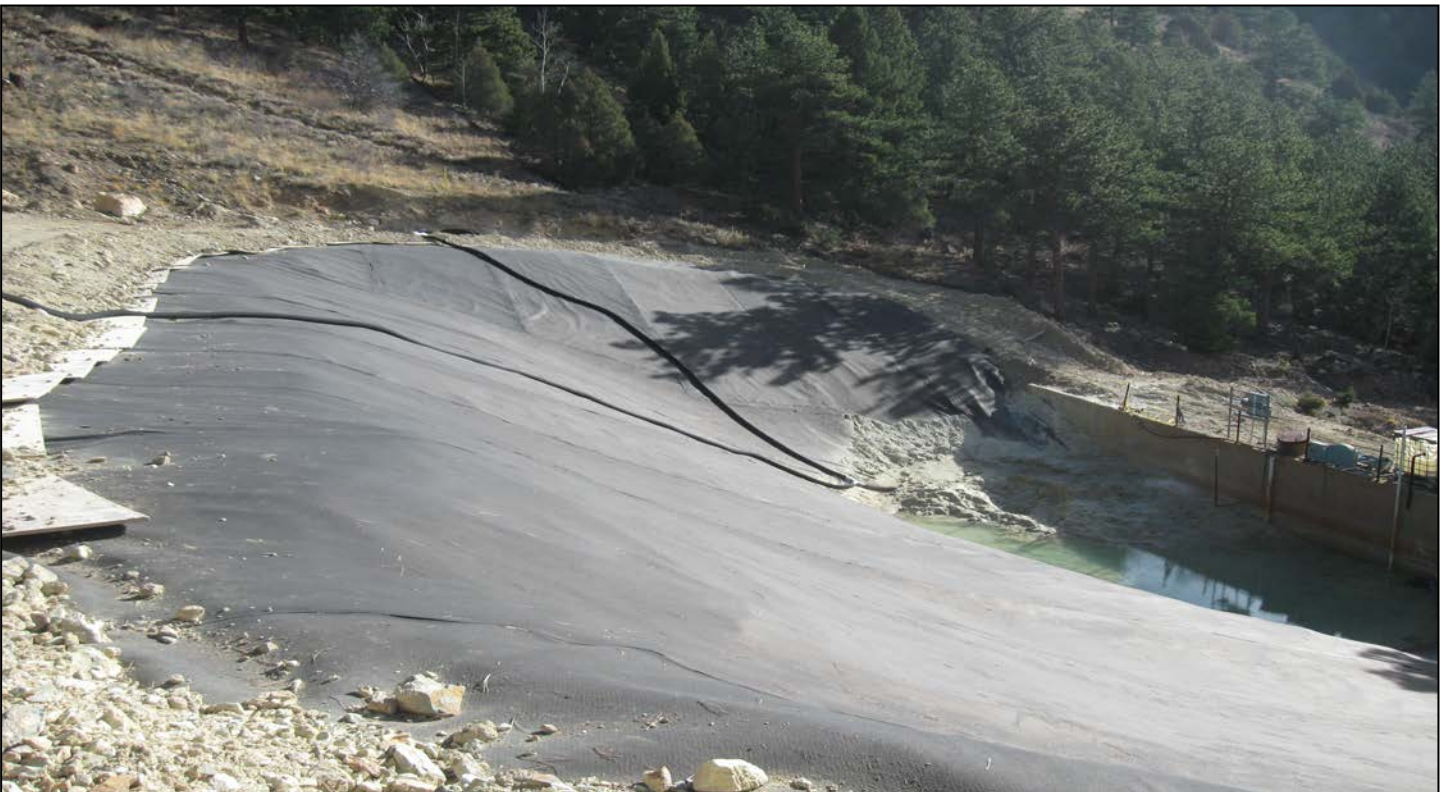
4. Overview of tailings impoundment, photo taken facing east.

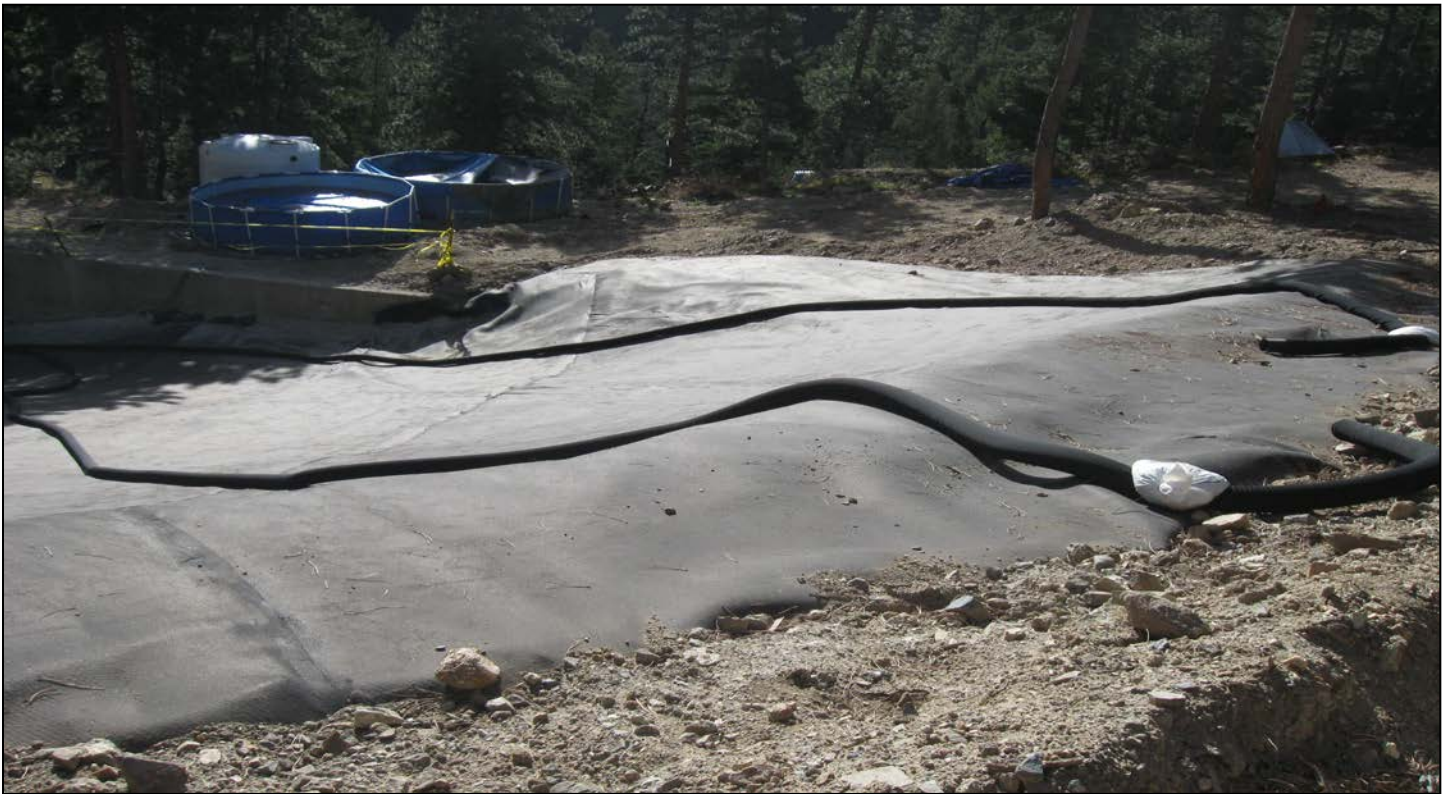
5. 4" perforated drain pipes.

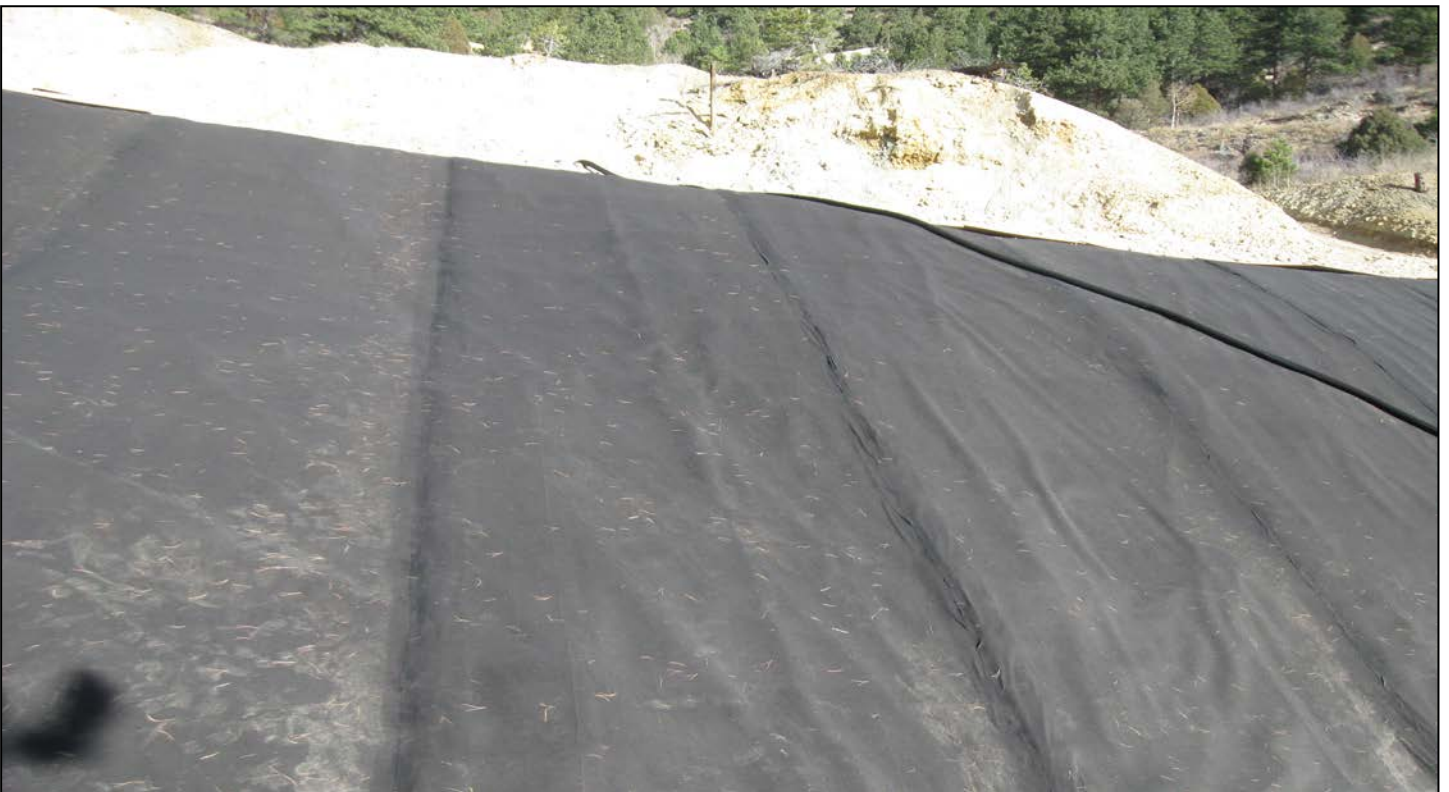
The composite liner system is comprised of a Geosynthetic Clay Liner, a 60 mil HDPE Geomembrane Liner, and a Geocomposite drainage layer. The appropriate repairs were made to all three layers of the composite liner system. On October 19, 2017, the Division received the Corrective Action Completion and Recertification Report which details the repairs made to the EPF. The Division found the repairs which were made to the liner system were carried out in accordance with the Corrective Action Plan approved under Technical Revisions No. 3 and No. 4 and with the requirements of Rule 7.3. Notice of acceptance of the certification of the EPF will be sent under separate cover.

6. Welded seams of the Geocomposite drainage layer.
