## MINERALS PROGRAM INSPECTION REPORT

<b>MINE NAME:</b> Sokol Pit	<b>MINE/PROSPECTING ID#:</b> M-1980-193	<b>MINERAL:</b> Sand and gravel	<b>COUNTY:</b> El Paso
<b>INSPECTION TYPE:</b> Monitoring	<b>INSPECTOR(S):</b> Timothy A. Cazier	<b>INSP. DATE:</b> October 11, 2016	<b>INSP. TIME:</b> 13:55
<b>OPERATOR:</b> Rocky Mountain Materials and Asphalt, Inc.	<b>OPERATOR REPRESENTATIVE:</b> Dave Bieber, Rusty Cochrane	<b>TYPE OF OPERATION:</b> 112c - Construction Regular Operation	
<b>REASON FOR INSPECTION:</b> Normal I&E Program	<b>BOND CALCULATION TYPE:</b> Partial Bond	<b>BOND AMOUNT:</b> \$113,757.00	
<b>DATE OF COMPLAINT:</b> NA	<b>POST INSP. CONTACTS:</b> None	<b>JOINT INSP. AGENCY:</b> None	
<b>WEATHER:</b> Cloudy	<b>INSPECTOR'S SIGNATURE:</b>

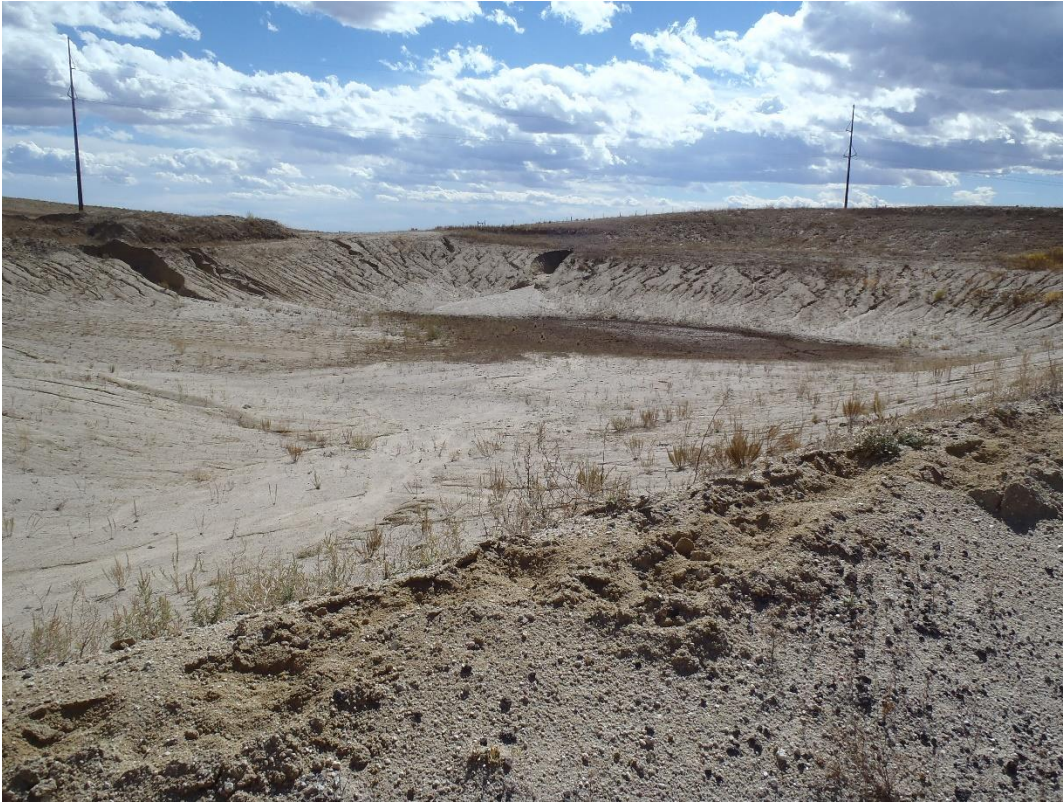
Hydrologic Balance: No standing water was observed in the pit and no exposed groundwater was observed. Sediment ponds and wash ponds were dry (see **Photos 1** and **2**)

Storm Water MGT Plan: No oil or fuel spills observed. Stormwater drains to the pit and to a stormwater pond within the pit area (see **Photo 1**).

Photo 1. Sediment pond (looking SW).

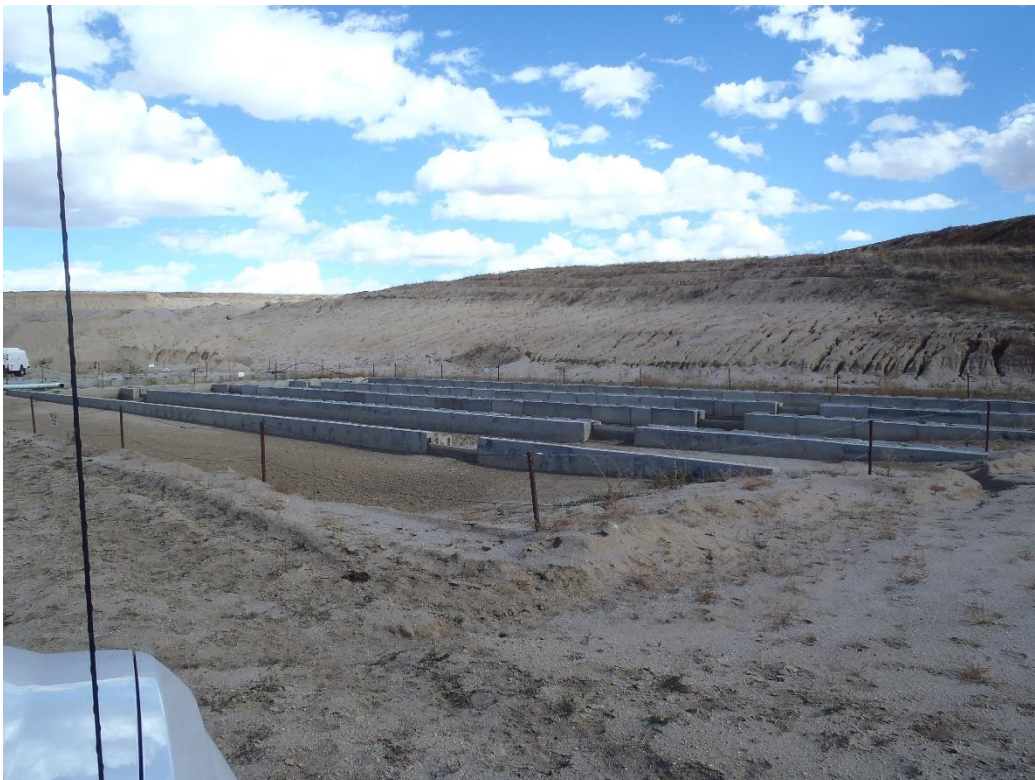
Photo 2. Wash ponds (looking SE).

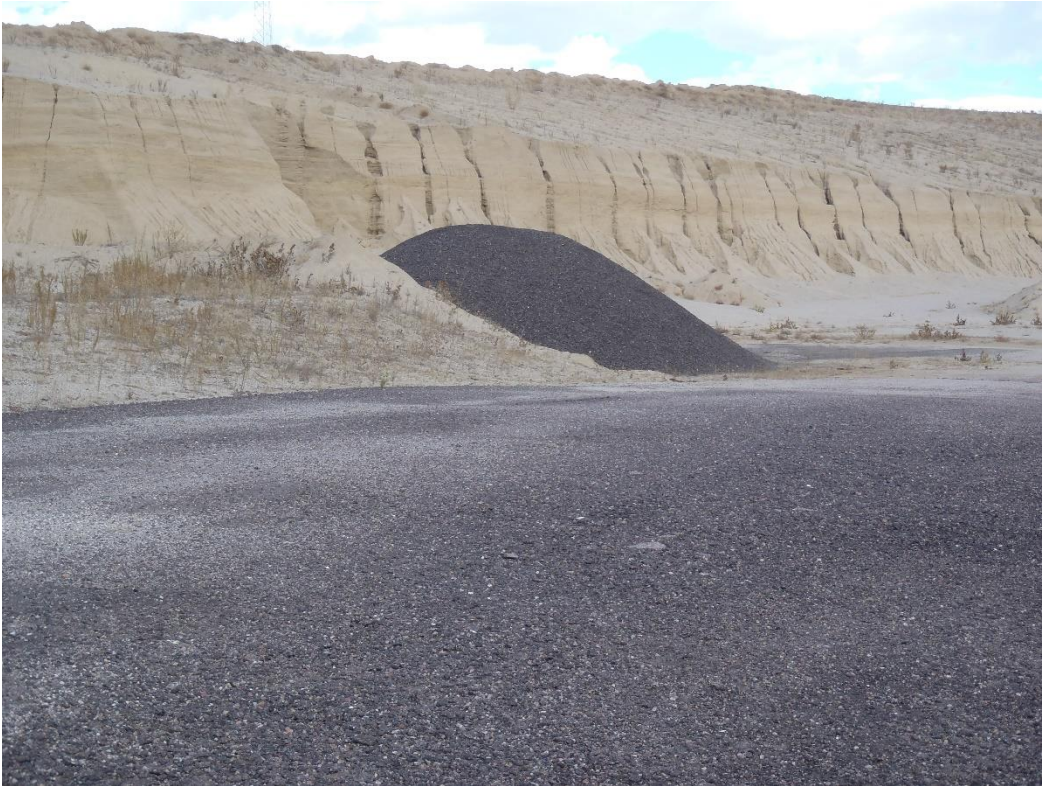
Sediment Control: Some erosion rills and gullies were observed on the highwalls but no BMPs were needed at the time of the inspection.

Photo 3. North highwalls showing signs of erosion (note stockpile of milled asphalt).

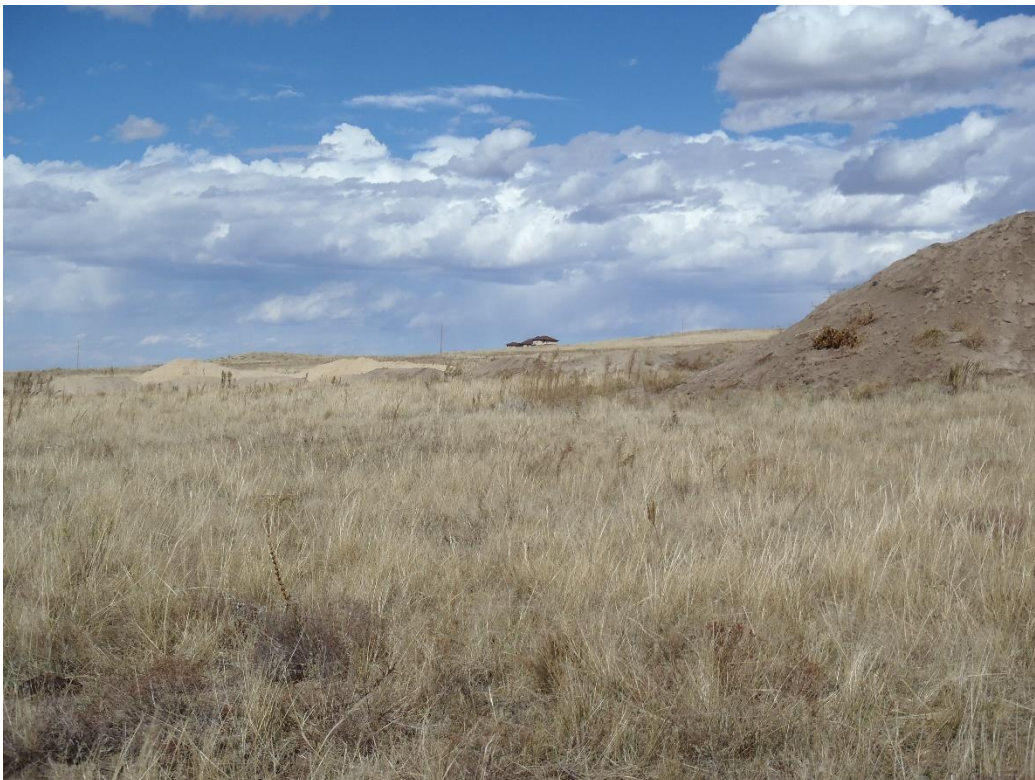
Reclamation Success: No reclamation has been initiated. The Division has confirmed the reclamation area (see **Photo 4**) in the northwest corner near Soap Weed Rd is in the permit boundary and is considered affected area

Photo 4. Reclamation area in the northwest corner near Soap Weed Rd (looking NW).

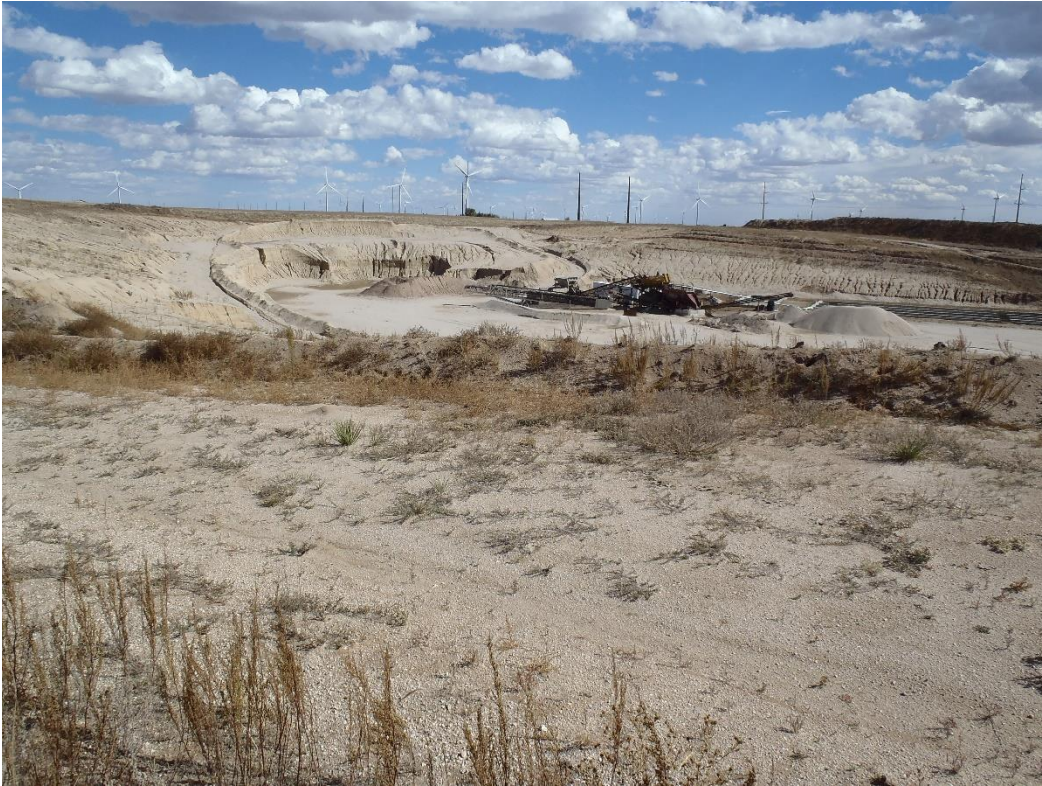
Support Facilities On-site: A screen plant and truck scale were observed on site (see **Photo 5** and **6**).

Photo 5. Screen plant (looking SE).

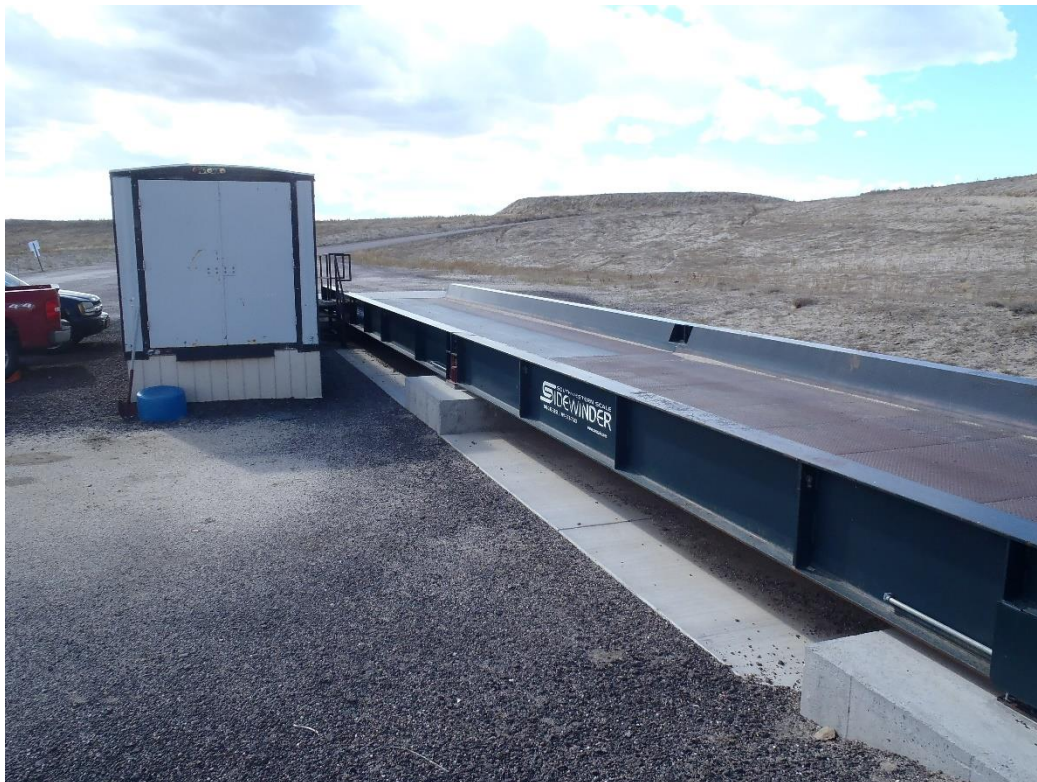
Photo 6. Truck scale.

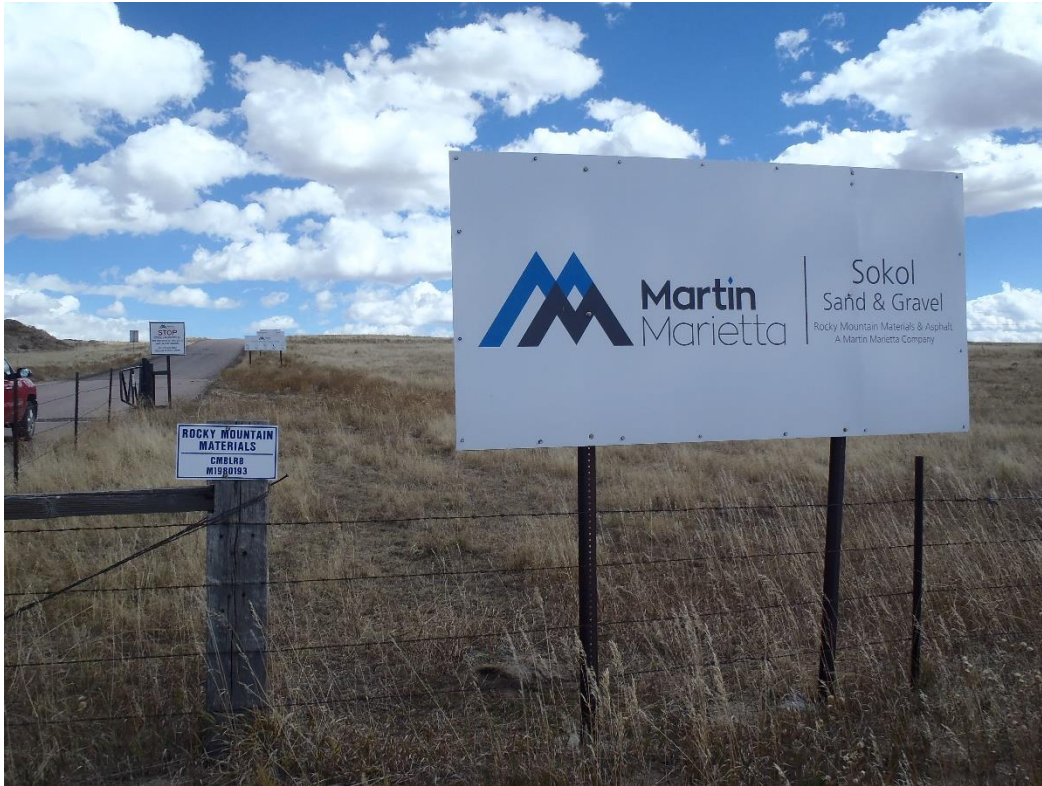
Signs and Markers: The permit sign was properly posted (see **Photo 7**), although the permit number should be included on the large sign. Boundary markers consisted of fences (see **Photo 8**) on the east and south sides, and T-posts on the north and west sides.

Photo 7. Permit sign at entrance.

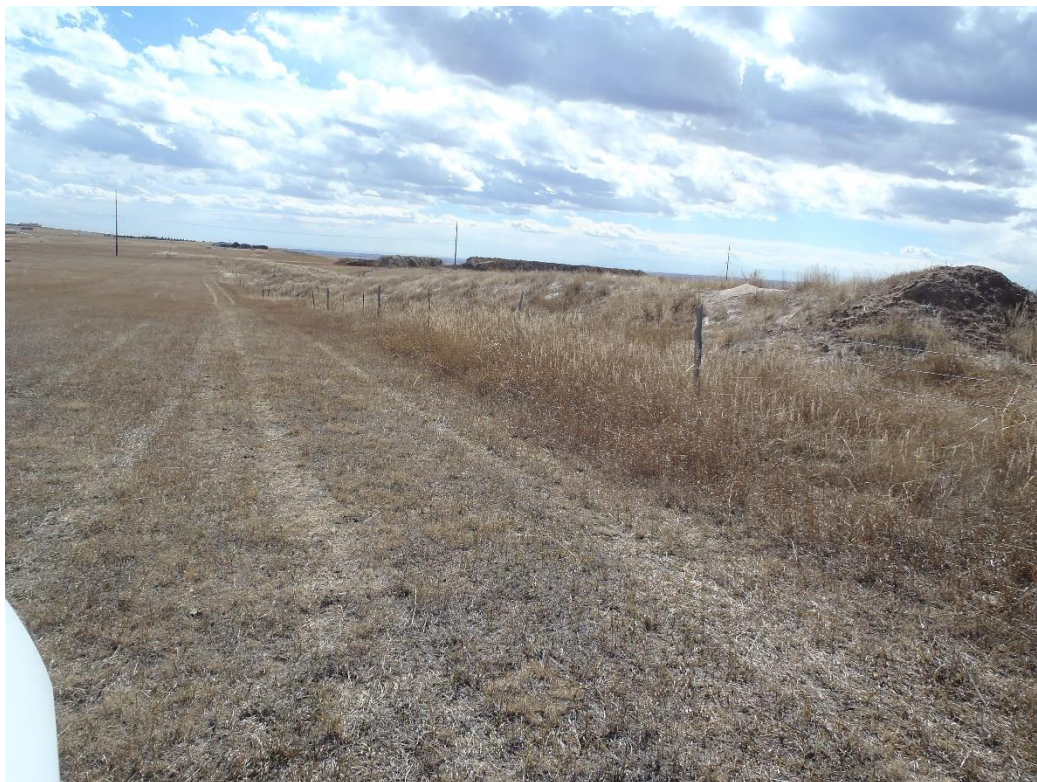
Photo 8. Fence marking east affected area boundary.
