MINERALS PROGRAM INSPECTION REPORT
PHONE: (303) 866-3567

MINE NAME: Dawson Gold Project	MINE/PROSPECTING ID#: P-2013-002	MINERAL: Gold	COUNTY: Fremont
INSPECTION TYPE: Monitoring	INSPECTOR(S): Timothy A. Cazier	INSP. DATE: September 29, 2016	INSP. TIME: 12:50
OPERATOR: Zephyr Gold USA Ltd	OPERATOR REPRESENTATIVE: Angela Bellantoni	TYPE OF OPERATION: MP - Mineral Prospecting	
REASON FOR INSPECTION: Normal I&e Program	BOND CALCULATION TYPE: Complete Bond	BOND AMOUNT: \$92,655.00	
DATE OF COMPLAINT: NA	POST INSP. CONTACTS: U.S.BLM	JOINT INSP. AGENCY: U.S.BLM	
WEATHER: Clear	INSPECTOR'S SIGNATURE:

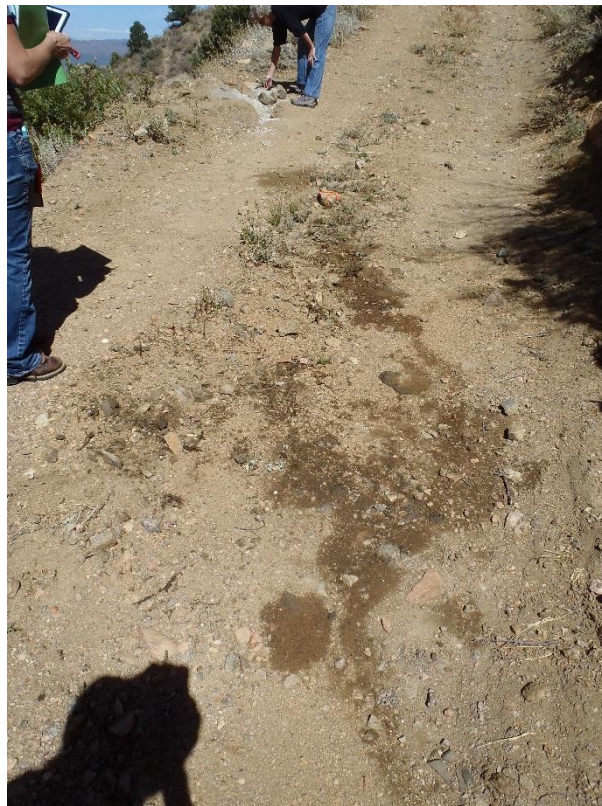
Hydrologic Balance: No standing water was observed and the borehole abandonment reports indicated not groundwater was encountered. However, petroleum product staining was observed at most observed drill sites (see **Photos 1, 2 and 3**). This was cited as a problem, but documentation of the cleanup was received (11/1/2016) prior to generating this report.

Photo 1. Petroleum product staining observed at drill site WG-16-35.

Storm Water MGT Plan: As mentioned above, fuel/oil stains were observed at each drill site. They were cleaned up and documentation of the cleanup was received by the Division on 11/1/2016.

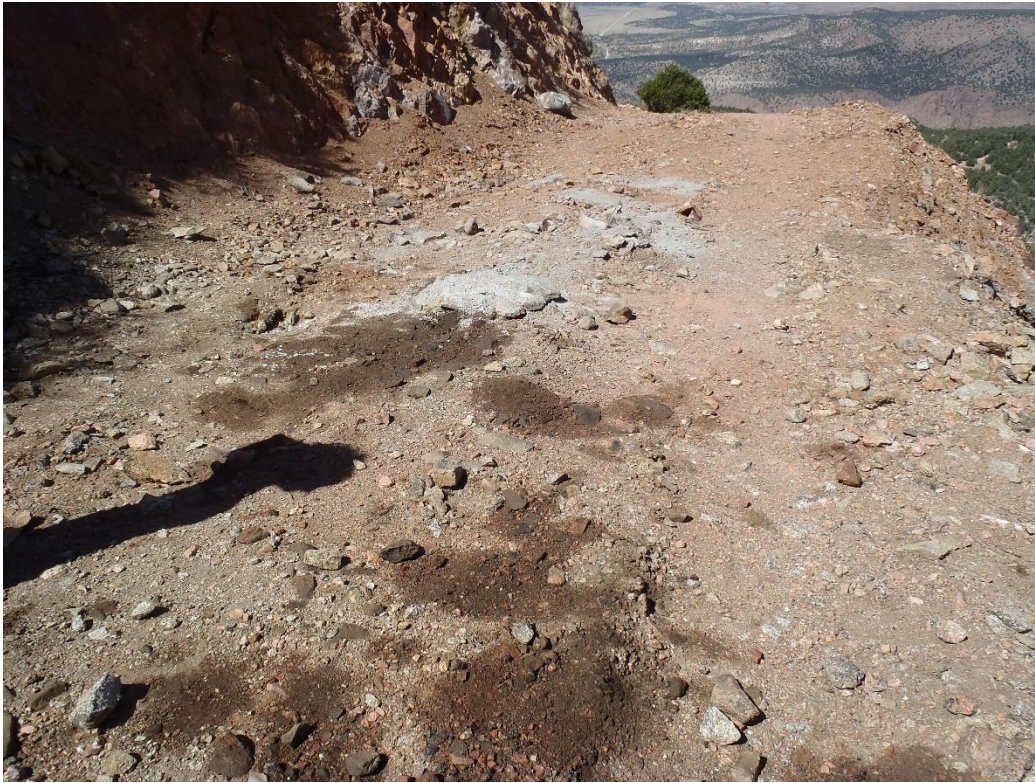
Photo 2. Petroleum product staining observed at drill site WG-16-30.

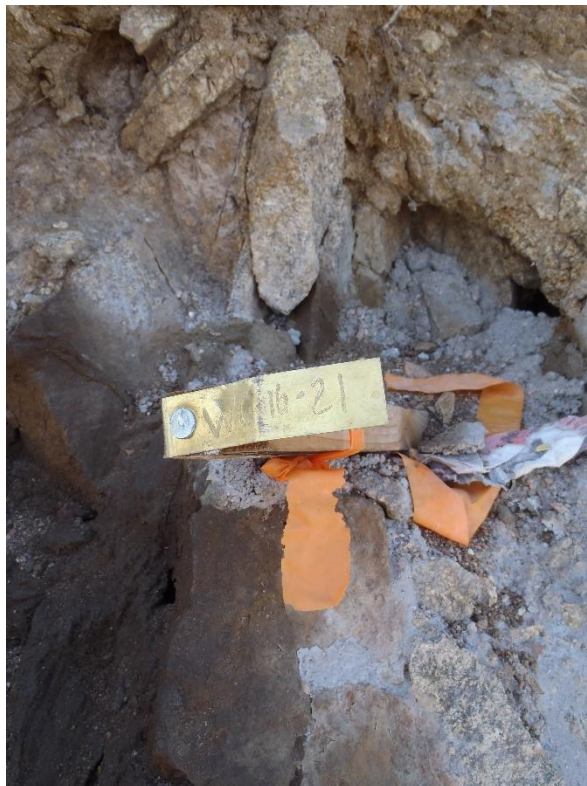
Photo 3. Petroleum product staining observed at drill site WG-16-21.

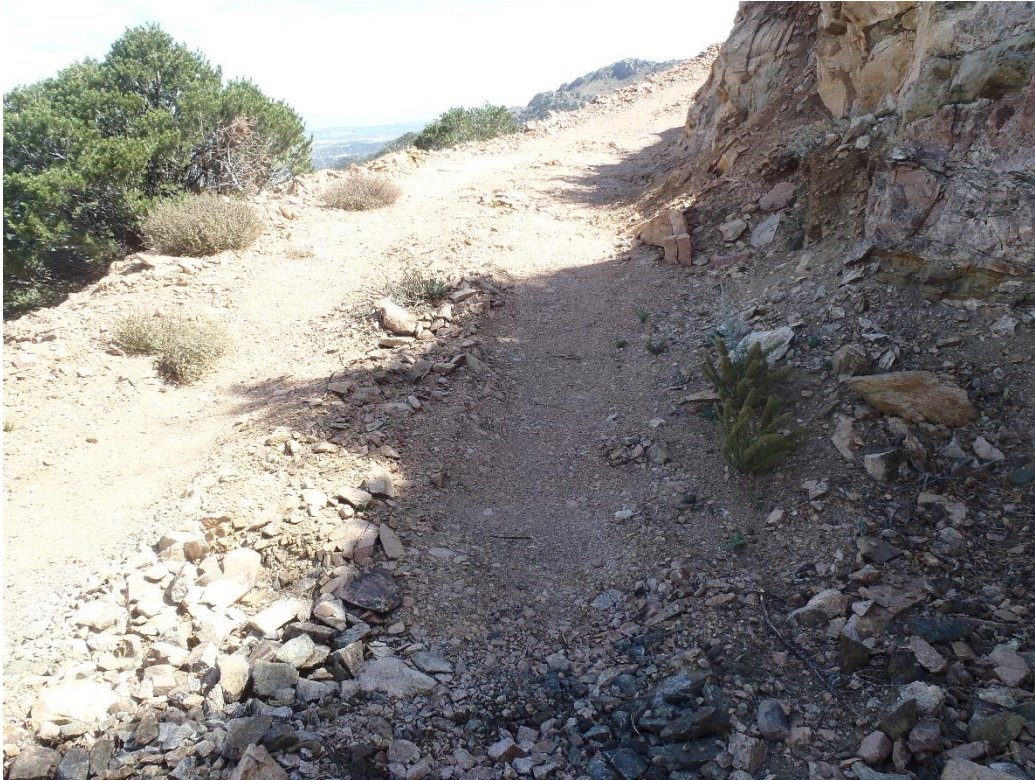
Roads: Access roads did not were not a source of sediment that could be tracked offsite (see **Photo 4**).

Photo 4. Typical access road.

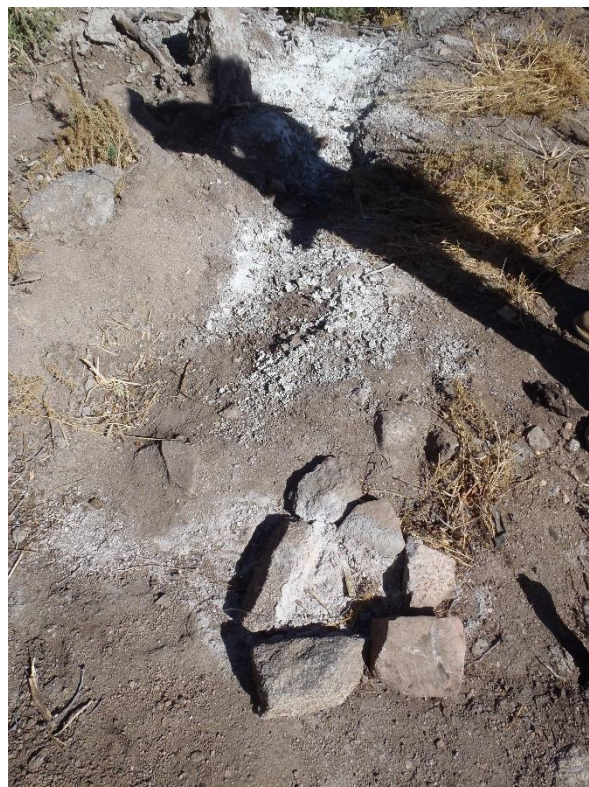
Sediment Control: Grout overflow was observed at WG-16-36 (see **Photo 5**). No BMPS appeared necessary at the time of the inspection.

Photo 5. Grout overflow was observed at WG-16-36.
