## MINERALS PROGRAM INSPECTION REPORT PHONE: (303) 866-3567

MINE NAME:		MINE/PROSPECTING ID#:	MINERAL:	COUNTY:		
Lindsey Pit		M-2013-015	Gravel	Phillips		
INSPECTION TYPE:		INSPECTOR(S):	INSP. DATE:	INSP. TIME:		
Monitoring		Elliott R. Russell	October 14, 2015	10:45		
OPERATOR:		<b>OPERATOR REPRESENTATIVE:</b>	TYPE OF OPERATION:			
Mike L. Koellner dba L&L Ready Mix		Jason Frost	110c - Construction Limited Impact			
<b>REASON FOR INSPECTION:</b>		BOND CALCULATION TYPE:	BOND AMOUNT:			
Normal I&E Program		Complete Bond	\$30,137.39			
DATE OF COMPLAINT:		POST INSP. CONTACTS:	JOINT INSP. AGENCY:			
NA		None	None			
WEATHER:	INSPECTOR'S SIGNATURE:		SIGNATURE DATE:			
Clear	At Pmill		October 30, 2015

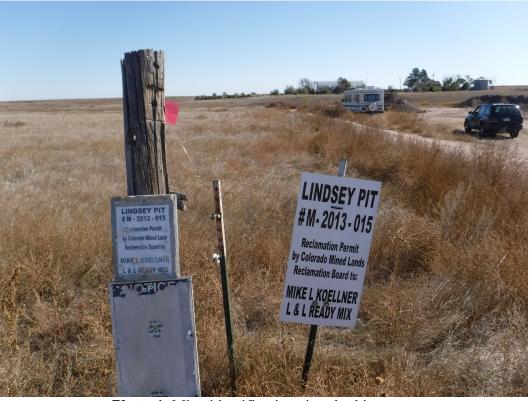
**Photo 1.** Mine identification sign; looking east.

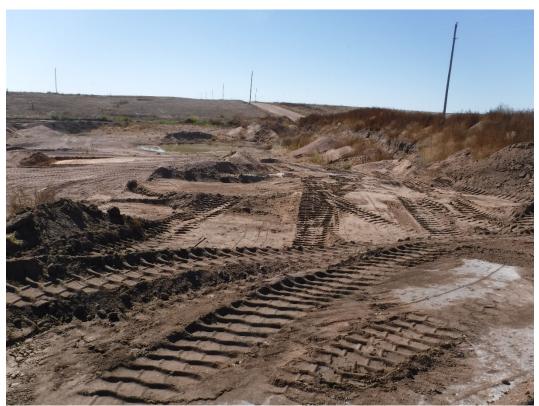
Photo 2. Western portion of the excavation; looking south.

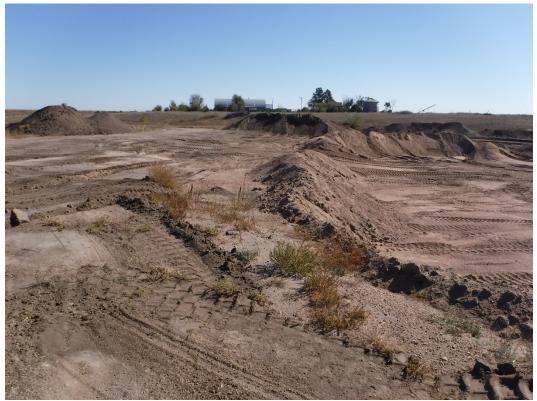
Photo 3. Active mining face of the northern portion of the excavation; looking east.

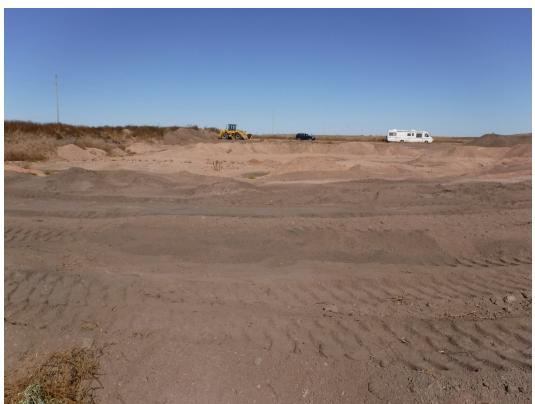
Photo 4. Pit overview; looking north.
