COLORADO DIVISION OF RECLAMATION, MINING AND SAFETY
MINERALS PROGRAM INSPECTION REPORT
PHONE: (303) 866-3567

MINE NAME: Carper Pit #2	MINE/PROSPECTING ID#: M-2008-072	MINERAL: Gravel, clay, sand	COUNTY: Phillips
INSPECTION TYPE: Pre-Operation Inspection	INSPECTOR(S): Elliott R. Russell	INSP. DATE: October 14, 2015	INSP. TIME: 12:00
OPERATOR: Tim Carper	OPERATOR REPRESENTATIVE: Randy Schafer	TYPE OF OPERATION: 110c - Construction Limited Impact

REASON FOR INSPECTION: Pre-Operation Inspection	BOND CALCULATION TYPE: None	BOND AMOUNT: \$19,250.00
DATE OF COMPLAINT: NA	POST INSP. CONTACTS: None	JOINT INSP. AGENCY: None
WEATHER: Clear	INSPECTOR'S SIGNATURE:

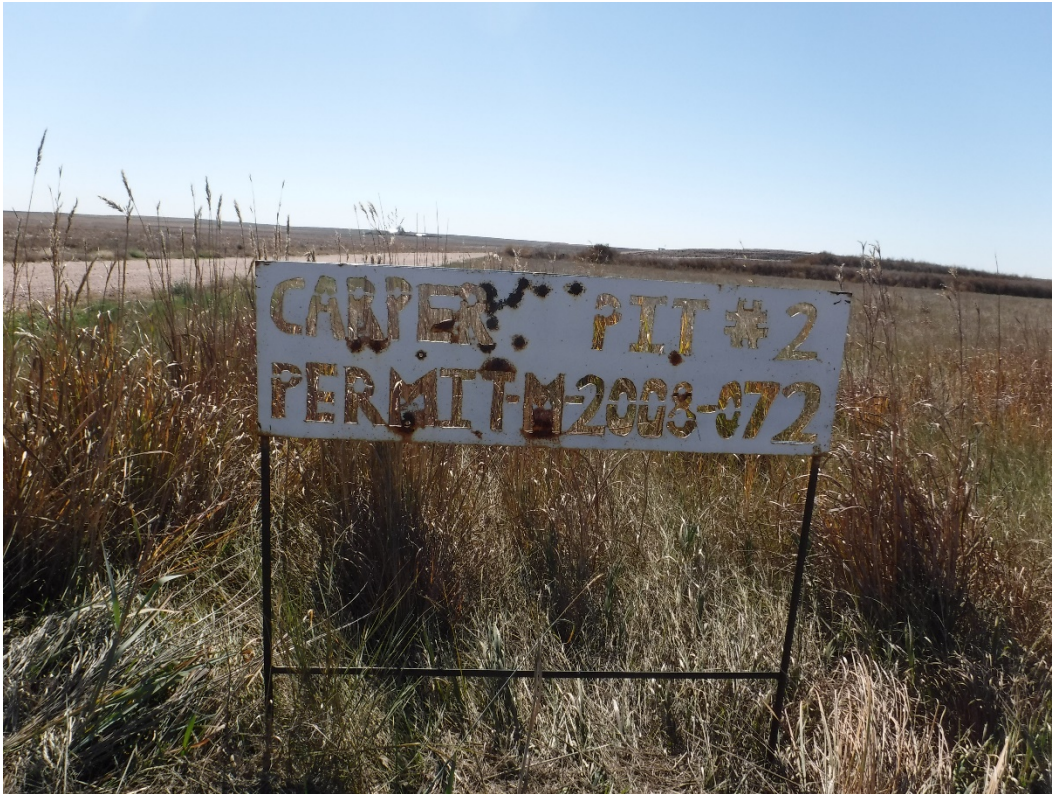
Photo 1. Mine identification sign; looking south.

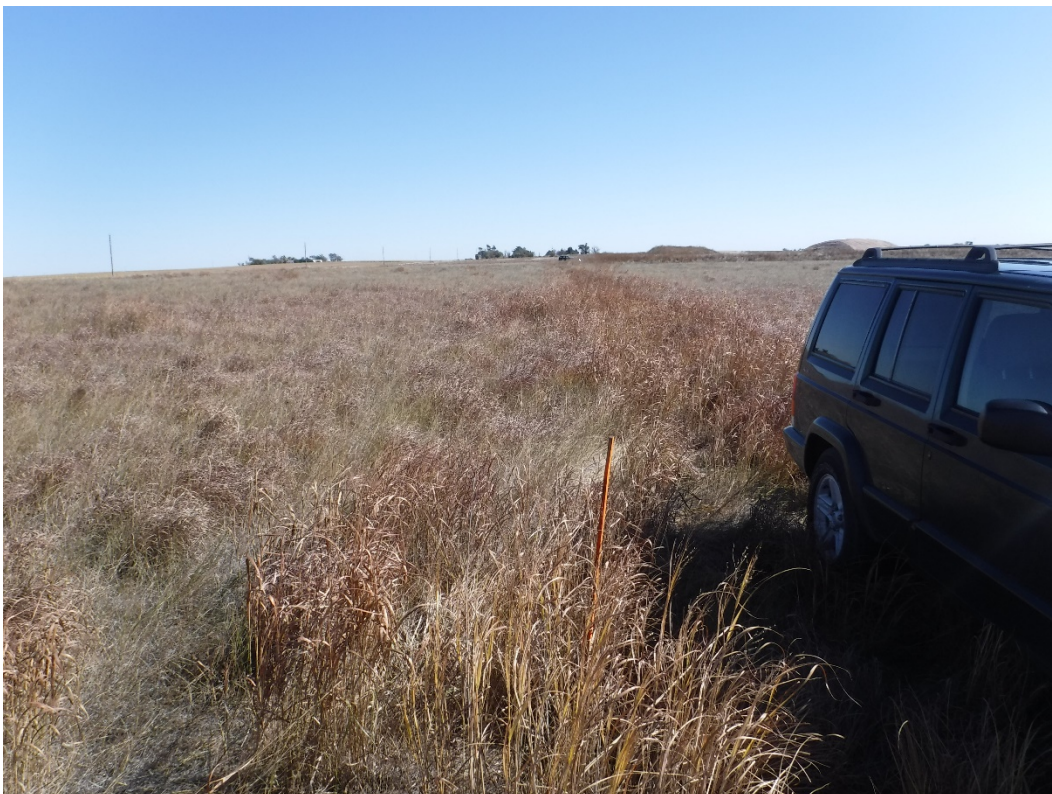
Photo 2. Northwest conversion boundary marker; looking east.

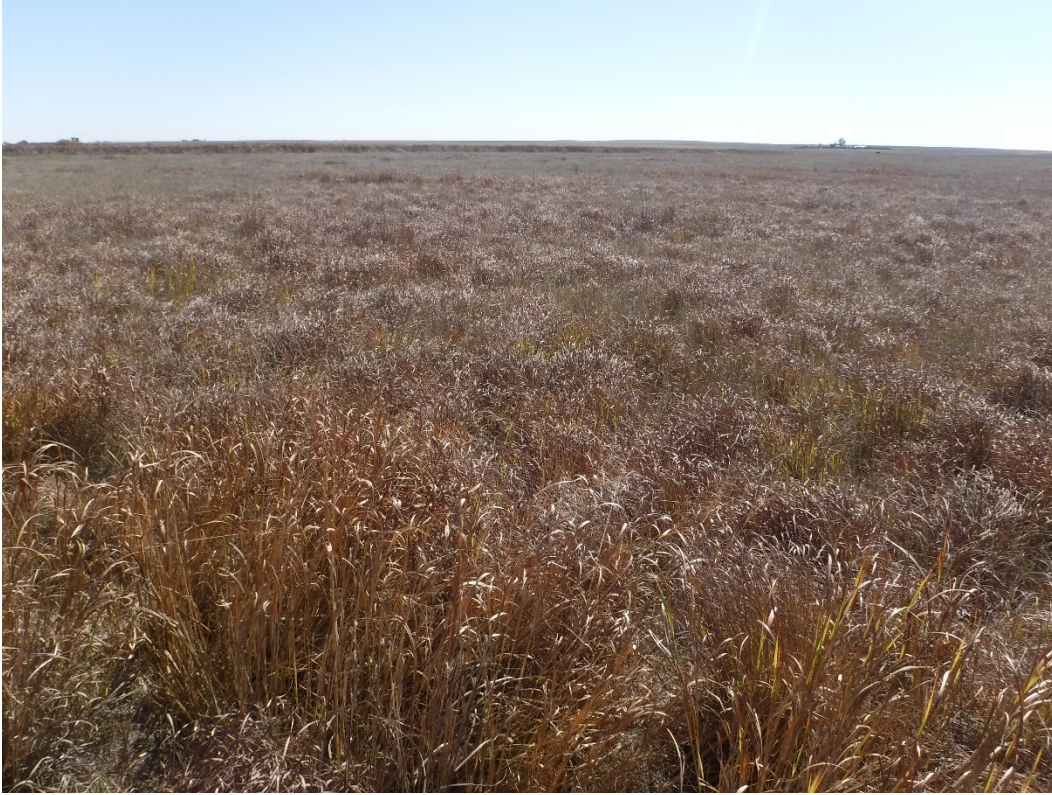
Photo 3. Expansion overview; looking southeast from the northwest conversion boundary marker.

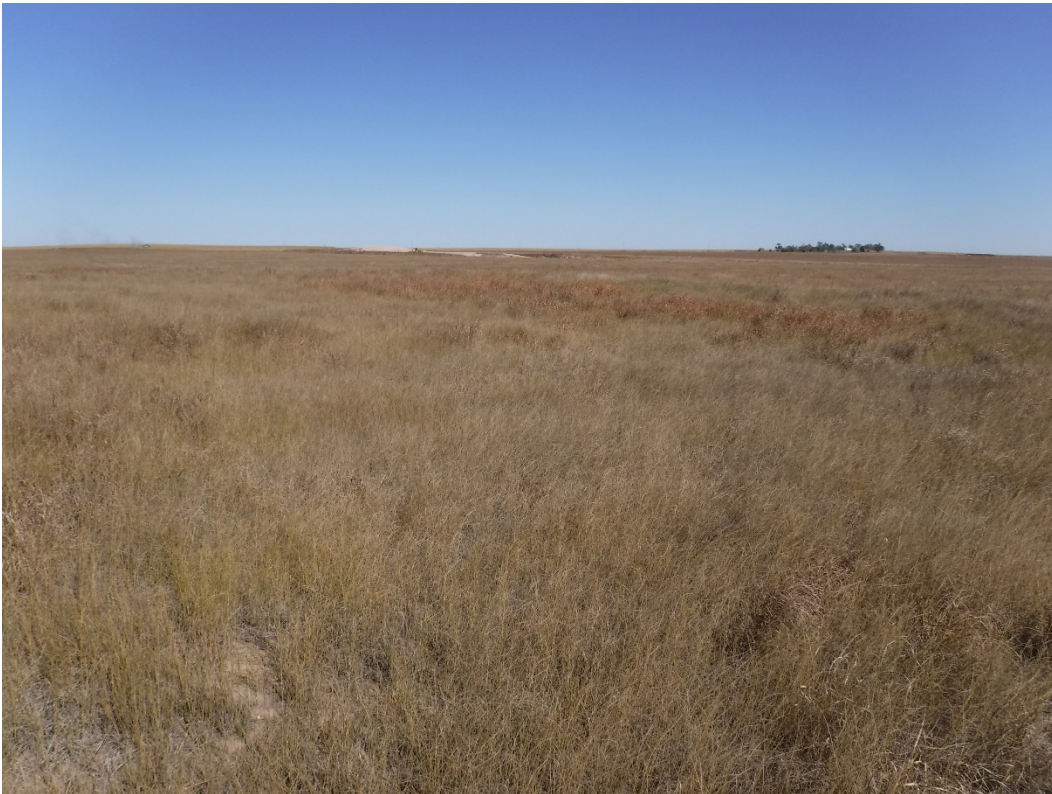
Photo 4. Expansion overview; looking northeast from the southwest conversion boundary marker.

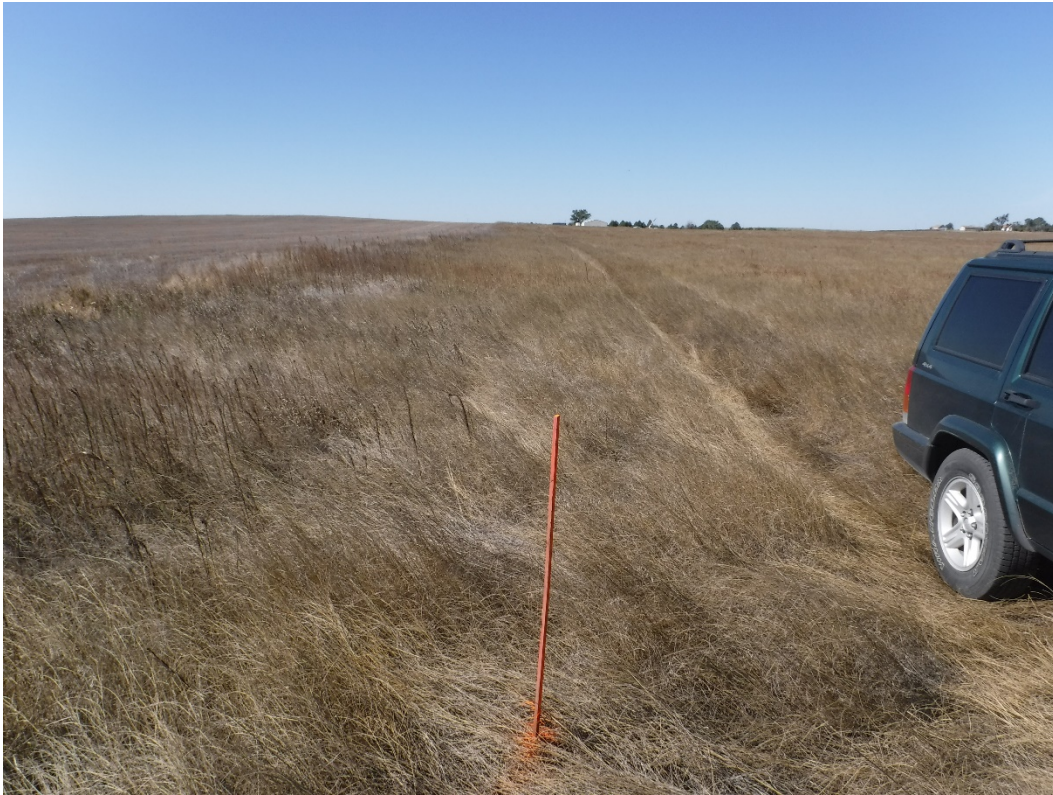
Photo 5. Southeast conversion boundary marker; looking west.

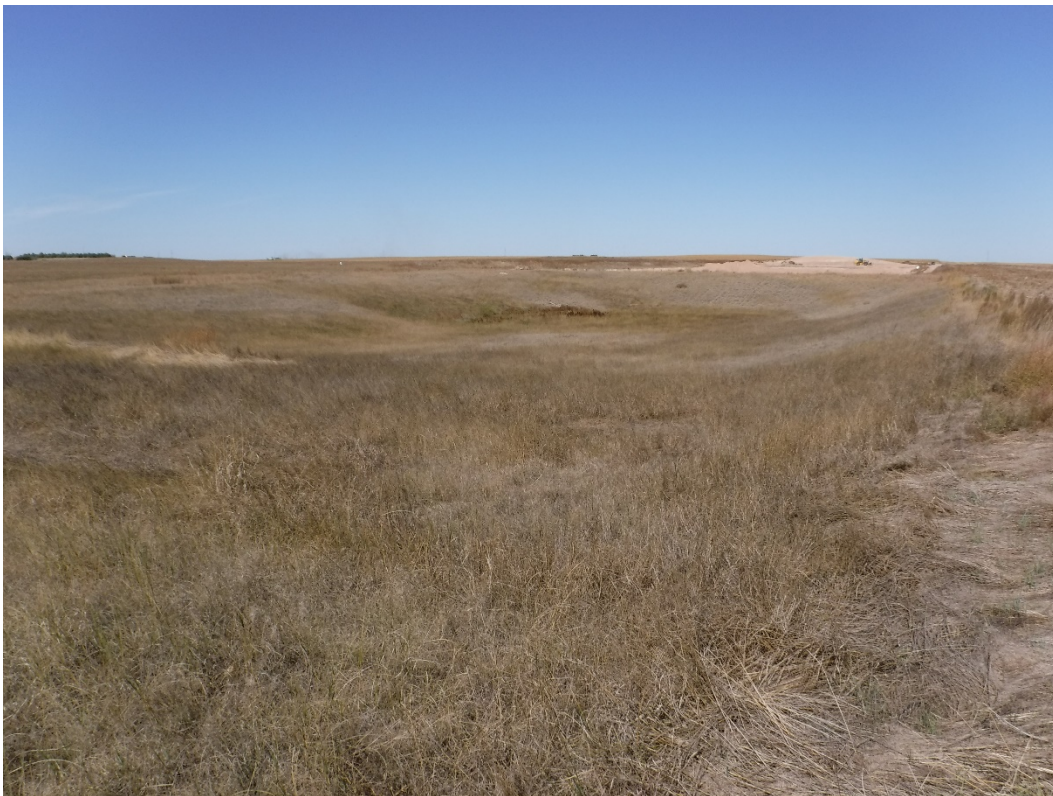
Photo 6. Old 111 pit located south of current 110c permit; looking north.
