COLORADO DIVISION OF RECLAMATION, MINING AND SAFETY
MINERALS PROGRAM INSPECTION REPORT
PHONE: (303) 866-3567

MINE NAME: Everitt Pit	MINE/PROSPECTING ID#: M-2004-037	MINERAL: Gravel	COUNTY: Phillips
INSPECTION TYPE: Monitoring	INSPECTOR(S): Elliott R. Russell	INSP. DATE: April 20, 2016	INSP. TIME: 12:30
OPERATOR: John M. Everitt	OPERATOR REPRESENTATIVE: John Everitt	TYPE OF OPERATION: 110c - Construction Limited Impact

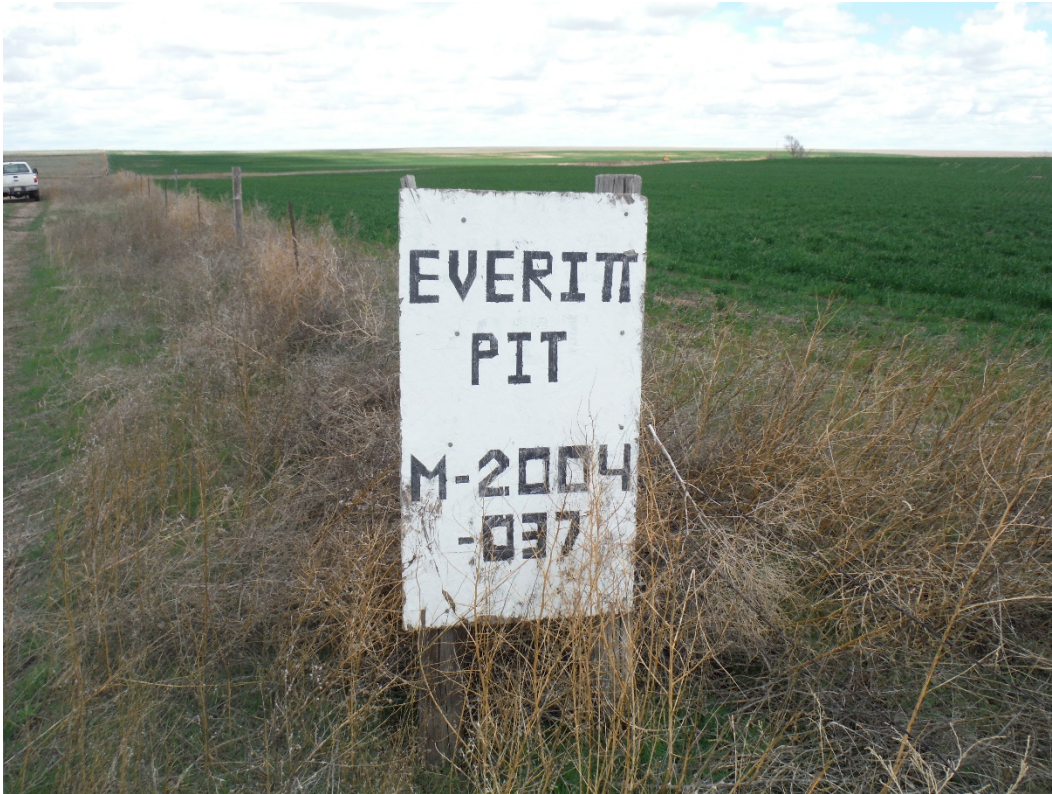
Photo 1. Mine identification sign; looking north.

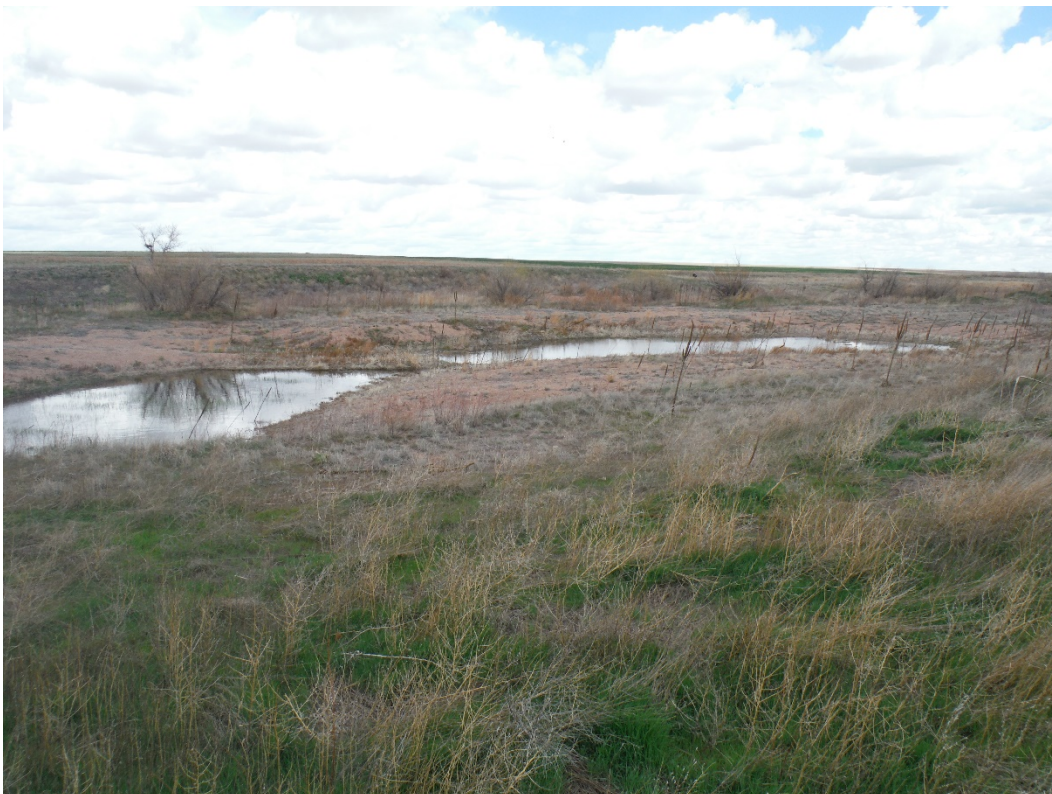
During the inspection, the sky was clear and the ground was dry. The site appears to see relatively frequent use. At the present time it appears that the mining operation has affected approximately 9 acres throughout the life of mine. All mining activity appeared to be within the approved affected land boundary. Although some standing water was observed from a recent rain event, there appeared to be no significant impacts to the prevailing hydrologic balance. Some common mullein, a noxious weed, was observed at the site, however, it appears the site is a sink rather than a source for this weed as there is a significant abundance of it upstream and downstream of the site. The operator should ensure the common mullein does not hinder the success of revegetation the creek banks when the time comes for final reclamation. The Operator is encouraged to continue to monitor and treat noxious weeds as they appear in the permit boundary. A mine I.D. sign was located at the entrance to the mine site. The permit boundary was marked t-posts. The reclamation cost estimate for this site was updated during the file review for this inspection. It was determined that the current required financial warranty amount is adequate.

Photo 2. Site overview; looking north.

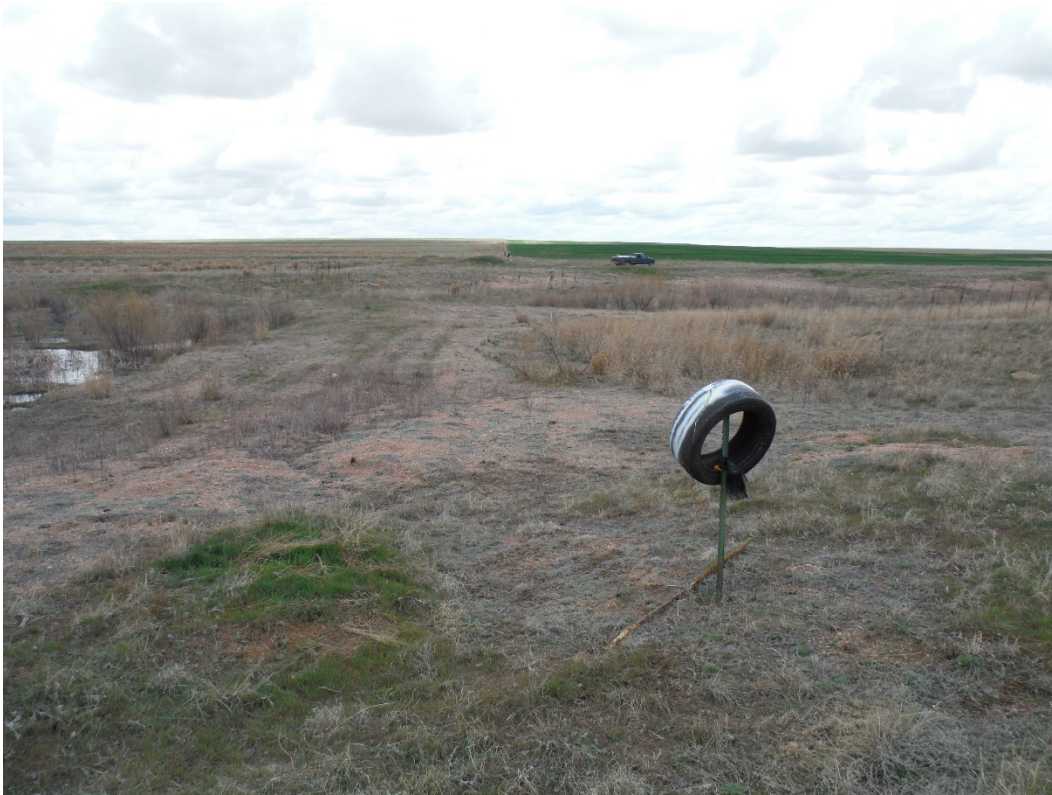
Photo 3. Eastern permit boundary, Permit no. M-2005-070 located immediately downstream of permit; looking north.

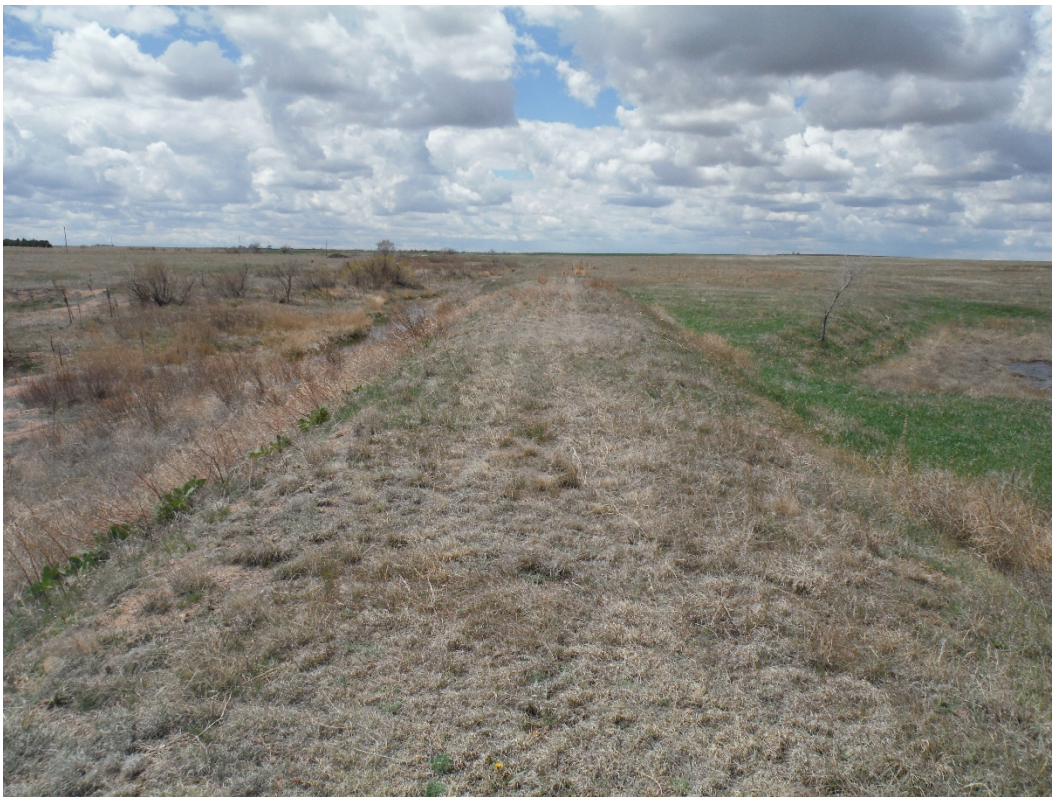
There is a pre-permit disturbance located just to the north of the site. This is a large berm and small livestock pond. The Operator should ensure his activities do not affect the stability of the berm which is located along the northern creek bank.

Photo 4. Mine site (left), pre-permit berm (center), and livestock pond (right); looking west.
