MINERALS PROGRAM INSPECTION REPORT
PHONE: (303) 866-3567

MINE NAME: Bad Boys Pit	MINE/PROSPECTING ID#: M-1996-081	MINERAL: Gemstones	COUNTY: Teller
INSPECTION TYPE: Monitoring	INSPECTOR(S): Elliott R. Russell	INSP. DATE: September 21, 2017	INSP. TIME: 10:00
OPERATOR: Bad Boys of Cripple Creek Mining Co., Inc.	OPERATOR REPRESENTATIVE: Harriet Graham	TYPE OF OPERATION: 110(2) - Hard Rock Limited Impact

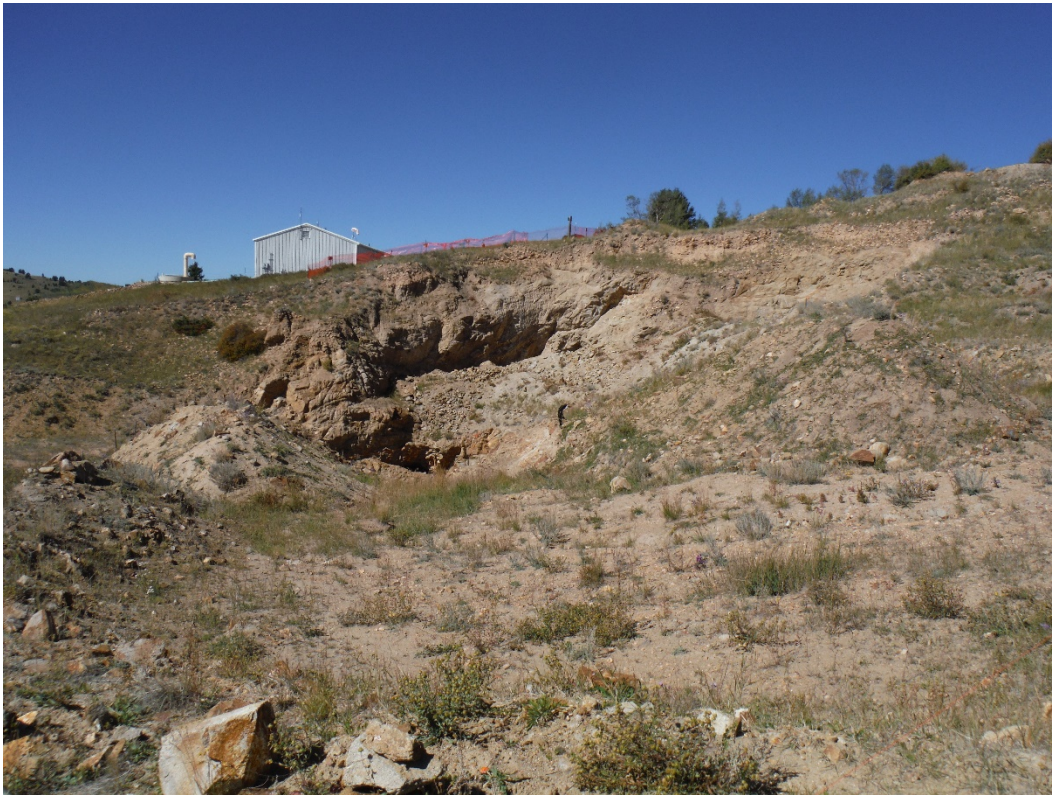
Photo 1. Pit overview; looking west.

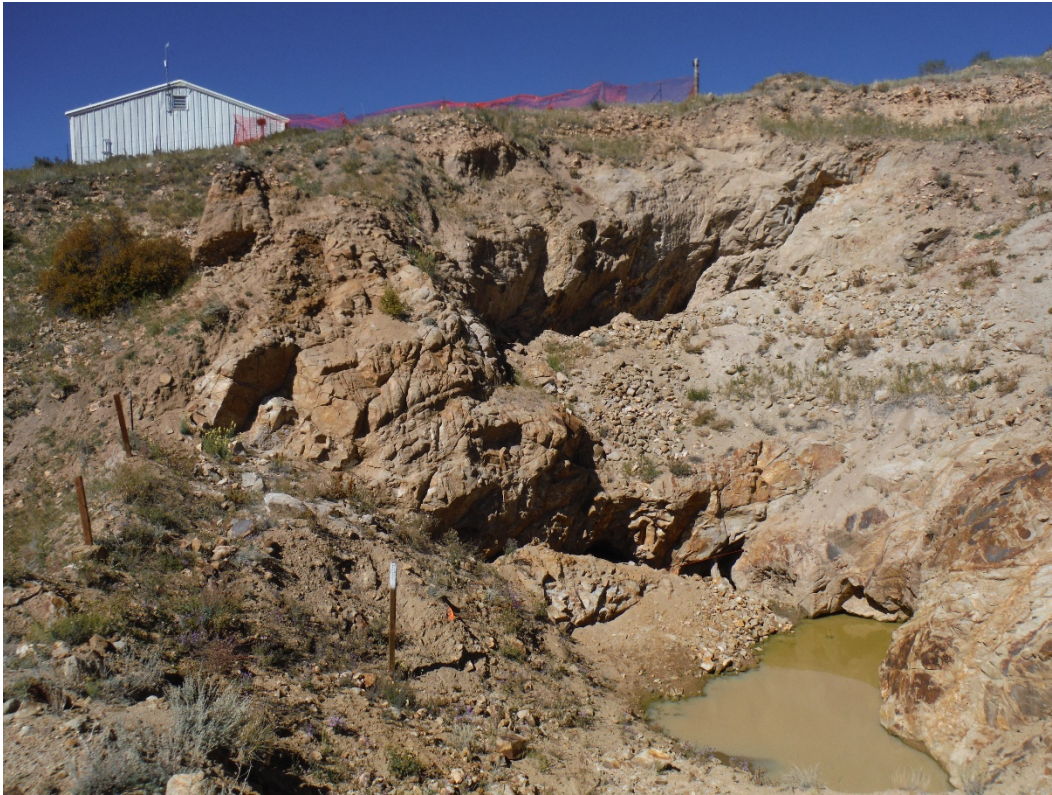
Photo 2. Pit overview; looking west.

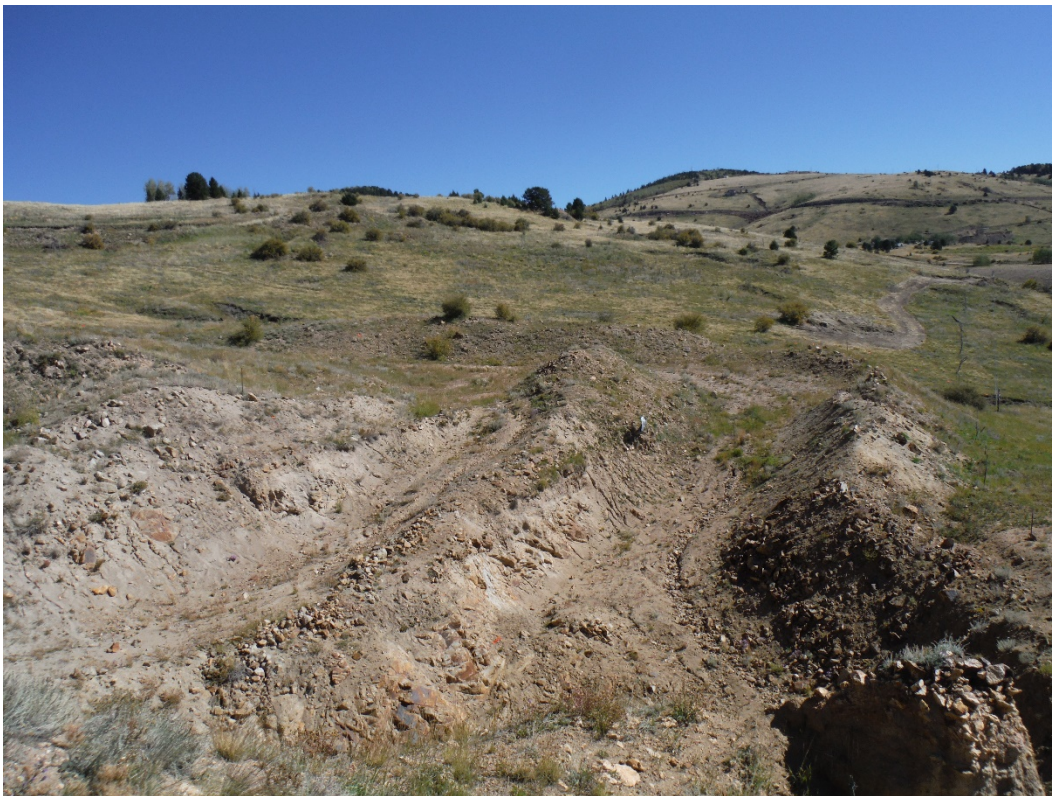
Photo 3. Pit overview; looking east.

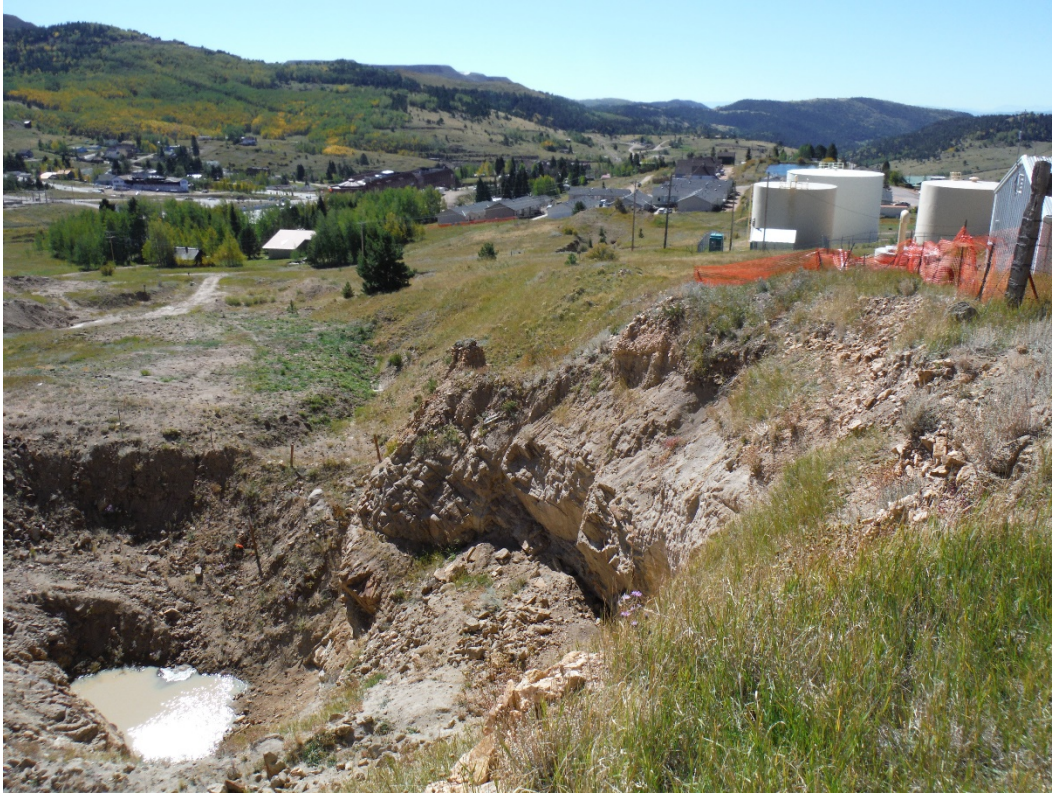
Photo 4. Pit overview; looking south.

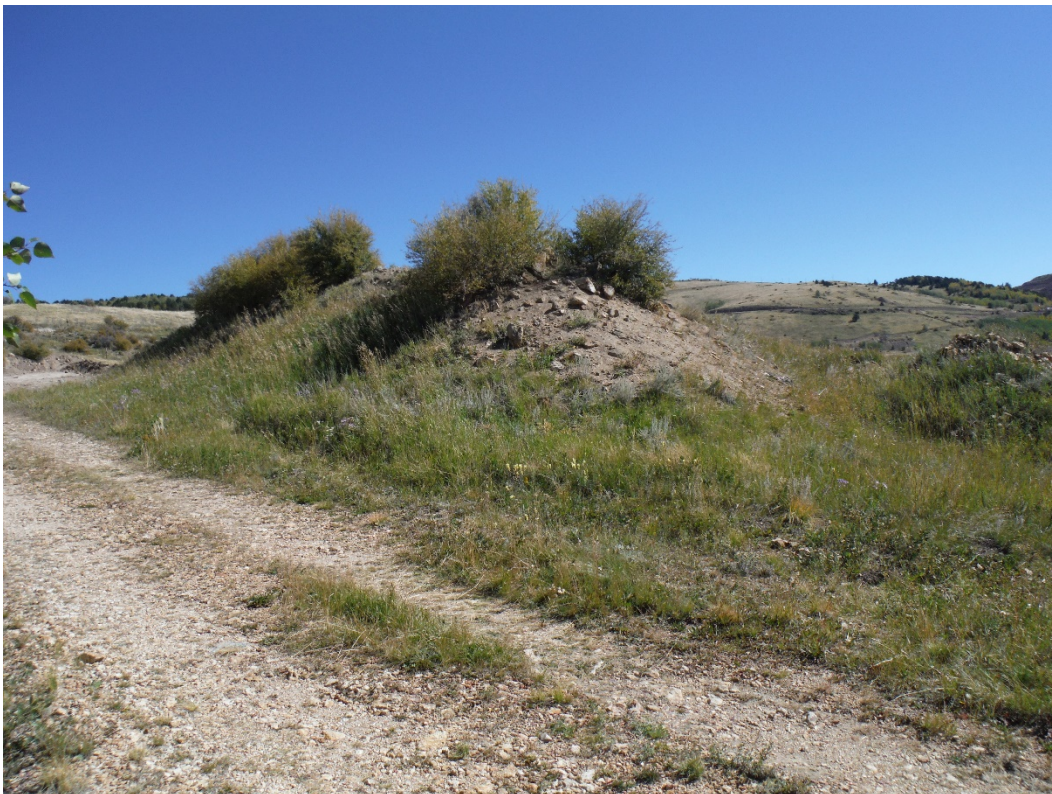
Photo 5. Overburden stockpiled northwest of the pit; looking northeast.

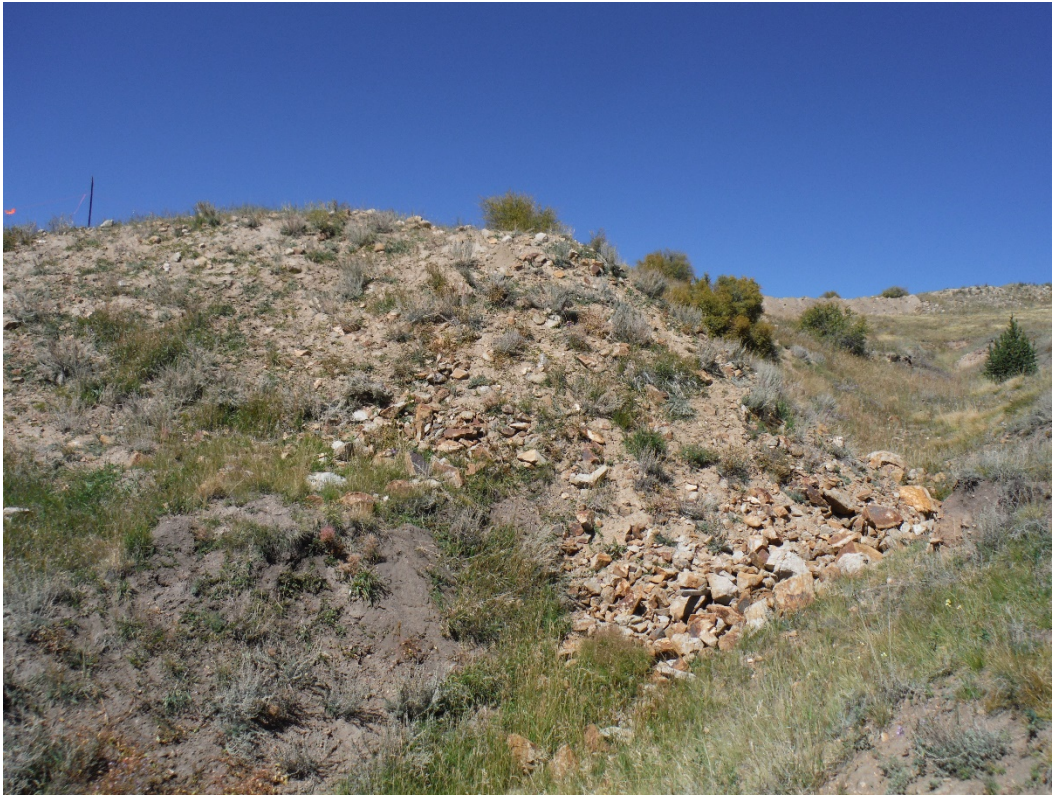
Photo Overburden stockpiled east of the pit; looking northwest.

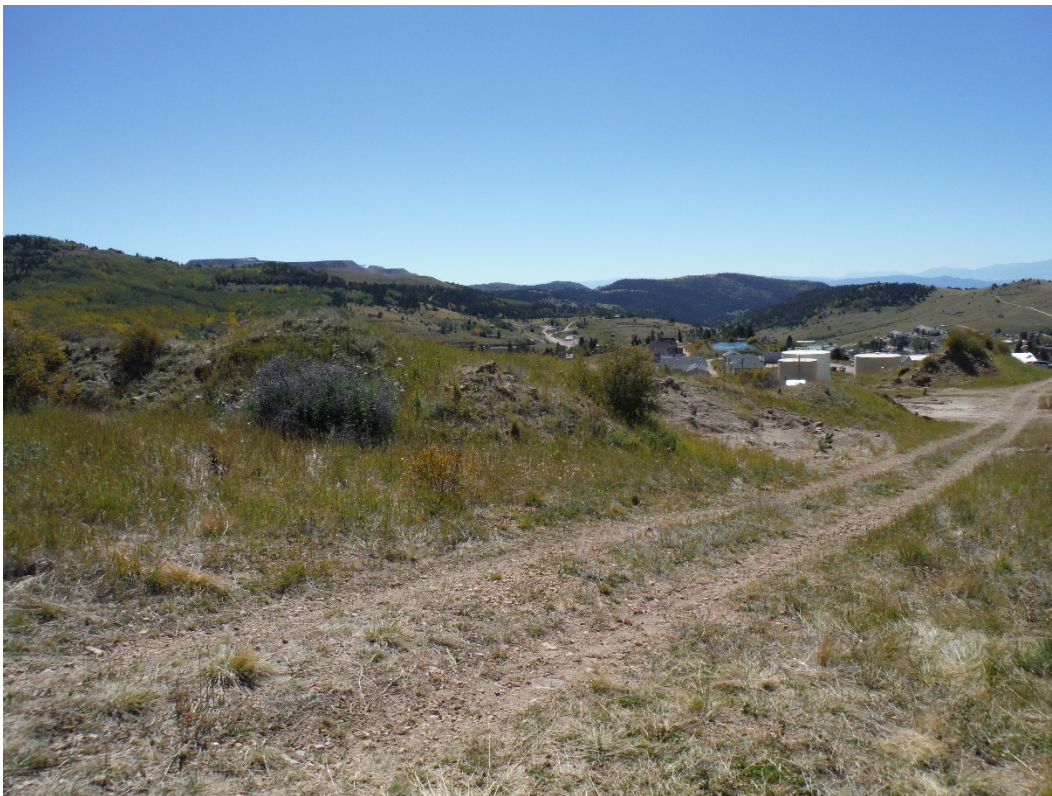
Topsoil: Topsoil has been salvaged and stockpiled to the north of the pit. This stockpile is approximately 230 feet long and is located within or near the City of Cripple Creek's waterline easement. It was not clear at the time of the inspection, but supposedly the topsoil had been stockpiled on top of the City's waterline. Mr. Cross stated that he contacted the City of Cripple Creek's Public Works Department and was starting to push the topsoil stockpile to the east of its location, outside of the city's easement. Mr. Cross stated that the new landowner viewed this stockpile as a liability being located on top of a water line and therefore wanted it pushed off of it. Similarly, the landowner views the pit's highwall as a liability and has installing warning signs and safety fencing at the crest of the highwall near the City's water treatment plant.

Photo 8. Topsoil stockpiled north of the pit; looking south.

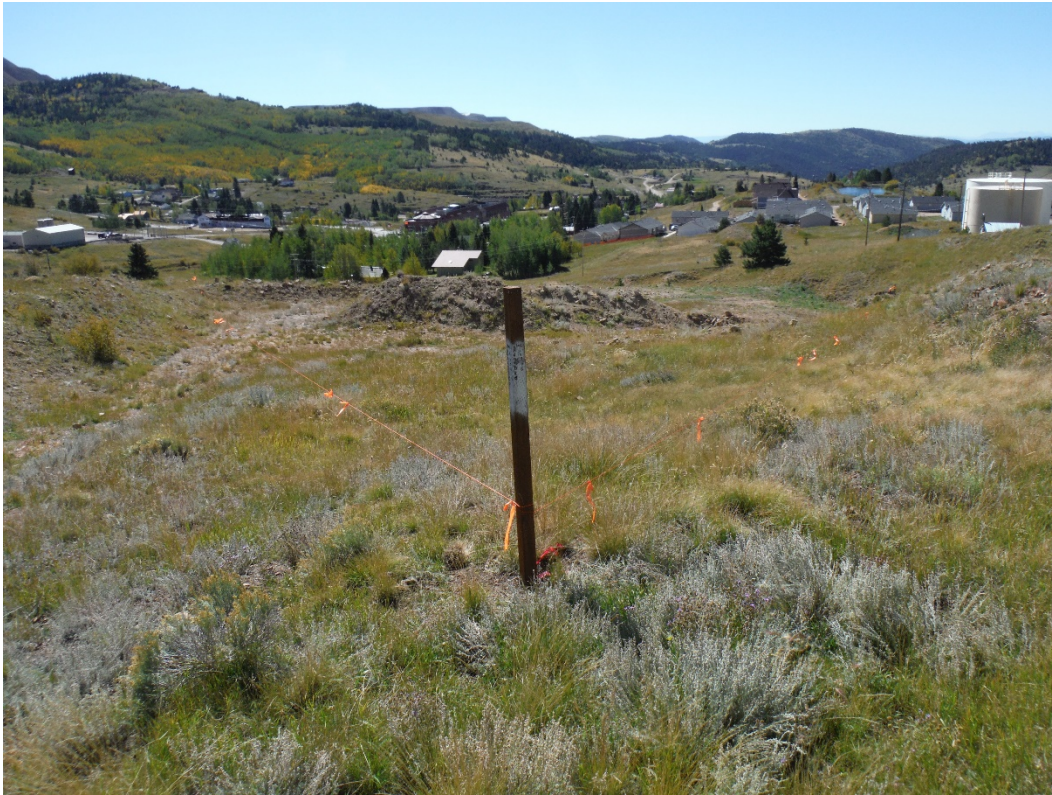
As discussed above, the Operator informed the Division that they no longer owned a portion of the affected lands. Bad Boys of Cripple Creek Mining Co., Inc. is still the landowner on a triangular-shaped area (approximately 0.4 acres) within the central portion of the permit. Areas to the east, north, and west of the triangle are now owned by a new landowner, making the permit's original Exhibit G - Source of Legal Right-to-Enter, obsolete. This is cited as Compliance Problem #1 on page two of this report requiring the operator to secure a legal right to enter with the new landowners. During the inspection, the Division observed the triangular-shaped area's property pins, which were recently placed when the new landowner had the property surveyed. The Division collected GPS data on these pins and is included in the attached inspection map.

Photo 9. Northern property corner of the triangular-shaped parcel still owned by the Operator; looking south.

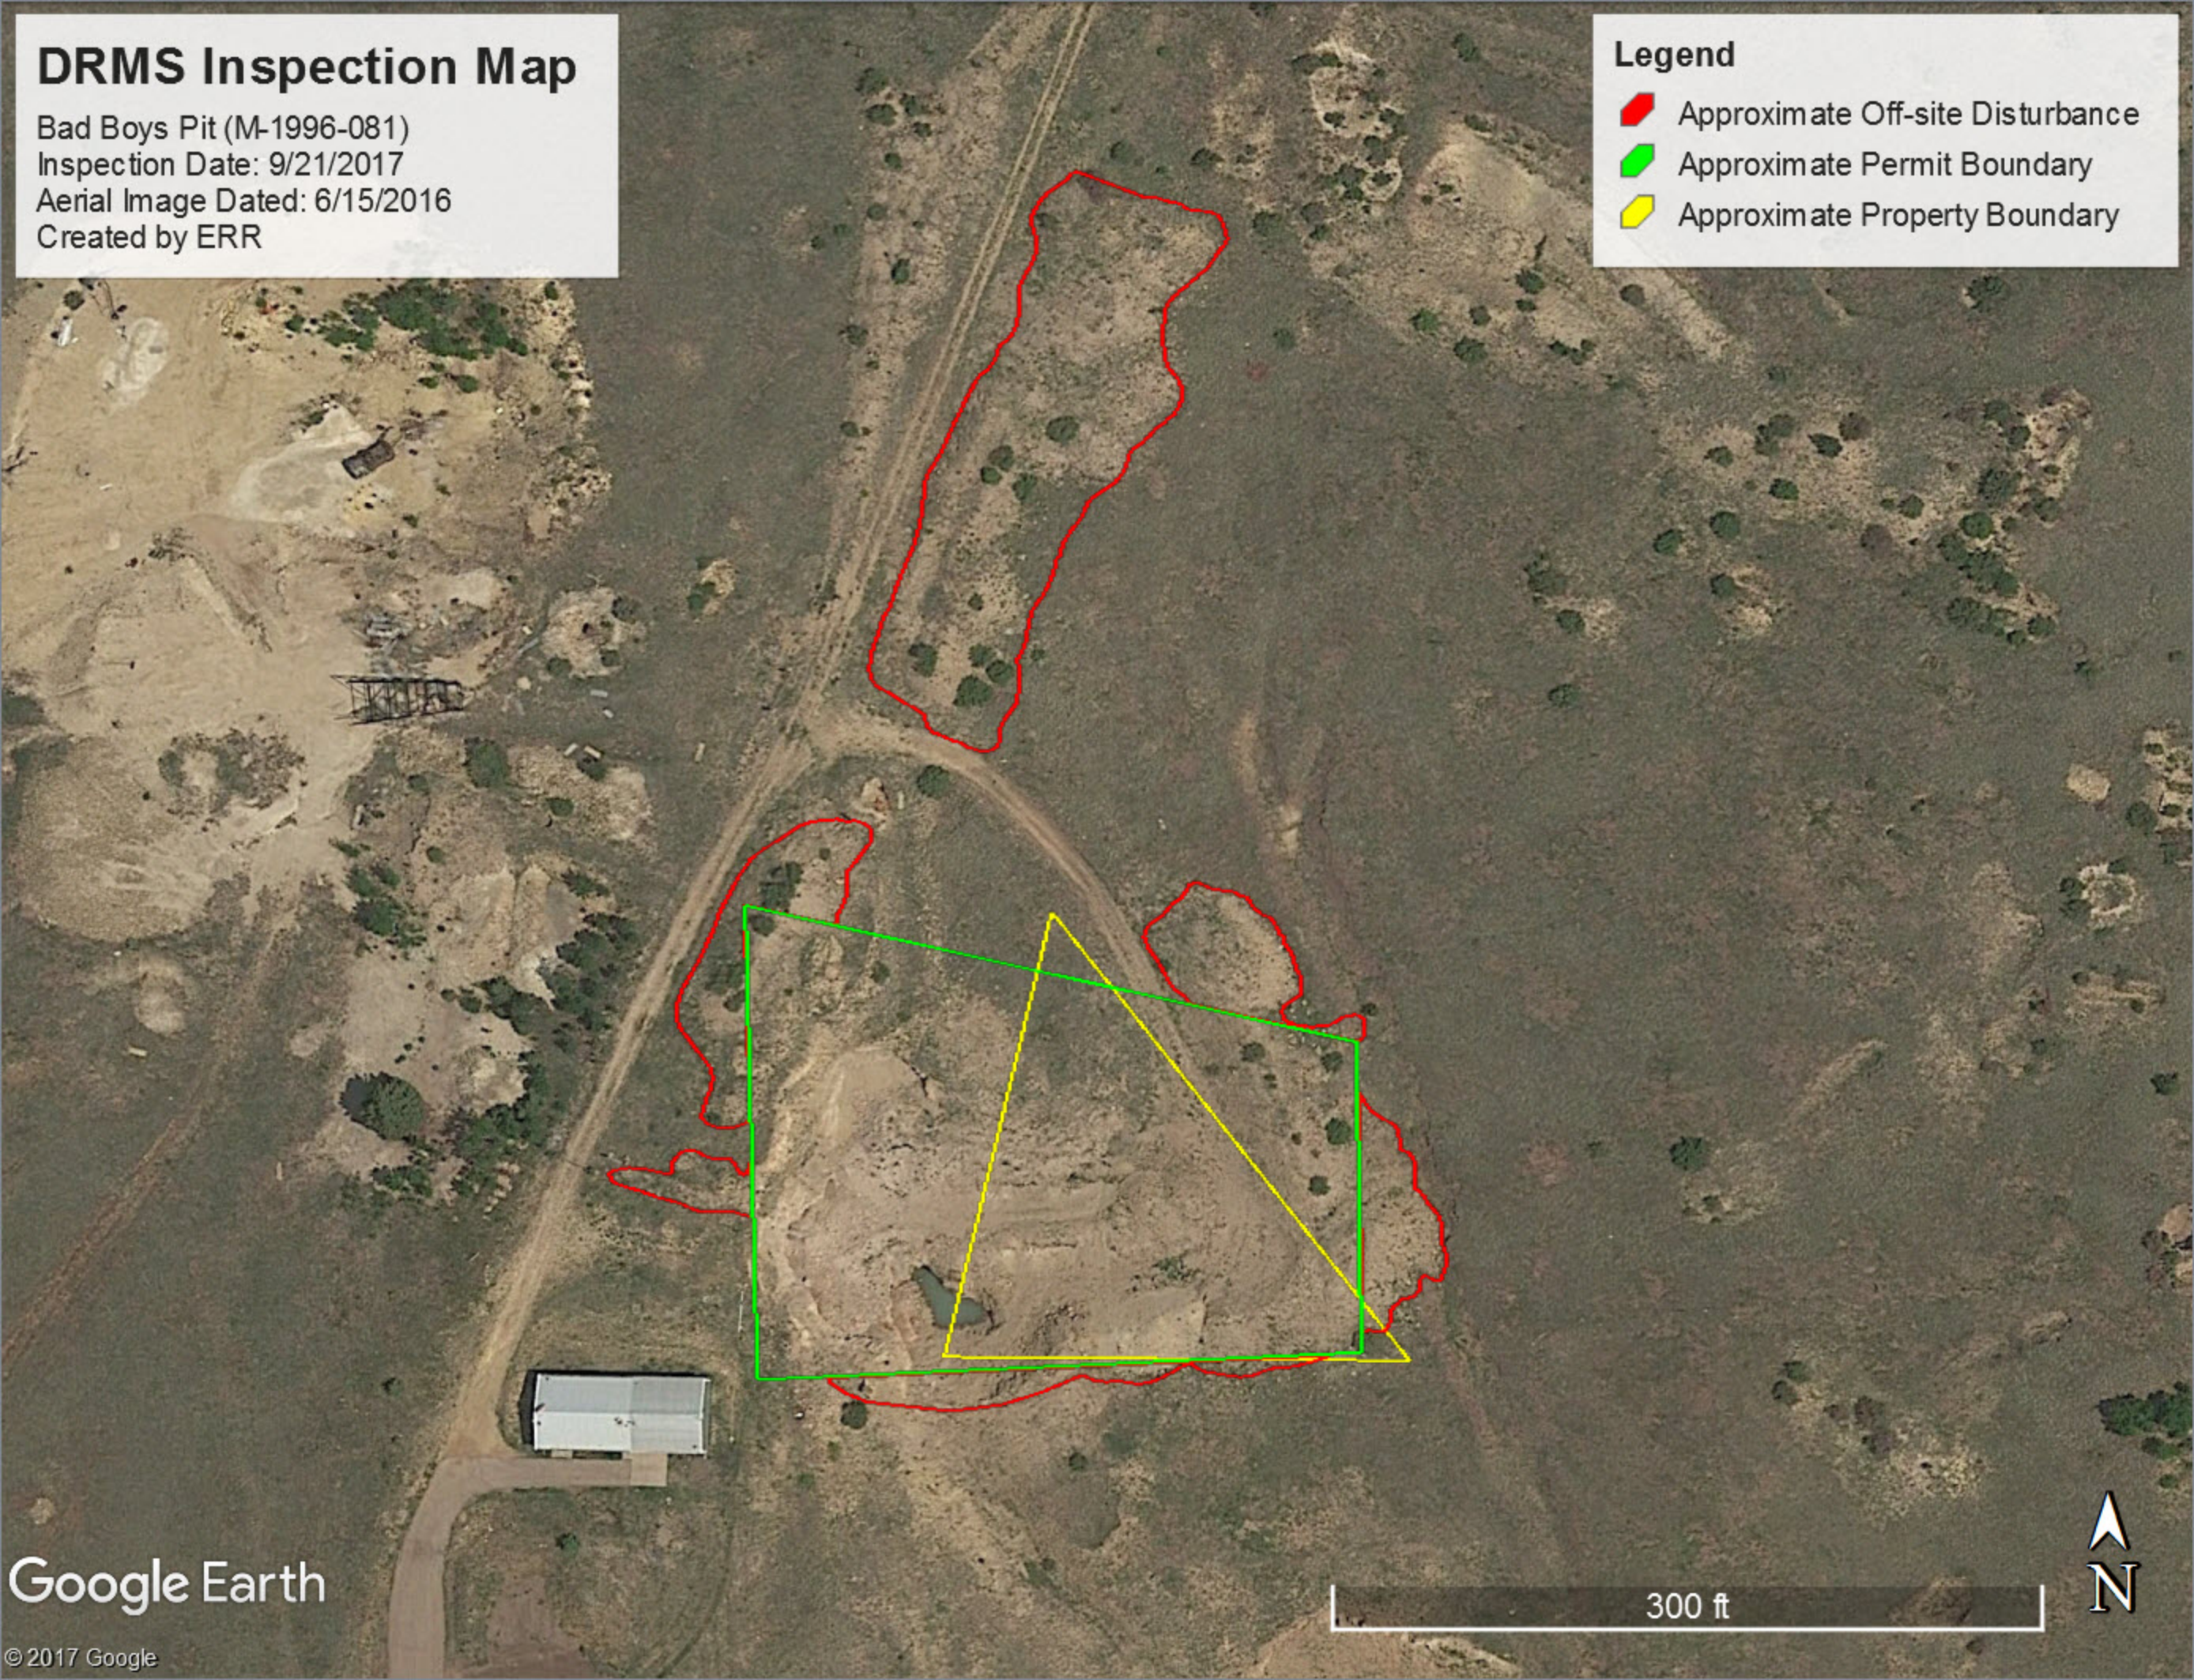
DRMS Inspection Map

POSSIBLE VIOLATION: Land has been affected by the mining operation outside of the approved permit boundary. This is a possible violation of C.R.S. 34-32-116(7)(h) for failure to protect areas outside of the affected land from slides or damages occurring during the mining operation.

The site was not active at the time of the inspection and it appeared to have not been active for quite some time. The site consists of a single pit, approximately 50 feet deep on the west side with a gradual access ramp coming in from the east. There were various stockpiles of overburden and topsoil surrounding the pit on the western and eastern sides. The Division collected GPS data of the pit with a Trimble Juno 3B. Attached to this report is an inspection map, a Google Earth aerial image dated June 15, 2016, which depicts the permit boundary and the disturbances associated with the permit. The approximate permit boundary was determined using the approved Mining and Reclamation Plan Map received October 15, 1996. The Division has determined approximately 0.6 acres of lands outside of the permit boundary have been affected from the mining operation. The off-site disturbances is cited as a Possible Violation on page two of this report.

CORRECTIVE ACTIONS: This possible violation will require a hearing before the Mined Land Reclamation Board scheduled for the December 13-14, 2017 Board meeting. The schedule and other details for the MLRB hearing will be provided under a separate document to be sent via certified mail to the Operator.
