**COLORADO**  
Division of Reclamation,  
Mining and Safety  
Department of Natural Resources

**PERMIT INFORMATION**

**INSPECTION INFORMATION**

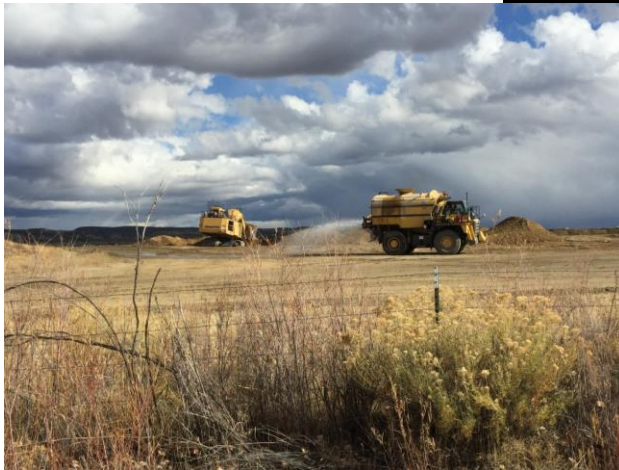
The in-pit roads were being watered for dust control (photo 1).

Photo 1 – Watering Pit Roads for Dust Control

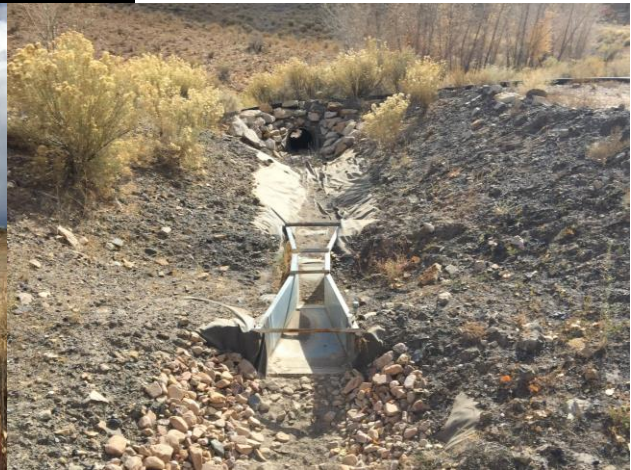
Pond 001 contained water but was not discharging. The discharge structure and flume (photo 2) were free and clear of obstructions. A rock lined inlet structure was installed on the pond 001 east ditch, north of the coal truck gate (photo 3). This structure directs water from the disturbed area into the ditch and is stable.

Photo 2 – Pond NHN 001 Discharge Flume

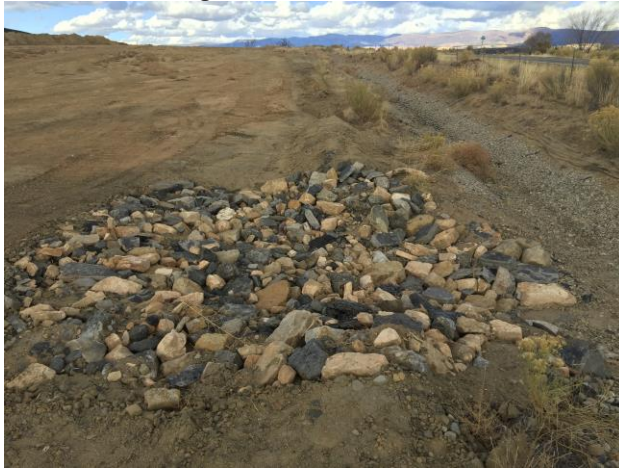
Photo 3 – Rock Lined Spillway

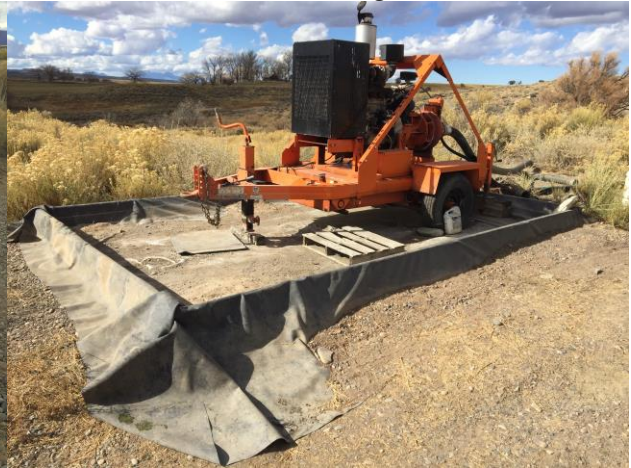
The water pump at pond NH1 001 was in operation. The pump was in a spill containment devise (photo 4). Water was being pumped to a water holding tank at the facilities area and used for dust suppression.

Photo 4 – Pump at Pond NH1 001

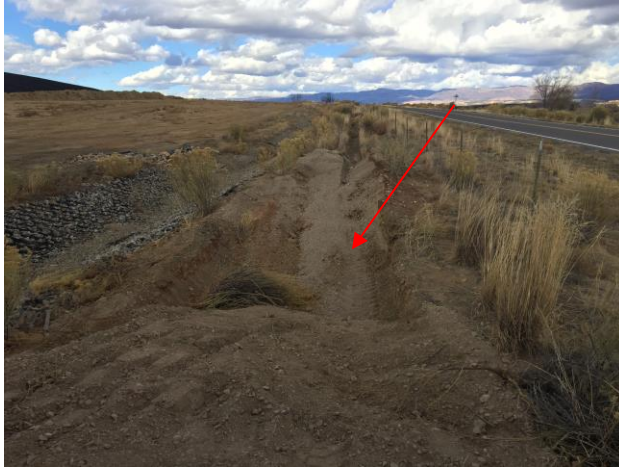
The entire CCC Ditch diversion pipeline has been removed (photo 5). Minimal disturbance was caused to the surrounding area.

Photo 5 – Former Location of CCC Ditch Pipe

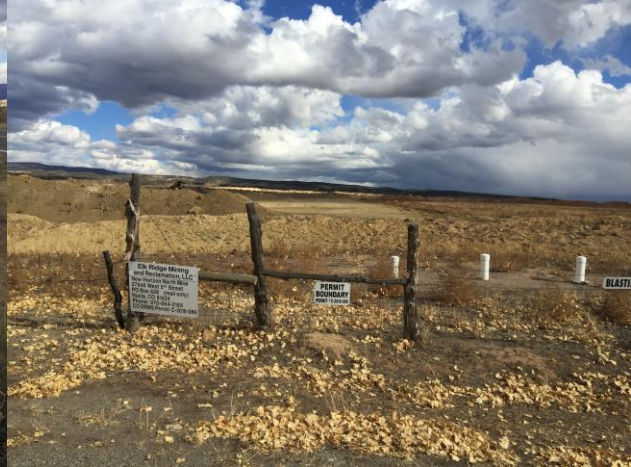
The entire permit boundary was inspected for permit boundary signs and mine entrance signs (photo 6). Permit boundary signs were in place at each corner with t-posts and/or fencing marking the boundary between each sign. Permit boundary signs were in place along both sides of the pond NH1 access road, around pond NH1 and the equipment corridor.

Permit entrance signs were in place at all entrances along the AA Road, 2600 Road and 2650 Road

Photo 6 – Entrance and Permit Boundary Signs
