**MINERALS PROGRAM INSPECTION REPORT****PHONE: (303) 866-3567**

<b>MINE NAME:</b> Vollmer Pit	<b>MINE/PROSPECTING ID#:</b> M-1983-035	<b>MINERAL:</b> Sand and gravel	<b>COUNTY:</b> El Paso
<b>INSPECTION TYPE:</b> Monitoring	<b>INSPECTOR(S):</b> Timothy A. Cazier	<b>INSP. DATE:</b> March 14, 2017	<b>INSP. TIME:</b> 8:50
<b>OPERATOR:</b> Schmidt Construction Company	<b>OPERATOR REPRESENTATIVE:</b> Mark Heifner	<b>TYPE OF OPERATION:</b> 110c - Construction Limited Impact	
<b>REASON FOR INSPECTION:</b> Normal I&E Program	<b>BOND CALCULATION TYPE:</b> Partial Bond	<b>BOND AMOUNT:</b> \$23,560.00	
<b>DATE OF COMPLAINT:</b> NA	<b>POST INSP. CONTACTS:</b> None	<b>JOINT INSP. AGENCY:</b> None	
<b>WEATHER:</b> Cloudy	<b>INSPECTOR'S SIGNATURE:</b>

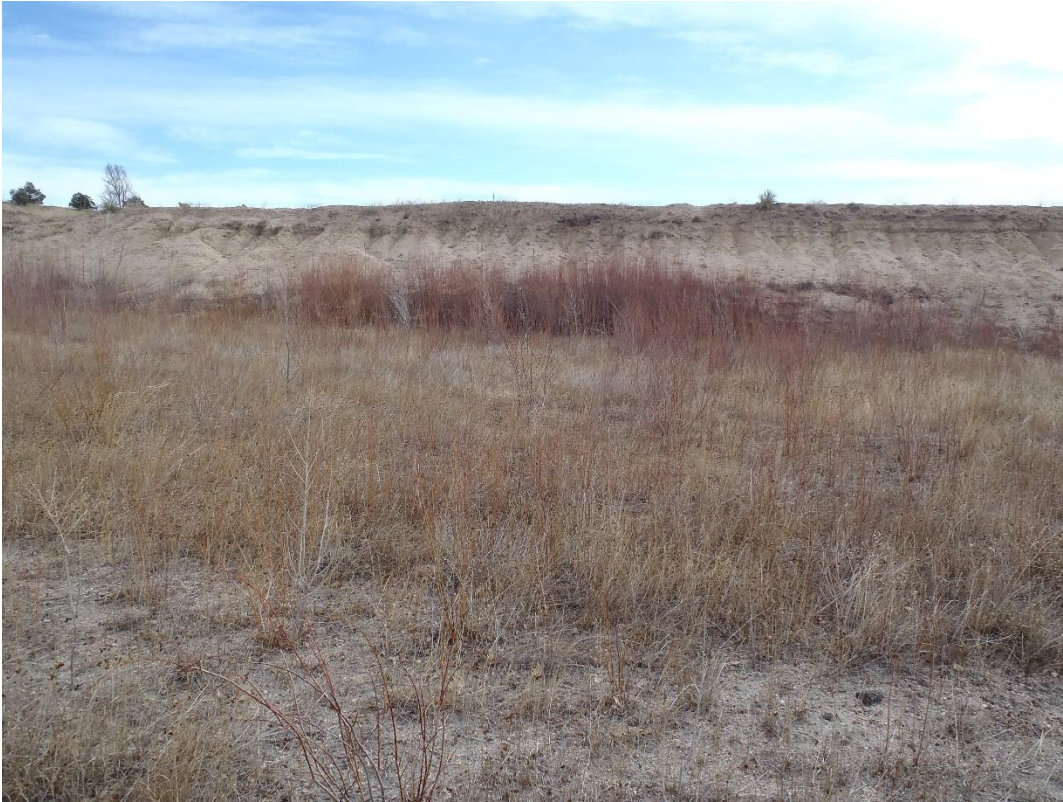
High walls were estimated to vary between 12 and 15 feet in height and appeared stable (see **Photo 1**).

Photo 1. Typical highwall, north side (looking north).

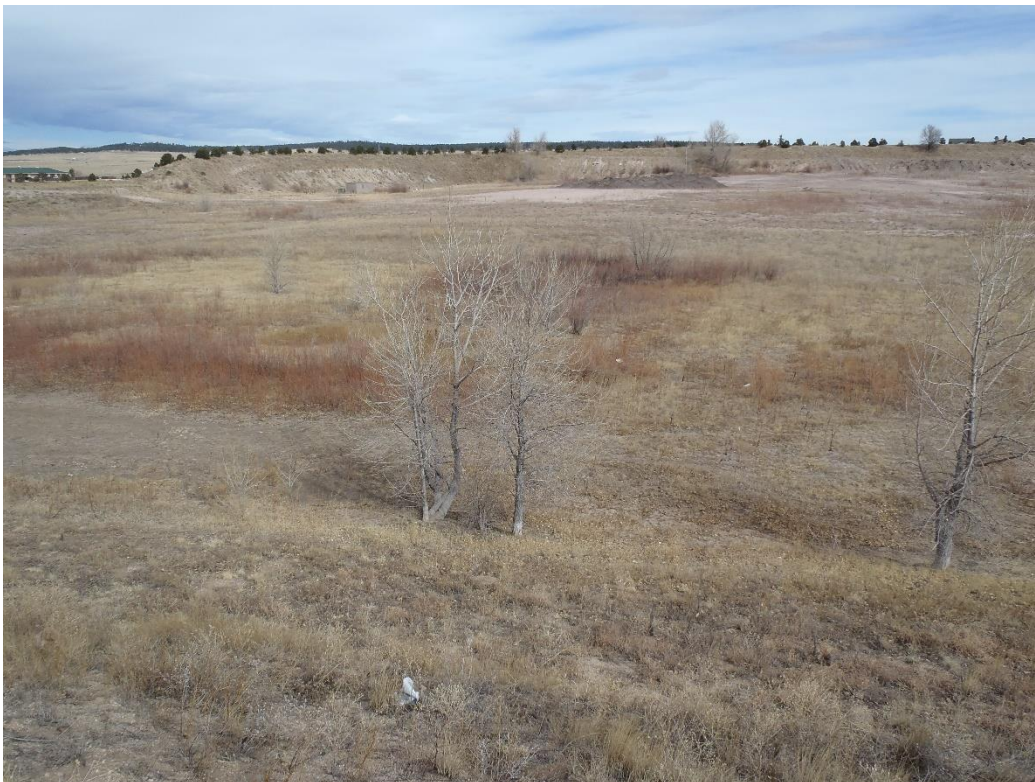
Revegetation: No noxious weeds were observed. Mr. Heifner explained the Permittee had not initiated any revegetation, but that most of the revegetation occurred due to self-propagation (see **Photo 2**).

Photo 2. Self-reclaimed vegetation on pit floor (from south visual berm looking NW).

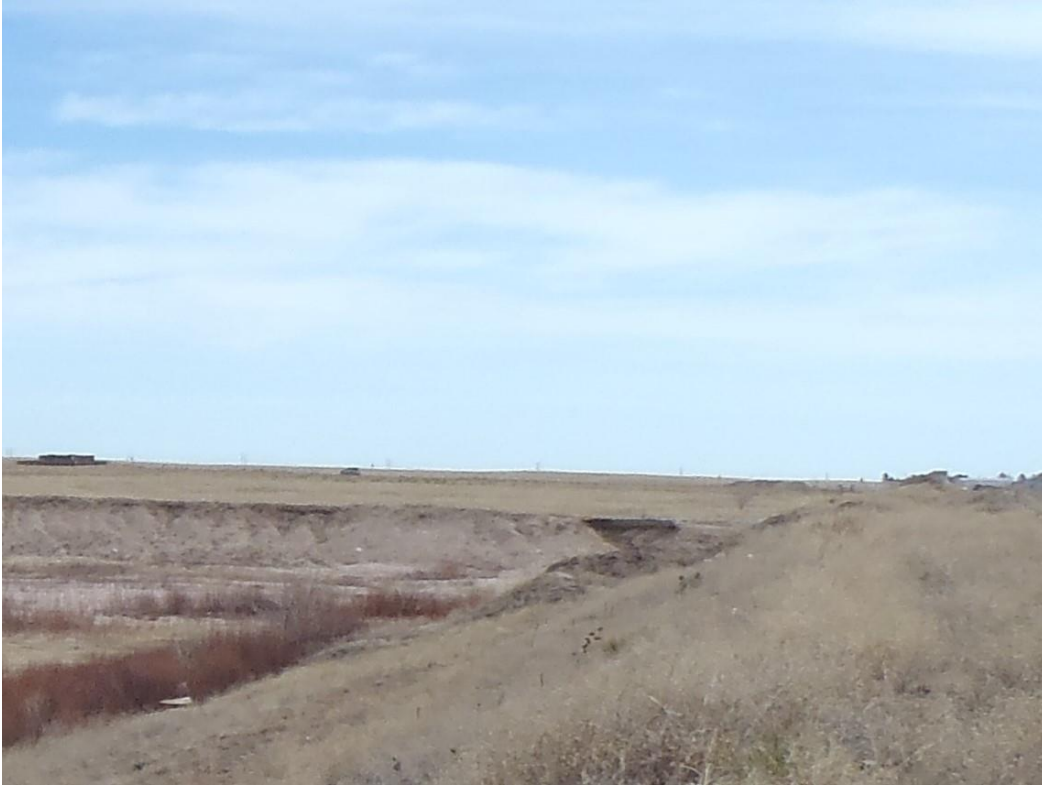
Sediment Control: A gulley was observed in the southeast corner of the pit (see **Photo 3**). The gulley was confined by the south visual berm and the unmined area to the east. It did not appear this gulley could lead to head cutting that could propagate offsite.

Photo 3. Gulley observed in the southeast corner of the pit (looking east).

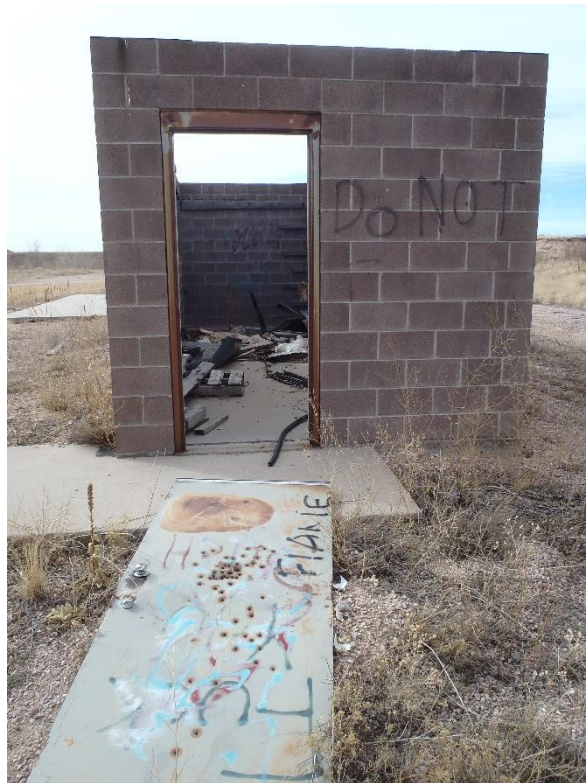
Support Facilities On-site: A cinder block scale house is still on site (see **Photo 4**), but the truck scale had been removed.

Photo 4. Scale house (looking south).

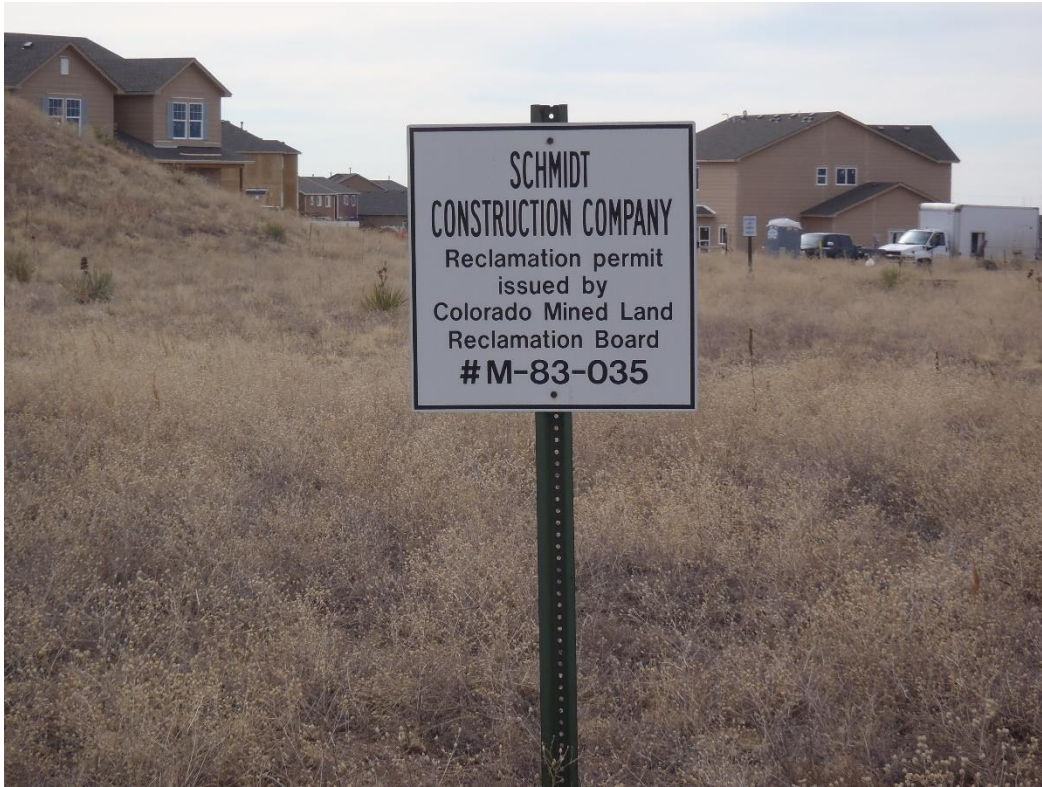
Signs and Markers: The permit sign was properly posted (see **Photo 5**) and the boundary was marked with the visual berms or fencing (see **Photos 6, 7 and 8**).

Photo 5. Permit sign (near entrance).

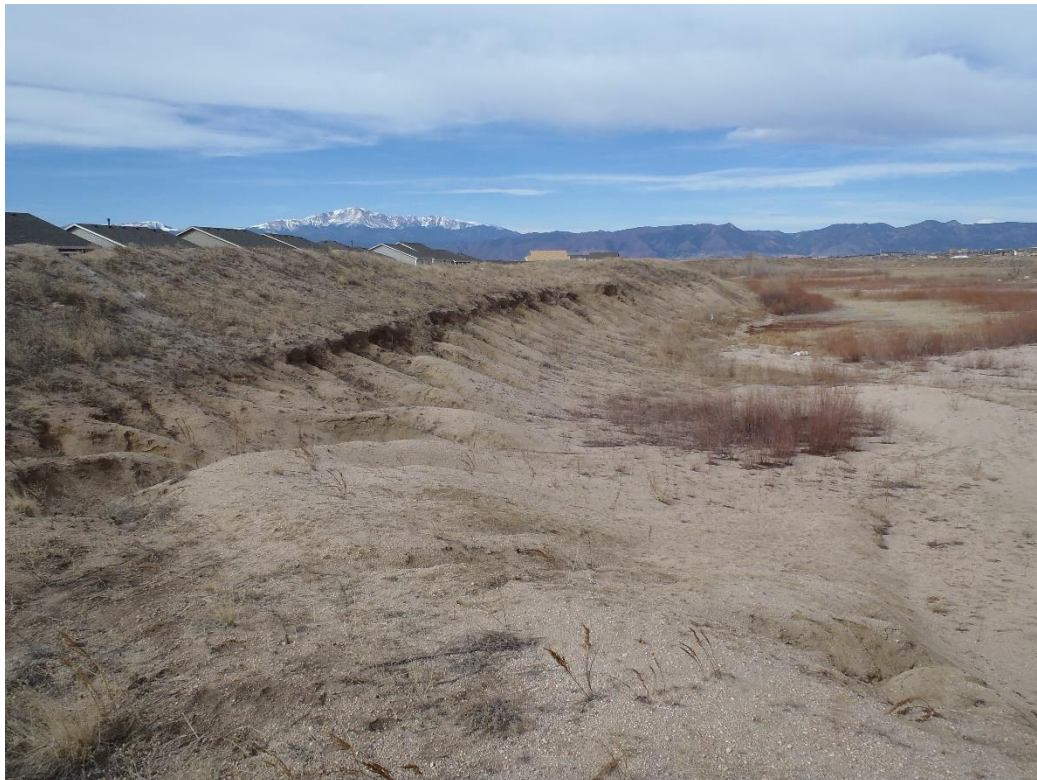
Photo 6. South visual berm (from SE corner, looking west).

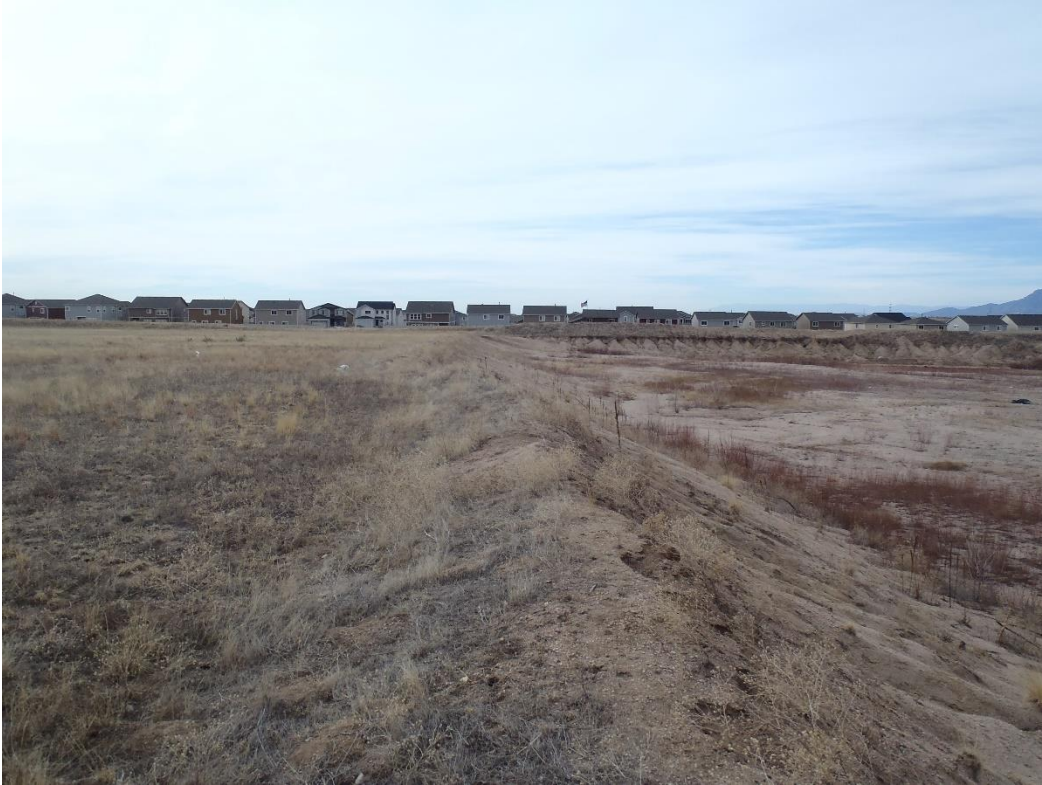
Photo 7. Stormwater control berm (east side, looking south).

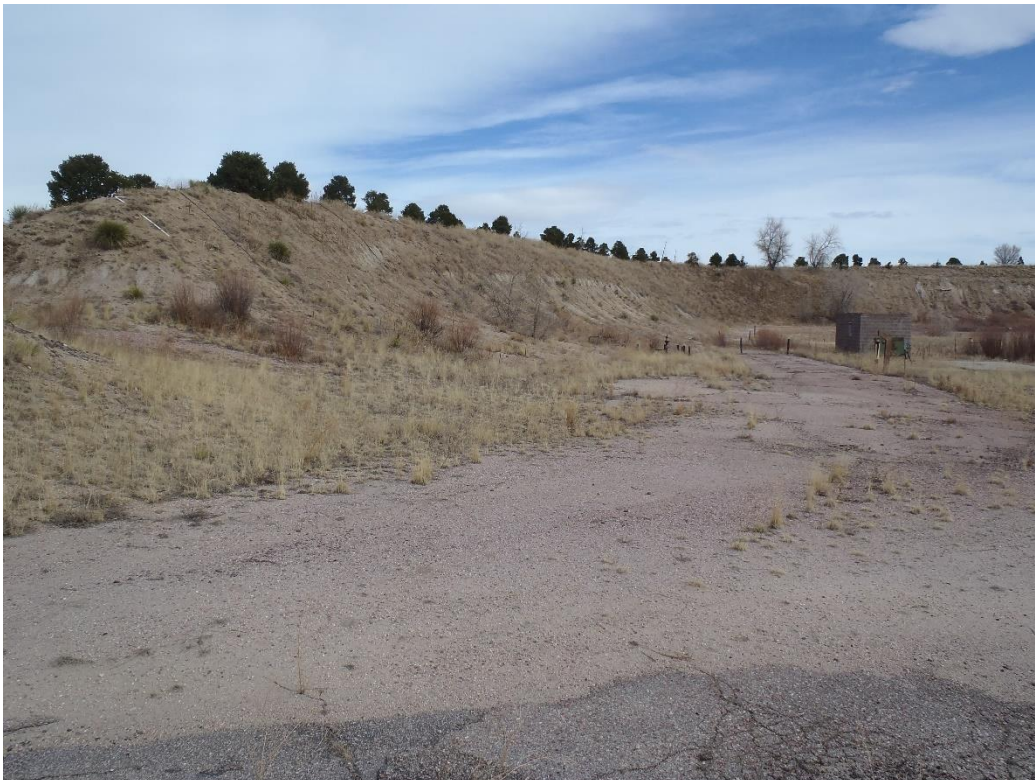
Photo 8. Visual berm boundary marker (west side, north end, looking north).
