COLORADO

Division of Reclamation,
Mining and Safety

MINERALS PROGRAM INSPECTION REPORT

MINE NAME: Sara Rose	MINE/PROSPECTING ID#: M-2015-020	MINERAL: Gemstones	COUNTY: Park
INSPECTION TYPE: Monitoring	INSPECTOR(S): Michael A. Cunningham	INSP. DATE: September 29, 2017	INSP. TIME: 10:30
OPERATOR: Red Rock Exploration, LLC	OPERATOR REPRESENTATIVE: Mike Bergmann	TYPE OF OPERATION: 110(1) - Hard Rock Limited Impact

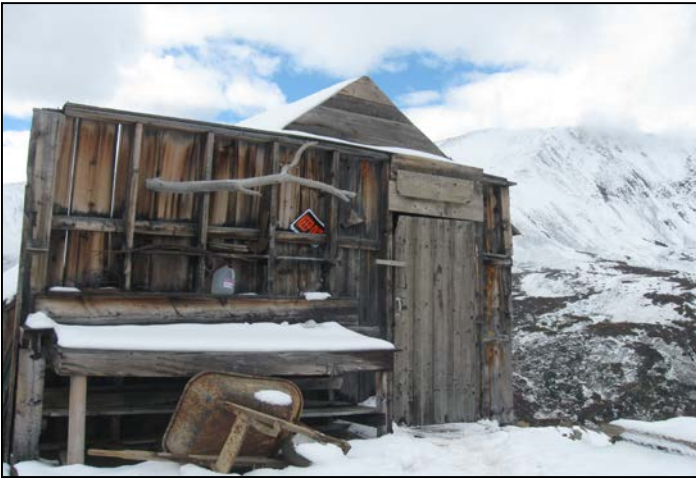
The Operator has restored a wooden shack from the 1950's which is located on the access road, just below the portal. The wooden shack will remain following reclamation. All fuel was stored within equipment with the proper secondary containment.

1. 1950's Wooden Shack.

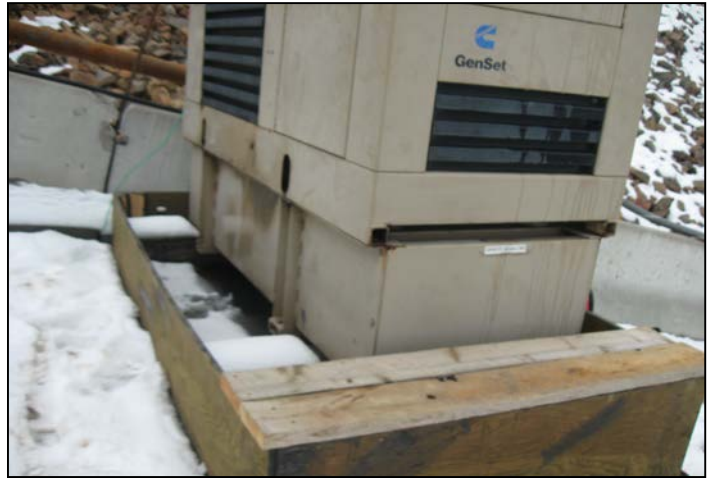
2. Lined secondary containment for generator.

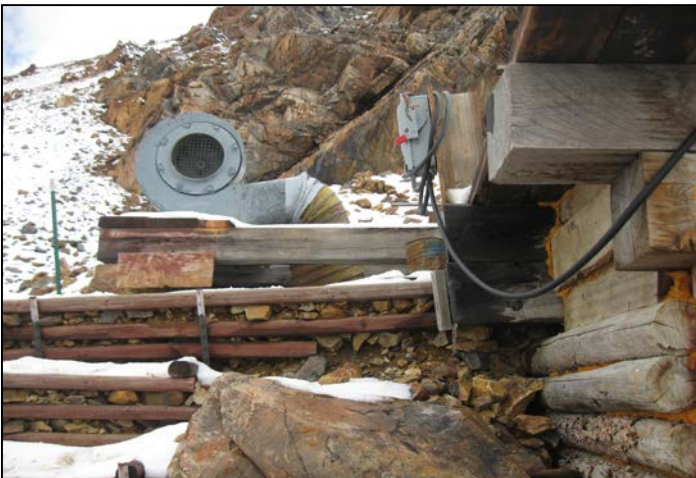
The Operator has recently completed construction of the portal. The activities consisted of stabilization and construction of a 20 ft. concrete and timber portal. Waste rock from the portal construction was placed on the native slope adjacent to the portal. The waste rock consists of Precambrian granite/gneiss which is blended into the talus slope. The portal is secured with a locking steel gate. Additional activities include installation of ventilation infrastructure and electrical panels. The Operator will move to the next phase of portal development in 2018. The Operator provided a commitment to submit a Technical Revision with a detail drawing of the portal upon completion of construction. The Technical Revision shall be submitted to the Division prior to the commencement of the next construction season. In addition, the technical revision shall provide additional details on the portal development, including but not limited to, portal dimensions and direction of portal development.

3. Side view of portal.

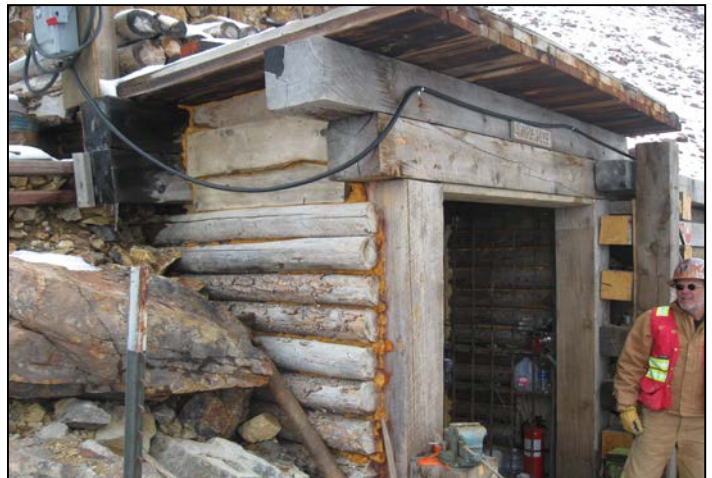
4. Front view of portal.
