**MINERALS PROGRAM INSPECTION REPORT**  
**PHONE: (303) 866-3567**

<b>MINE NAME:</b> Mica White	<b>MINE/PROSPECTING ID#:</b> M-1992-058	<b>MINERAL:</b> Mica and silica (quartz)	<b>COUNTY:</b> Fremont
<b>INSPECTION TYPE:</b> Monitoring	<b>INSPECTOR(S):</b> Timothy A. Cazier	<b>INSP. DATE:</b> April 27, 2017	<b>INSP. TIME:</b> 9:30
<b>OPERATOR:</b> Colorado Quarries Inc.	<b>OPERATOR REPRESENTATIVE:</b> Greg Cleeves	<b>TYPE OF OPERATION:</b> 112c - Construction Regular Operation	
<b>REASON FOR INSPECTION:</b> Normal I&E Program	<b>BOND CALCULATION TYPE:</b> Partial Bond	<b>BOND AMOUNT:</b> \$184,720.00	
<b>DATE OF COMPLAINT:</b> NA	<b>POST INSP. CONTACTS:</b> BLM	<b>JOINT INSP. AGENCY:</b> BLM	
<b>WEATHER:</b> Cloudy	<b>INSPECTOR'S SIGNATURE:</b>

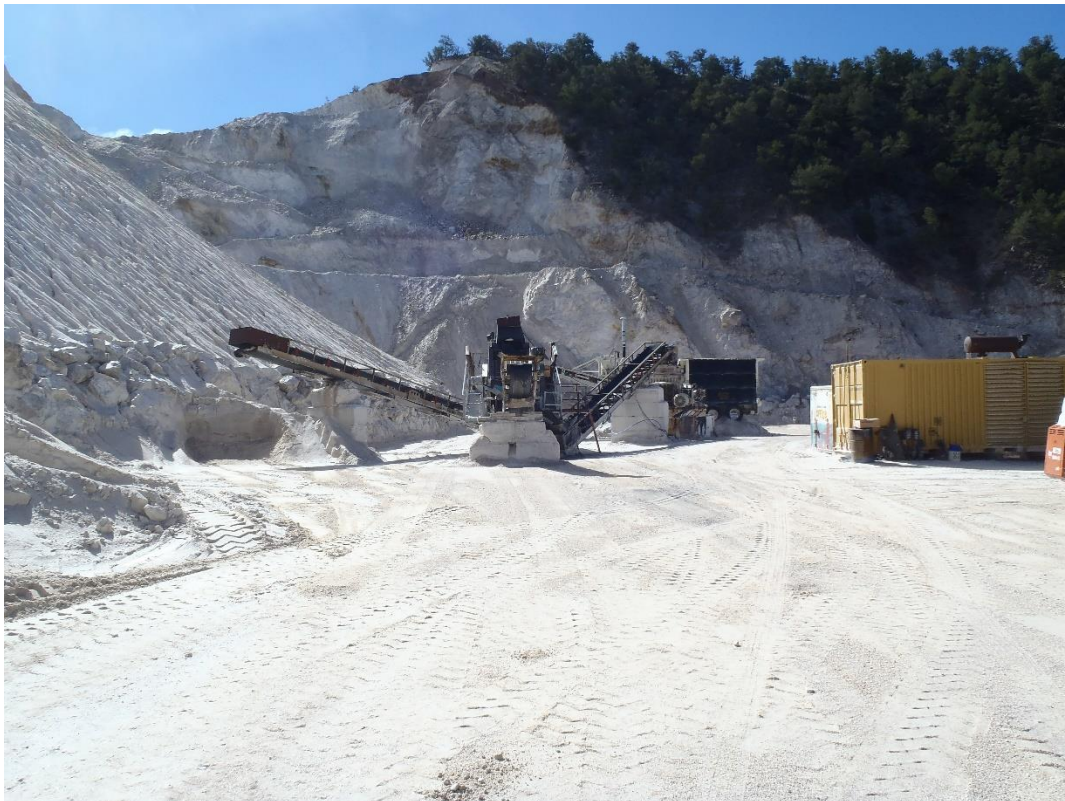
Backfilling and Grading: The pit highwalls are to be mined/excavated at an overall 2H:1V slope including 8-foot bench widths. The 20-foot high stockpile site retention berm will not remain after reclamation as this material will be utilized as capping material for reclamation.

Photo 1. Benched highwalls estimated to vary from 75 to 100 feet in height (looking SE).

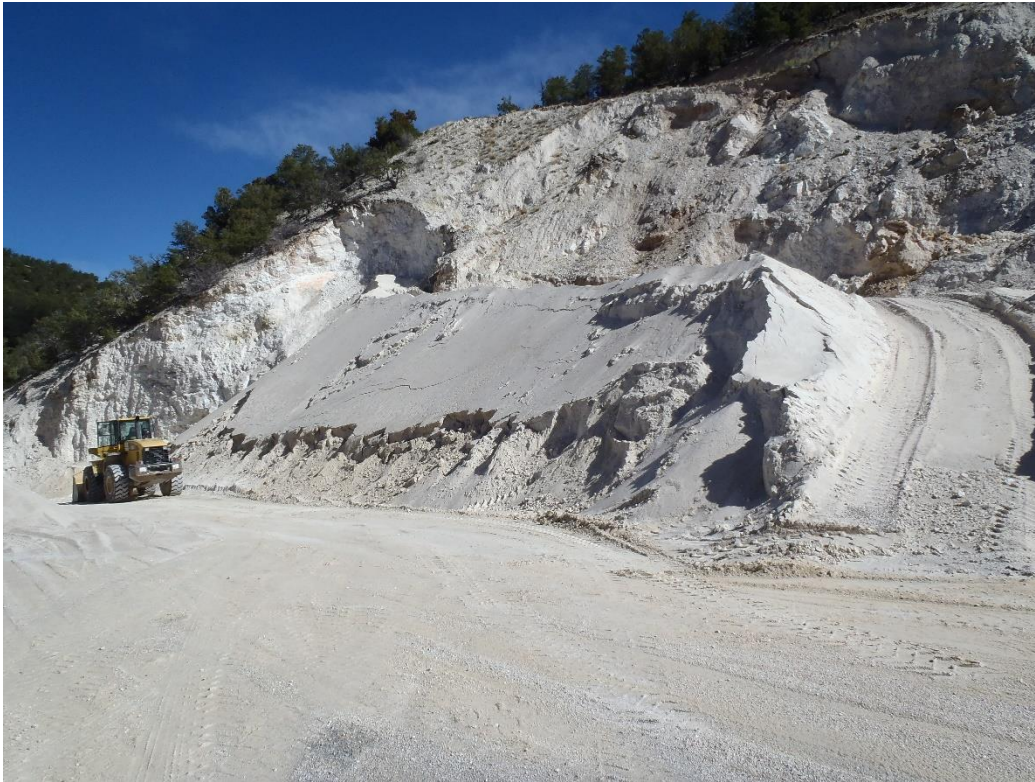
Processing Waste: A stockpile of fines (see **Photo 2**) was observed at the mine site (northwest end).

Photo 2. Fines stockpile observed in northwest end of pit area (looking NW).

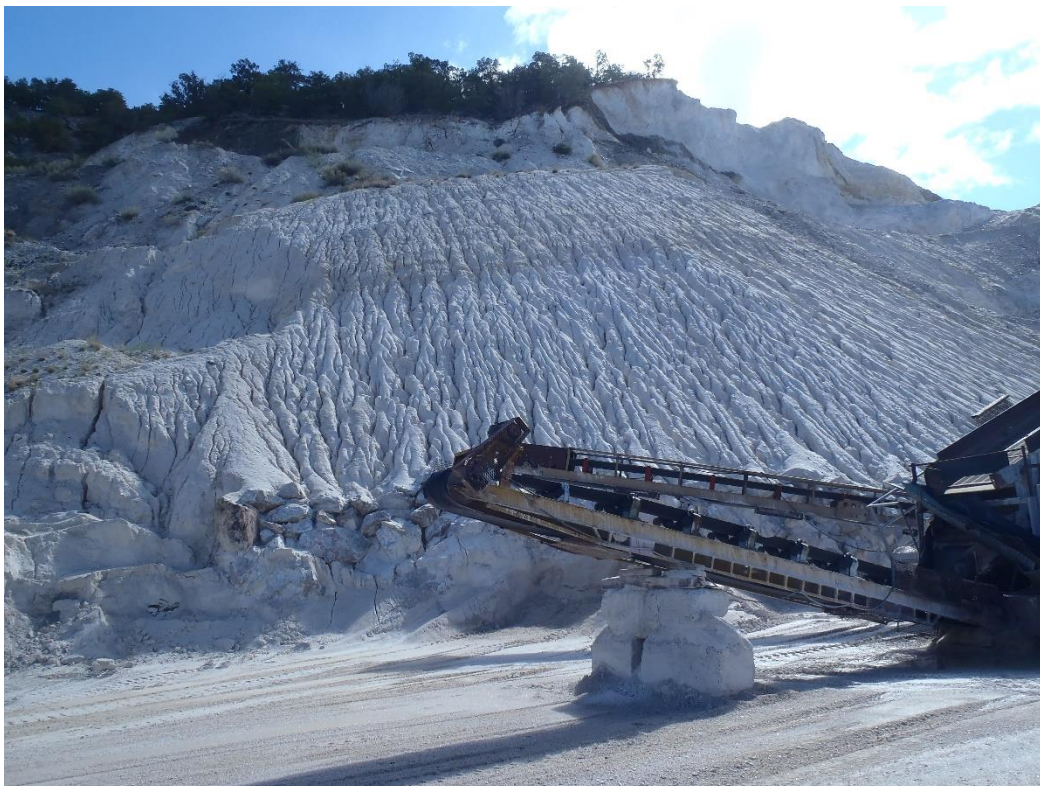
Sediment Control: The older fines stockpile showed signs of erosion (see **Photo 3**). However, eroded sediments from this stockpile appeared to be confined to the pit area. Five sediment traps (see **Photo 4**) were observed along the haul road between the mine site and the stockpile site. Mr. Cleeves pointed out the sediment pond in the stockpile site (see **Photo 5**). No erosion problems were observed and no BMPs were needed at the time of the inspection.

Photo 3. Older fines stockpile showing signs of erosion (central pit area).

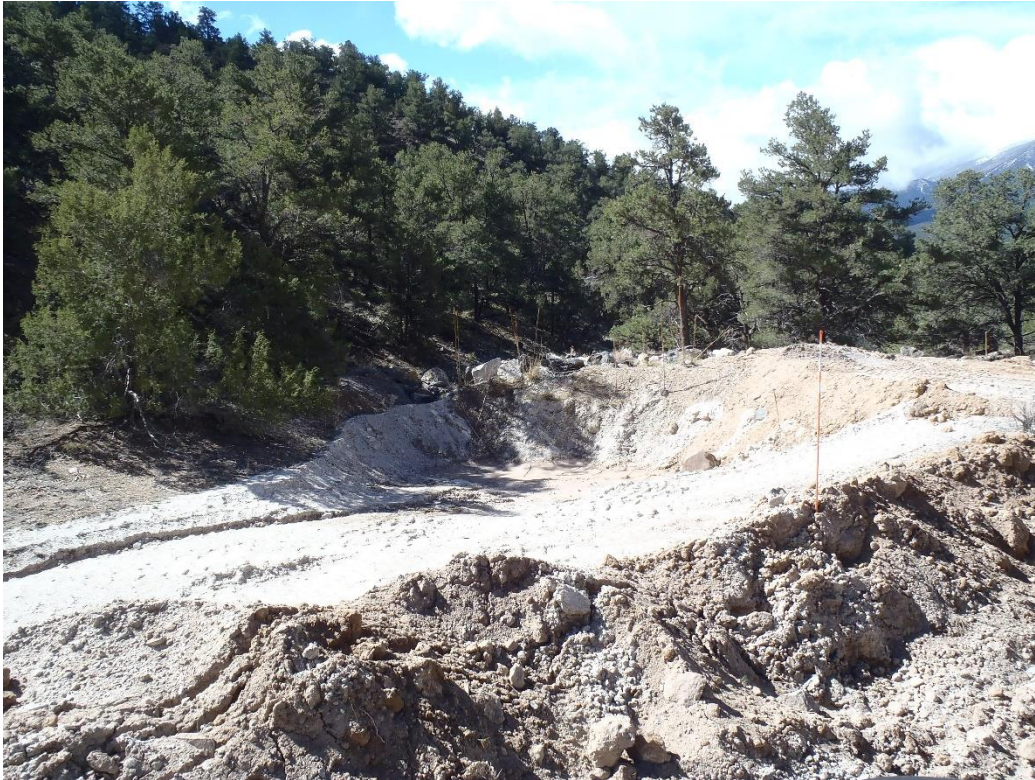
Photo 4. Typical sediment trap (along haul road).

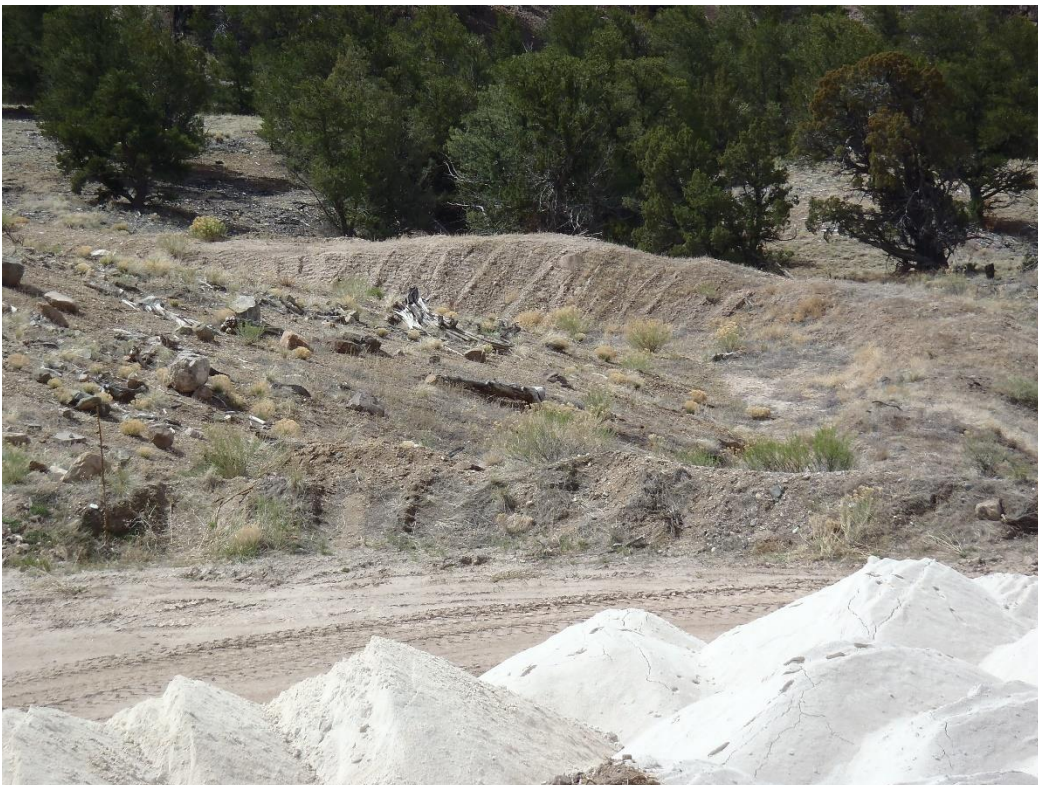
Photo 5. Staging area sediment pond (looking south).

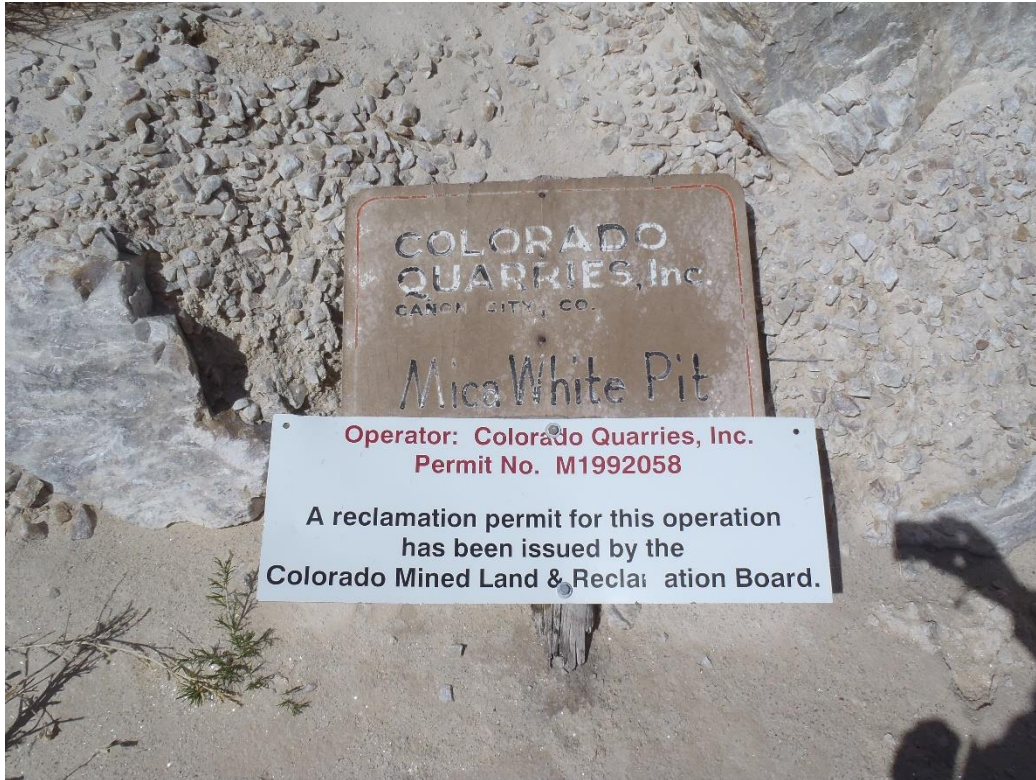
Signs and Markers: A permit sign was posted at the mine site (see **Photo 6**), but not at the stockpile site. Subsequent to the inspection, the permittee provided photographic documentation of a permit sign at the stockpile site. Alternatively, the Division would accept a single permit sign posted at the gate off County Road 45, as this is the site entrance. Boundary markers (survey lathe) were observed to delineate the new permit boundary at the stockpile site (see **Photo 7**). This inspector recommended more permanent markers be installed as survey lathe do not typically last very long in the field.

Photo 6. Permit sign (posted at the pit area entrance).

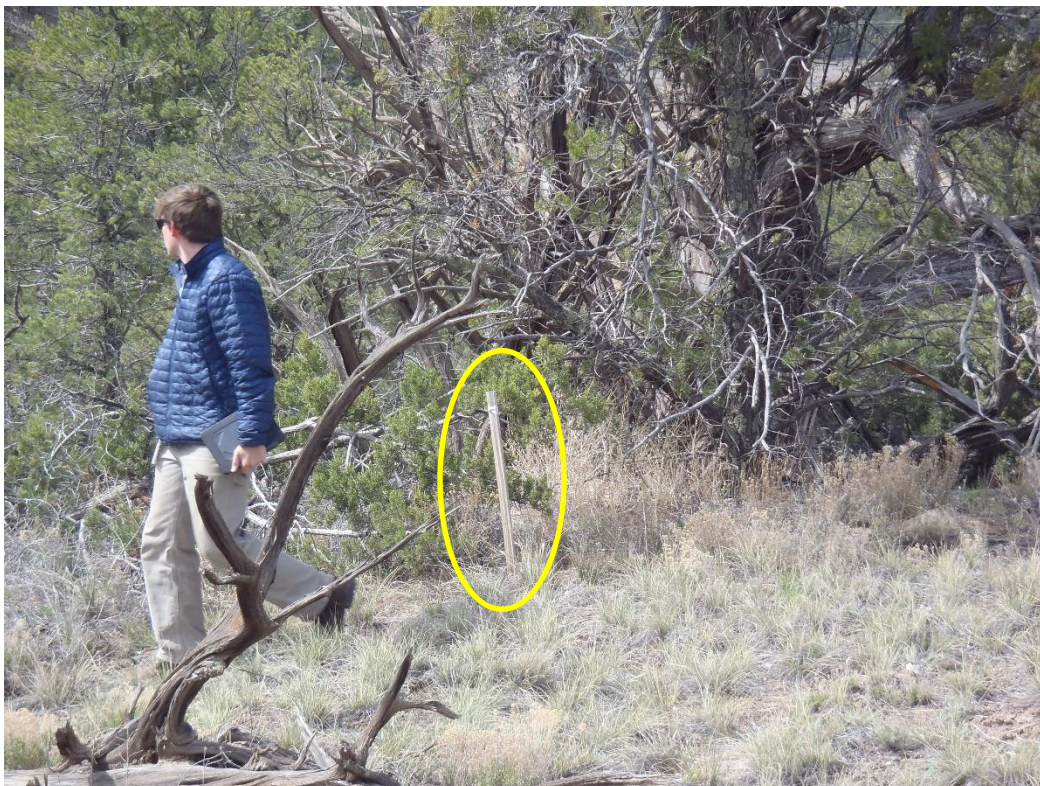
Photo 7. Survey lathe boundary marker observed delineating new staging area permit boundary.

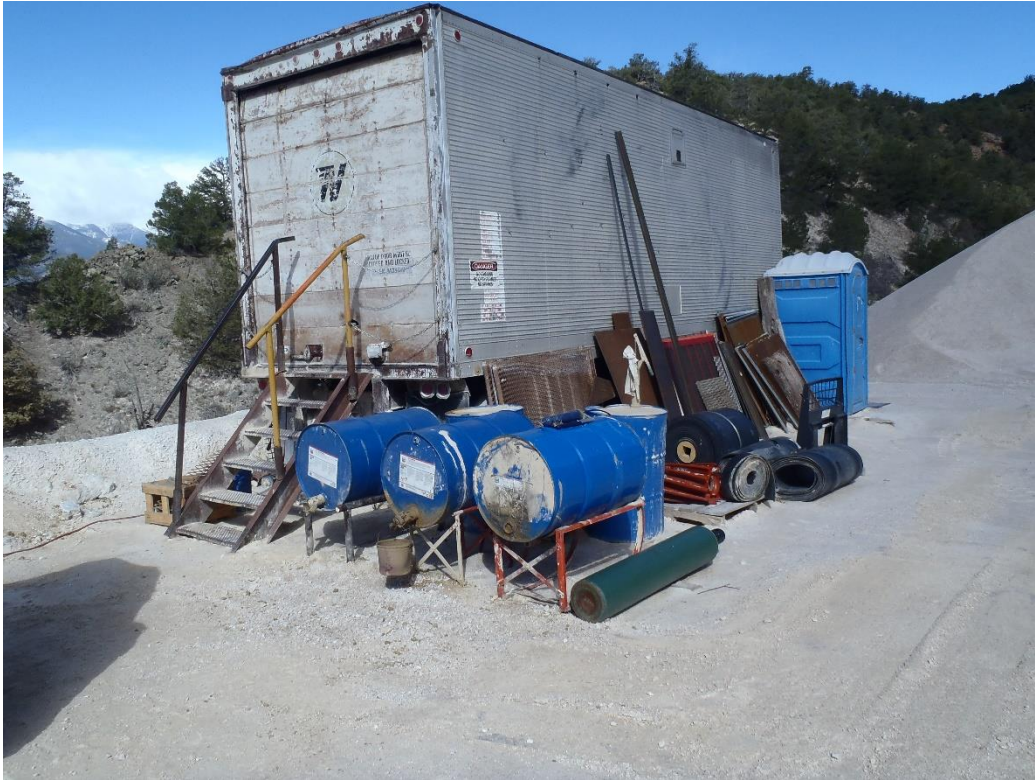
Storm Water MGT Plan: Mr. Cleeves indicated the site stormwater management plan is kept in the office. No oil or fuel spills observed. However, three petroleum product storage barrels were observed at the mine site (see **Photo 8**) without secondary containment. The lack of secondary containment was cited as a problem during the inspection. Mr. Cleeves stated he would promptly correct the problem. Subsequent to the inspection, the Division received photographic documentation from the Permittee demonstrating secondary containment had been provided for these petroleum product barrels (see **Photo 9**). Stormwater is captured in five sediment traps (see **Photo 10**) along the haul road.

Photo 8. Petroleum product storage barrels observed at pit area (looking west).

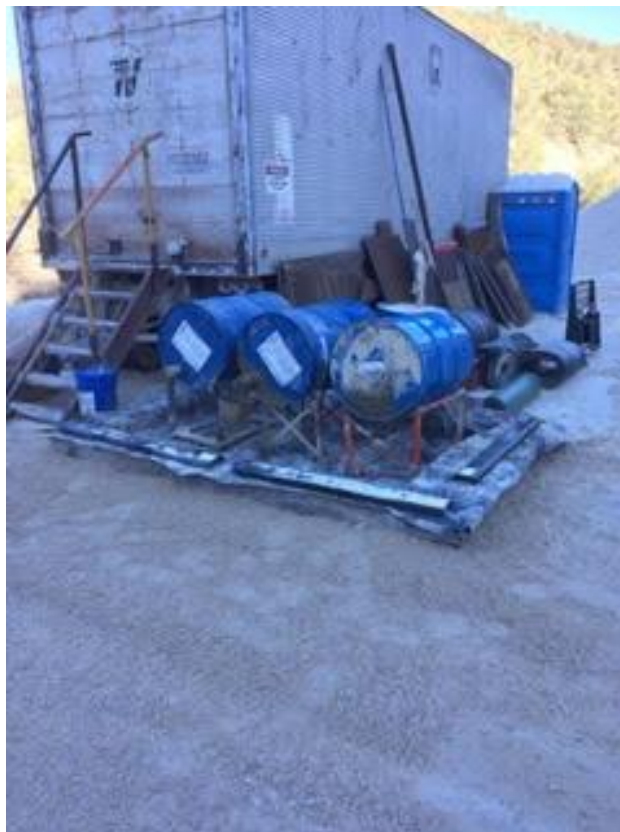
Photo 9. Secondary containment photo provided for petroleum product barrels (from Permittee).

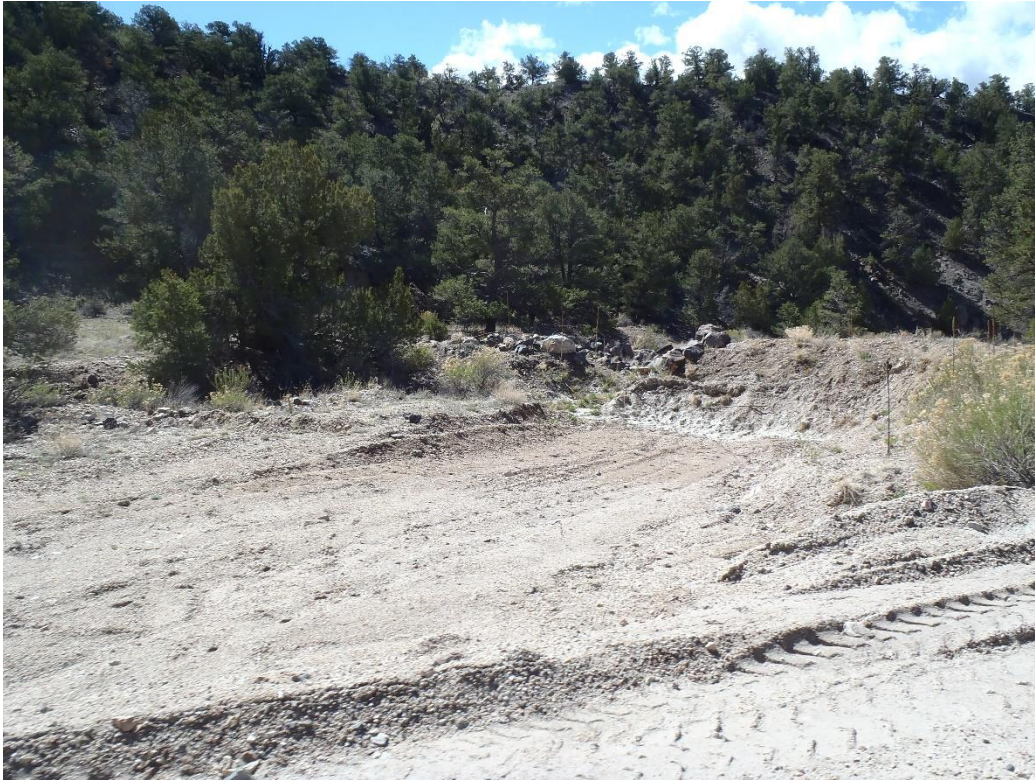
Photo 10. Another sediment trap (along haul road).
