## Bureau of Land Management Colorado River Valley Field Office Minerals Inspection Report

General Information	
<b>Date</b>	9/6/2017
<b>Project Name</b>	Mid-Continent Limestone Quarry
<b>Operator</b>	RMR Aggregates, Inc.
<b>Serial Number</b>	COC-074205
<b>Project Classification</b>	Plan of Operations
<b>Project Location</b>	T5S R89W Sec36, Garfield County
<b>Inspection Purpose</b>	Regular site inspection (per 43 CFR 3809.600 (a))
<b>Time Period Onsite</b>	4 hours
<b>Attendees</b>	Jessica Lopez Pearce, BLM Geologist
	Bobby Wagner, RMR Aggregates, Inc. Director of Operations
	Justin Olin, RMR Aggregates, Inc. Mine Superintendent

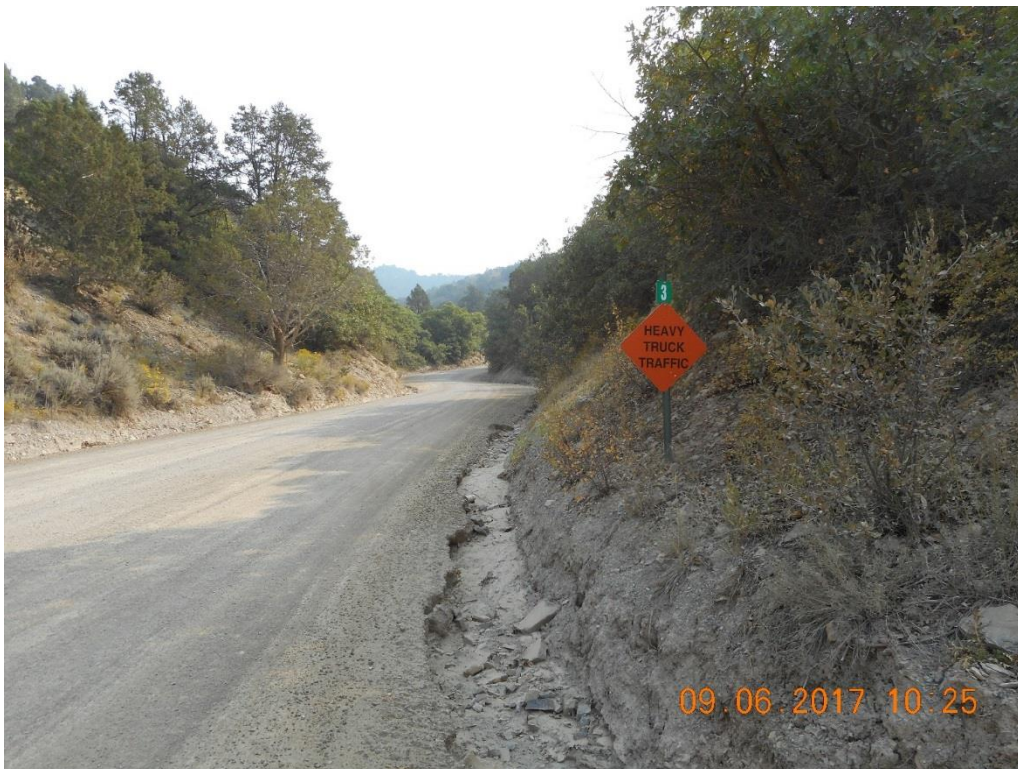
As I drove up Transfer Trail to the quarry, I observed "Heavy Truck Traffic" signage at the intersection of Traver Trail and Transfer Trail and at two other points along Transfer Trail (Photo 1). Per the January 14, 2011 BLM letter related to parking and access on Transfer Trail: "CalX will install a metal sign at the intersection of Transfer Trail Road and Traver Trail Road. The sign will be approximately 2 feet by 4 feet in size and will read: Caution, Semi Truck Traffic, Mine in Operation 7 Days a Week, Park in Designated Areas Only, Do Not Block Road." The 2011 letter further states: "CalX will install "Heavy Truck Traffic" signs at multiple points along Transfer Trail Road." This requirement has been fulfilled.

Photo 1. One of two Heavy Truck Traffic signs northbound along Transfer Trail.

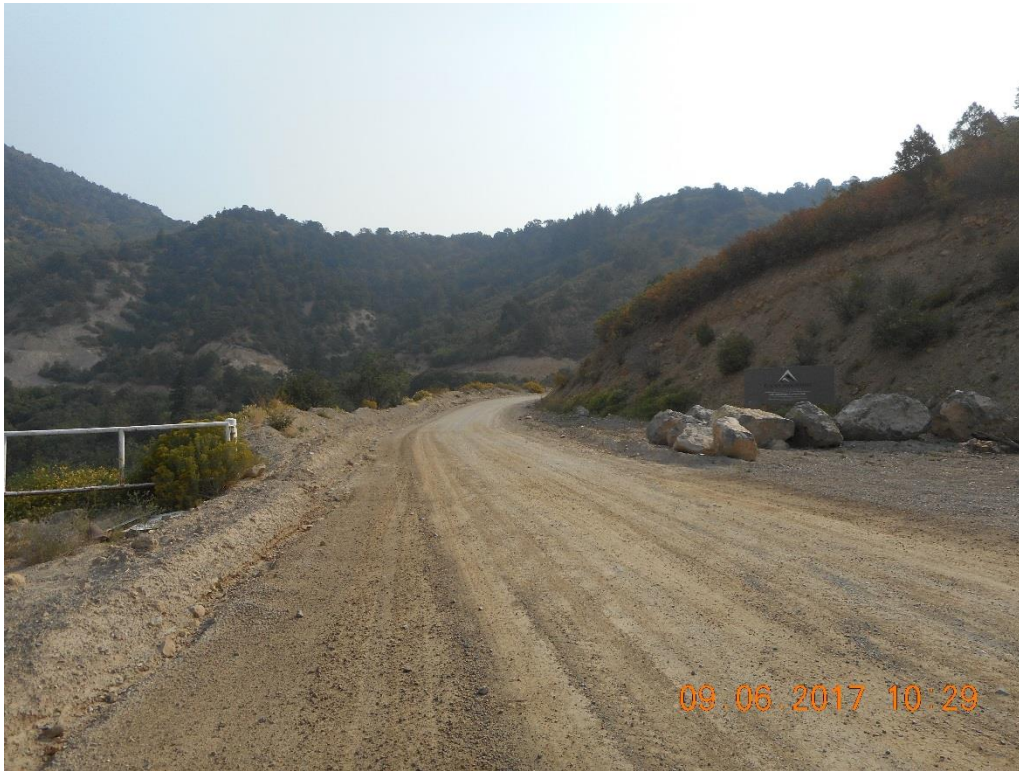
At the entrance gate to the operation, I observed a RMR Aggregates sign (Photo 2). The gate, a scale shack, and a scale were approved under 43 CFR 3809 in a BLM letter dated November 20, 1986 which states: "The installation of a gate, scales, and scale shack is approved subject to item 3b(3) of the reclamation plan submitted by Mid-Continent Resources, Inc." The sign and gate were recently granted an occupancy authorization under 43 CFR 3715 in a letter dated January 9, 2017. The scale and scale shack that were previously located at the gate have been removed. Haul trucks are currently weighed on a digital scale located on the south side of the mill building.

Photo 2. At entrance gate, looking north to gate and RMR sign.

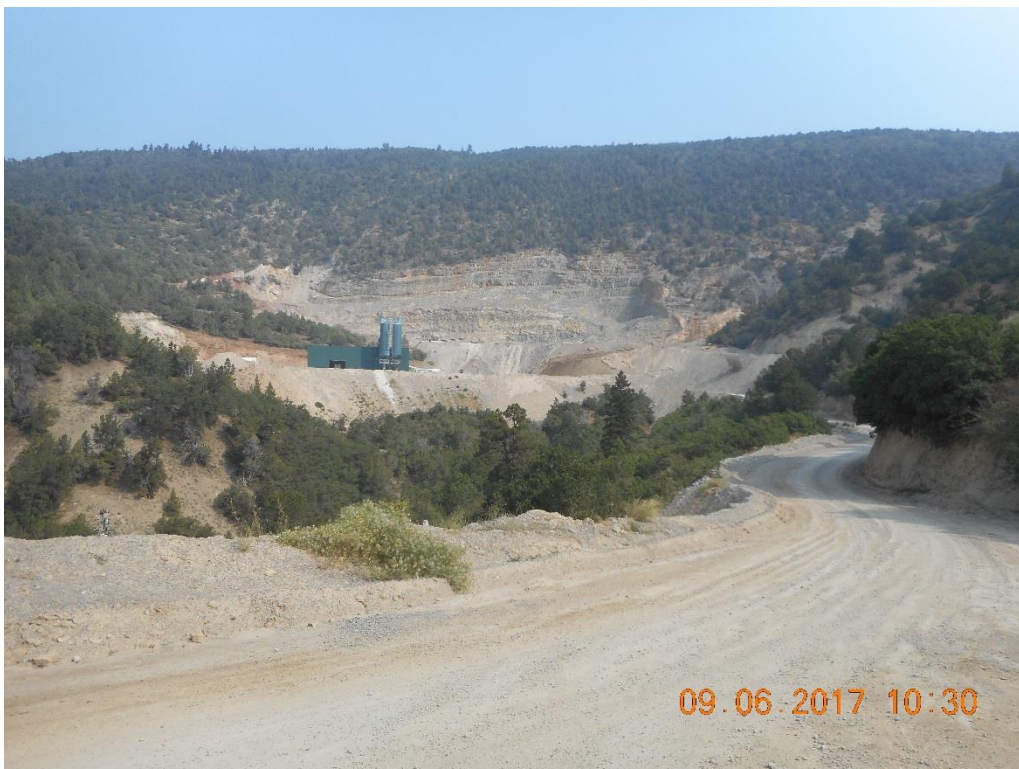
I drove into the quarry on the Lower Road and established a new photopoint at the junction between the middle road and the lower access road (Photo 3).

Photo 3. New photopoint, looking north from Lower Road and Middle Road junction.

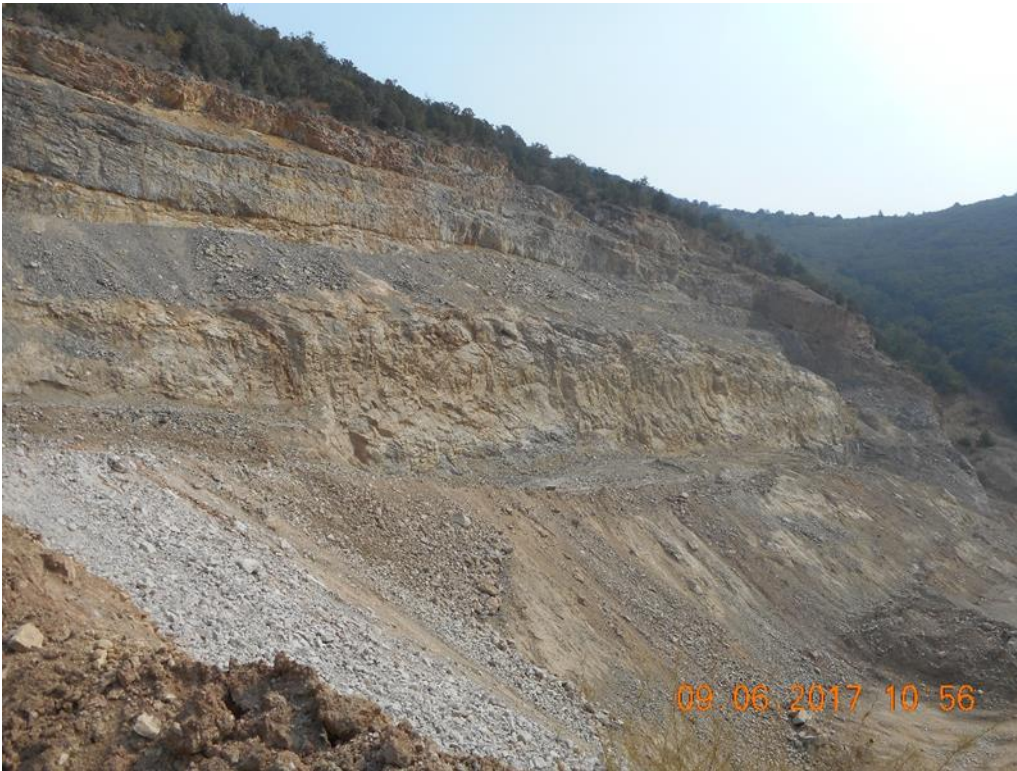
There are currently two mine benches and a third mine bench in development on the far west side (Photo 4). The lowest mine bench is separated from the production bench by a 55-foot tall highwall, which is mostly covered in loose rock. The lowest mine bench is approximately 600 feet long and 50 feet wide, with a 55 foot tall highwall above it. The second mine bench is approximately 600 feet long and 15 feet wide, with a 60 foot tall highwall above it. Quarrying activities include a combination of using an excavator attached with rotary rock cutters and drill-and-blast. Justin stated that the blasting contractor (Rock Solid Solutions) would be arriving that day and would establish approximately 200 shot holes in the lowest mine bench. The blasting date was tentatively set for next week. Per the June 15, 2009 BLM authorization letter, neighboring property owners are notified of blasting in advance. According to the 1982 Plan of Operations (Exhibit D, Section 4. Blasting Plan): "Limestone is quarried by developing benches in the solid rock with the bench width being at least twice the height of the high wall." This statement does not match what currently exists on the mine benches. Additionally, according to the 1989 approved Plan Amendment 1: "Only one quarry bench will be worked at a time. Bench widths will not exceed 60 feet and the length of the portion being quarried will be approximately 300 feet." Any upcoming Plan of Operations Modification should include an update to the mining plan and mine bench design.

Photo 4. Looking eastward at the lowest mine bench, middle mine bench and associated highwalls.

- Address and eradicate the mullein and thistle growing in numerous patches throughout the project area.
- Redesign the quarry highwall and mine benches to conform with the 1982 Plan of Operations and 1989 Plan Amendment 1 or include an updated mining plan and mine bench design in the upcoming proposed Plan of Operations modification to reflect the current mine operations.
- Regrade topsoil stockpile to the 4:1 slope as stated in the 1989 Plan Amendment 1 or include the current topsoil conditions in the upcoming proposed Plan of Operations modification.
- Per the 2015 Colorado River Valley Field Office Resource Management Plan, Appendix K- Best Management Practices: submit a surface drainage plan (or stormwater management plan) with the upcoming proposed Plan of Operations modification.

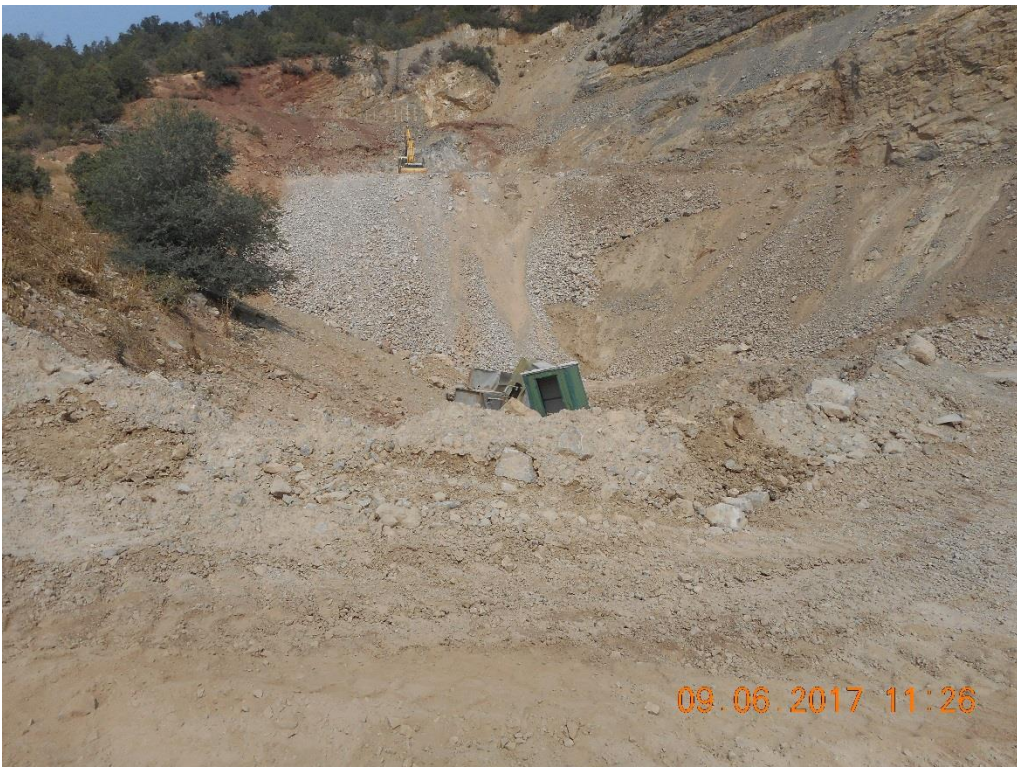
While walking on the west side of the production bench, I observed an excavator with hydraulic rock hammer operating on the lowest mine bench (Photo 5). Several pieces of scrap metal are located on the western side of the production bench. I was told these would be removed before the blast occurred. Two types of noxious weeds were observed on this side of the production bench. I observed mullein and thistle growing in patches in this area (Photo 6). These noxious weeds must be addressed. The 2015 Colorado River Valley Field Office Resource Management Plan, Appendix K – Best Management Practices (BMPs) and Conservation Measures states: "WEED-17: Inspect and document all ground-disturbing activities in noxious weed infested areas for at least three growing seasons following completion of the project. For ongoing projects, continue to monitor until reasonably certain that no weeds are present. Plan for follow-up treatments based on inspection results."

Photo 5. Looking west at excavator on lowest mine bench and scrap metal.

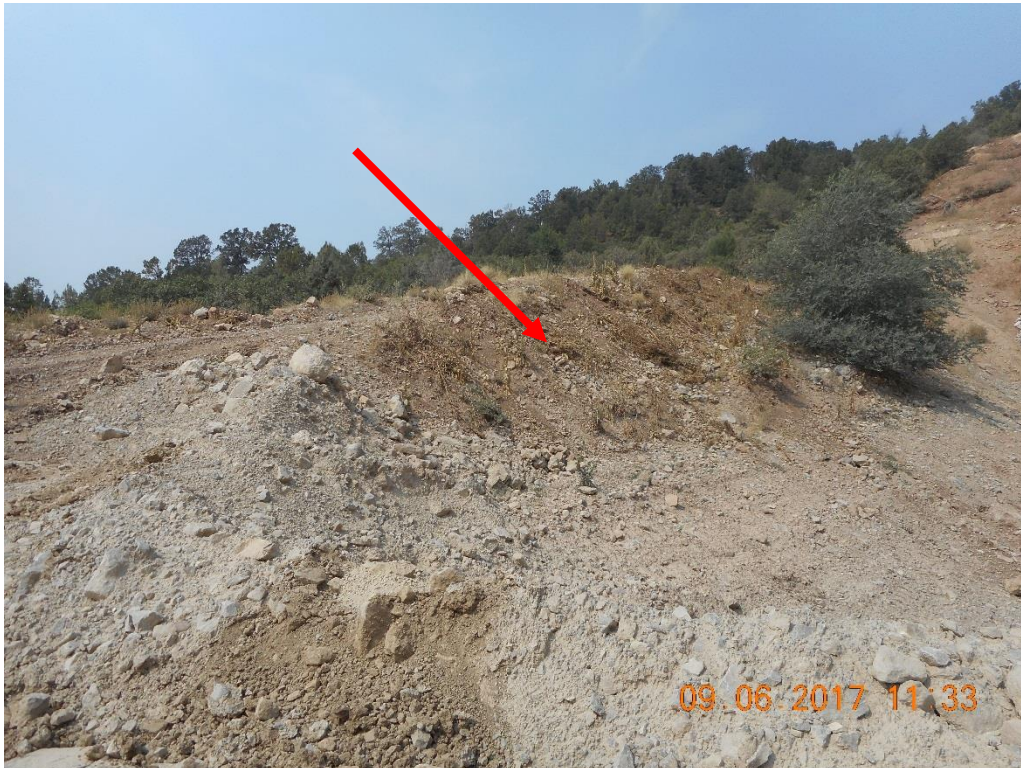
Photo 6. Looking west from production bench to patches of mullein and thistle (indicated with red arrow).

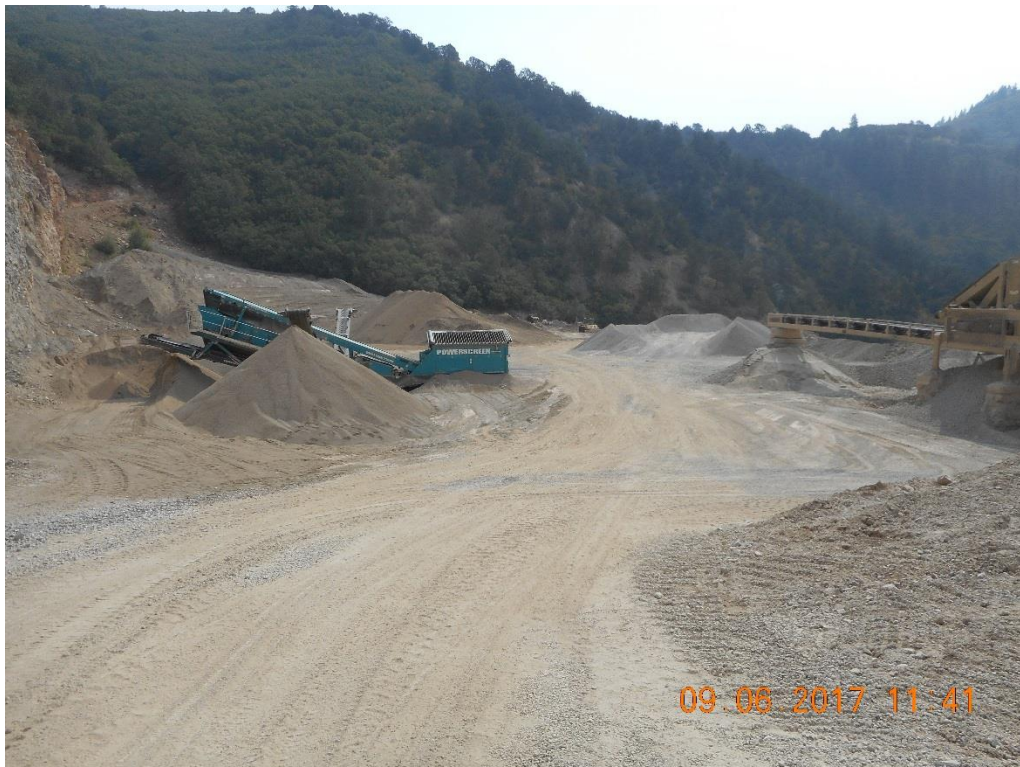
In the central portion of the production bench, I observed a crusher, a new screen plant, a 2,500 gallon water tank for dust suppression, a transformer box, and several material stockpiles (Photo 7). The new screen plant was brought in to fulfill a contract from Colorado Egg for chicken grid product. The contract was for a total of 1,800 tons of material. The stockpiles present in the area consisted of chicken grit, an undersized stockpile, an oversized stockpile, and a large fines stockpile.

Photo 7. Looking east from central production bench to new screenplant, crusher, and stockpiles.

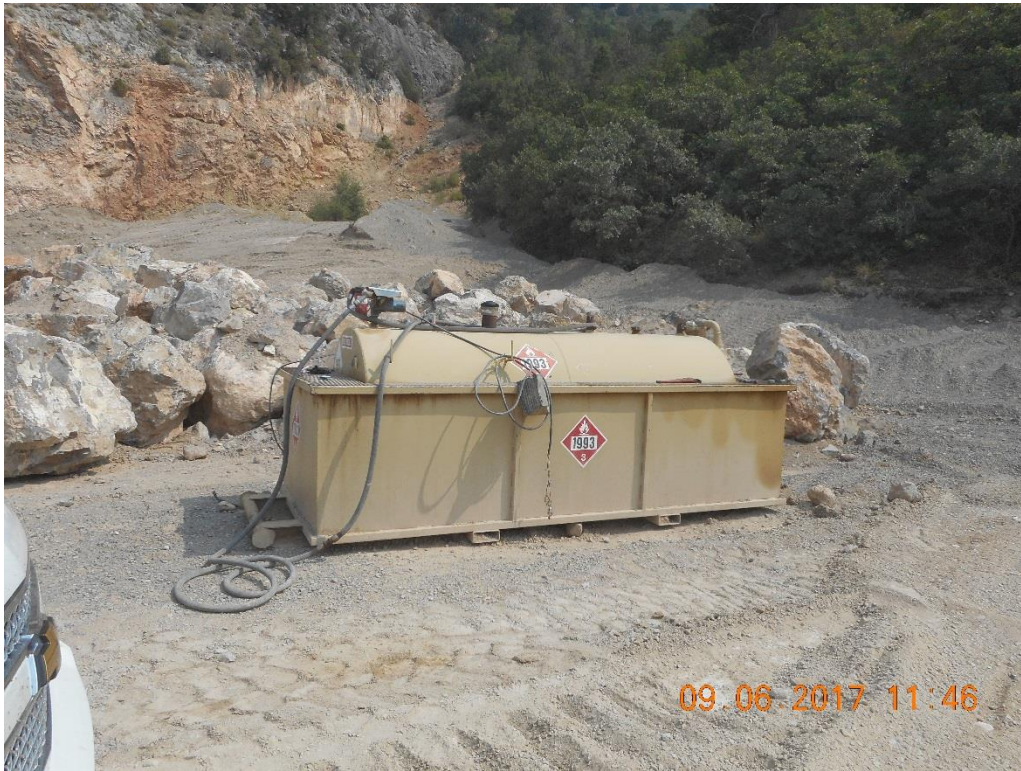
Photo 8.

On the east side of the production bench, I observed an empty rusted tank and a double-wall diesel tank, as well as additional scrap metal, miscellaneous spare parts, and a dozer (Photo 8). The 2015 CRVFO RMP – Appendix K BMPs state: "MIN-7: Project materials which could be a hazard to public health, safety or resource value will be stored in appropriate secondary containment. No oil or lubricants will be drained onto the ground surface." Additionally, per BMP MIN-50: "Standard secondary containment shall hold 110% of the capacity of the largest single tank it contains and be impervious to any oil, glycol, produced water, or other toxic fluid for 72 hours. Earthen berms must be compacted and of fine material that will prevent seepage of any spill to surrounding area."

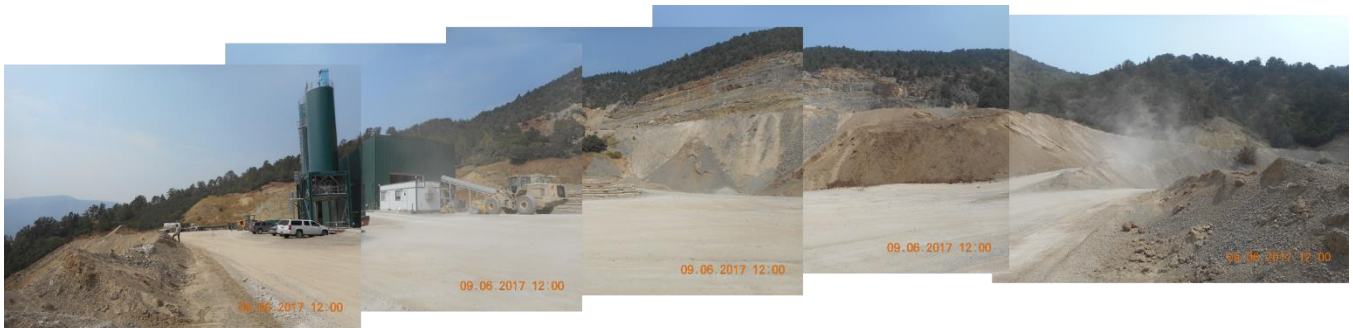
On the mill bench, I observed several stockpiles and a parked loader. In the central portion of the mill bench, from east to west there was a large fines stockpile, a small 8-3" stockpile, and a small 4-1" stockpile (Photo 9). The fines are used for road maintenance and a portion may be available for reclamation backfill. In the last round of road improvement, approximately 6,000 tons of fines were used. The 8-3" stockpile is used for aggregate. The 4-1" stockpile is fed to the mill for pulverized rock dust product.

Photo 9. Looking north from central mill bench photo point

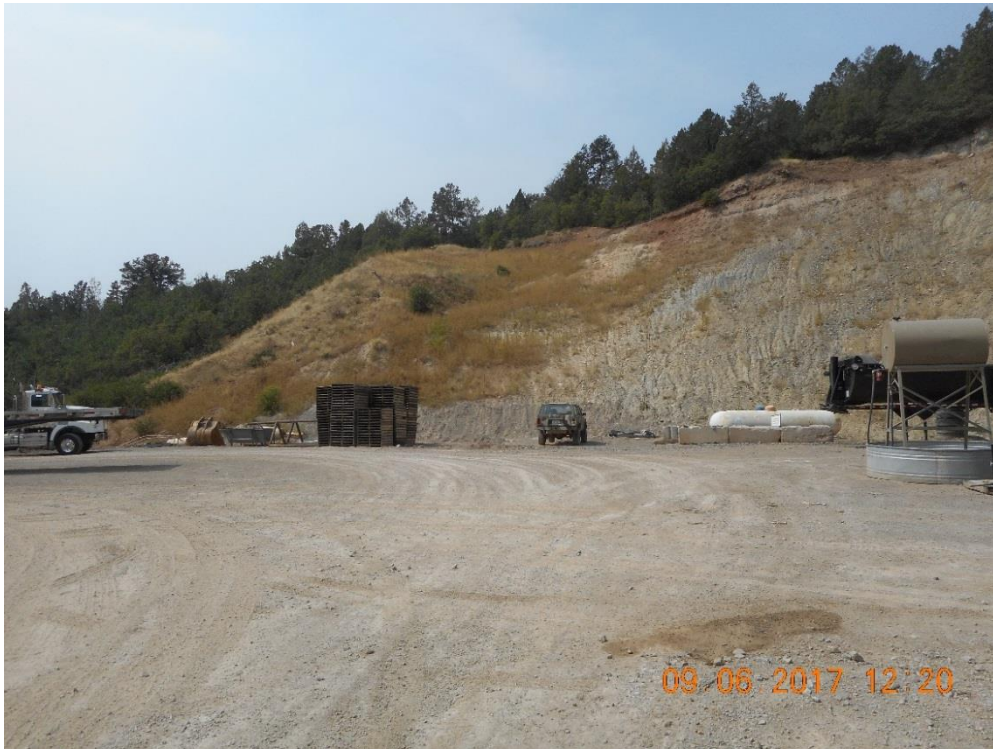
Topsoil is stored on the far western side of the mill bench (Photo 10). There were patches of mullein on and north of the stockpile that need to be eradicated. The soil stockpile appeared to be at approximately 2:1 slope and the quantity inadequate for future site reclamation. According to the stipulations included in BLM's approval of Amendment 1, dated July 21, 1989: "The stored topsoil will be graded to a slope of approximately 4:1 to prevent erosion and to facilitate seeding and establishment of grasses."

Photo 10. Looking west from mill facility at items in boneyard and topsoil stockpile.

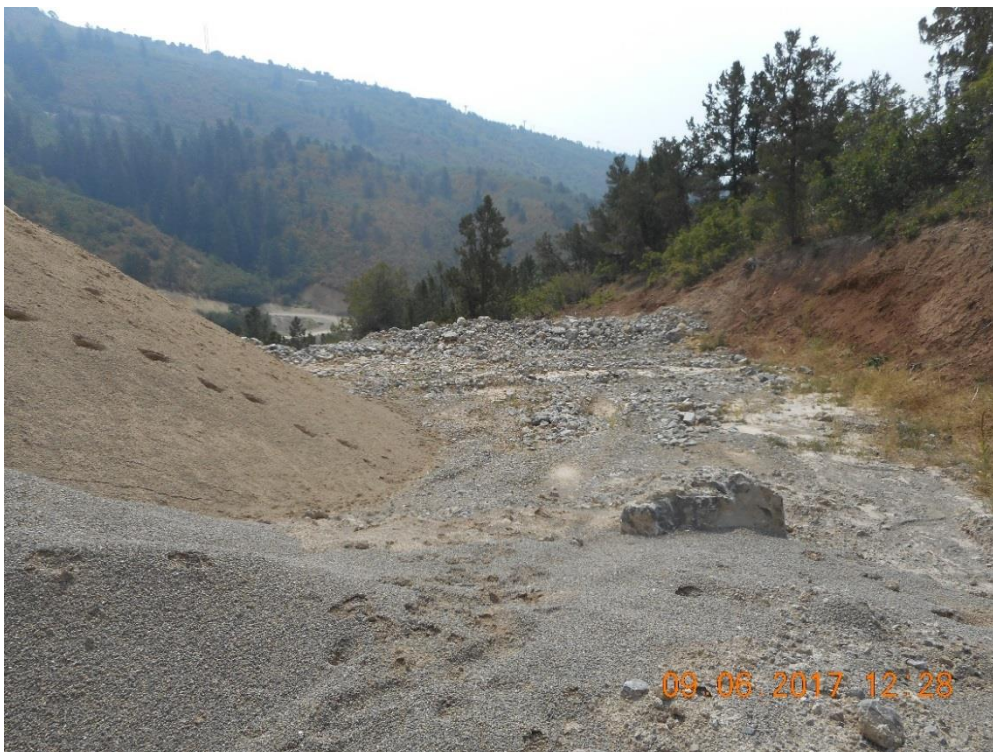
The southwestern side of the mill bench contains a stormwater retention pond (Photo 11). According to Justin, the stormwater structure was working as designed during the spring melt periods of high precipitation. The 2015 Colorado River Valley Field Office Resource Management Plan, Appendix K – Best Management Practices (BMPs) and Conservation Measures states: "MIN-17: Before activities take place, every pad, access road, or facility site will have an approved surface drainage plan (storm water management plan) for establishing positive management of surface water drainage, to reduce erosion and sediment transport. The drainage plan will include adaptive BMPs, monitoring, maintenance and reporting. BMPs may include run-on/run-off controls such as surface pocking or revegetation, ditches or berms, basins, and other control methods to reduce erosion. Pre-construction drainage BMPs will be installed as appropriate." The BMPs also state: "MIN-24: As detailed in the site plan for surface/storm water management, drainage from disturbed areas will be confined or directed to minimize erosion, particularly within 100 feet of all drainages. No runoff, including that from roads, will be allowed to flow into intermittent or perennial waterways without first passing through sediment-trapping mechanisms such as vegetation, anchored bales or catchments." Additionally, per 43 CFR 3809.420(b)(5): "all operators shall comply with applicable Federal and state water quality standards, including

the Federal Water Pollution Control Act, as amended (30 U.S.C. 1151 et seq.).” An upcoming Plan of Operations modification would benefit from a surface drainage plan.

Photo 11. Looking south from mill bench at sediment control structure.
