Bureau of Land Management Colorado River Valley Field Office Minerals Inspection Report

General Information	
Date	8/8/2017
Project Name	Rifle Quarry
Operator	Colorado Lien Company
Serial Number	COC-077876
Project Classification	Plan of Operations
Project Location	T4S R92W Sec15, Garfield County
Inspection Purpose	Reclamation site inspection
Time Period Onsite	1 hour
Attendees	Jessica Lopez Pearce, BLM Geologist

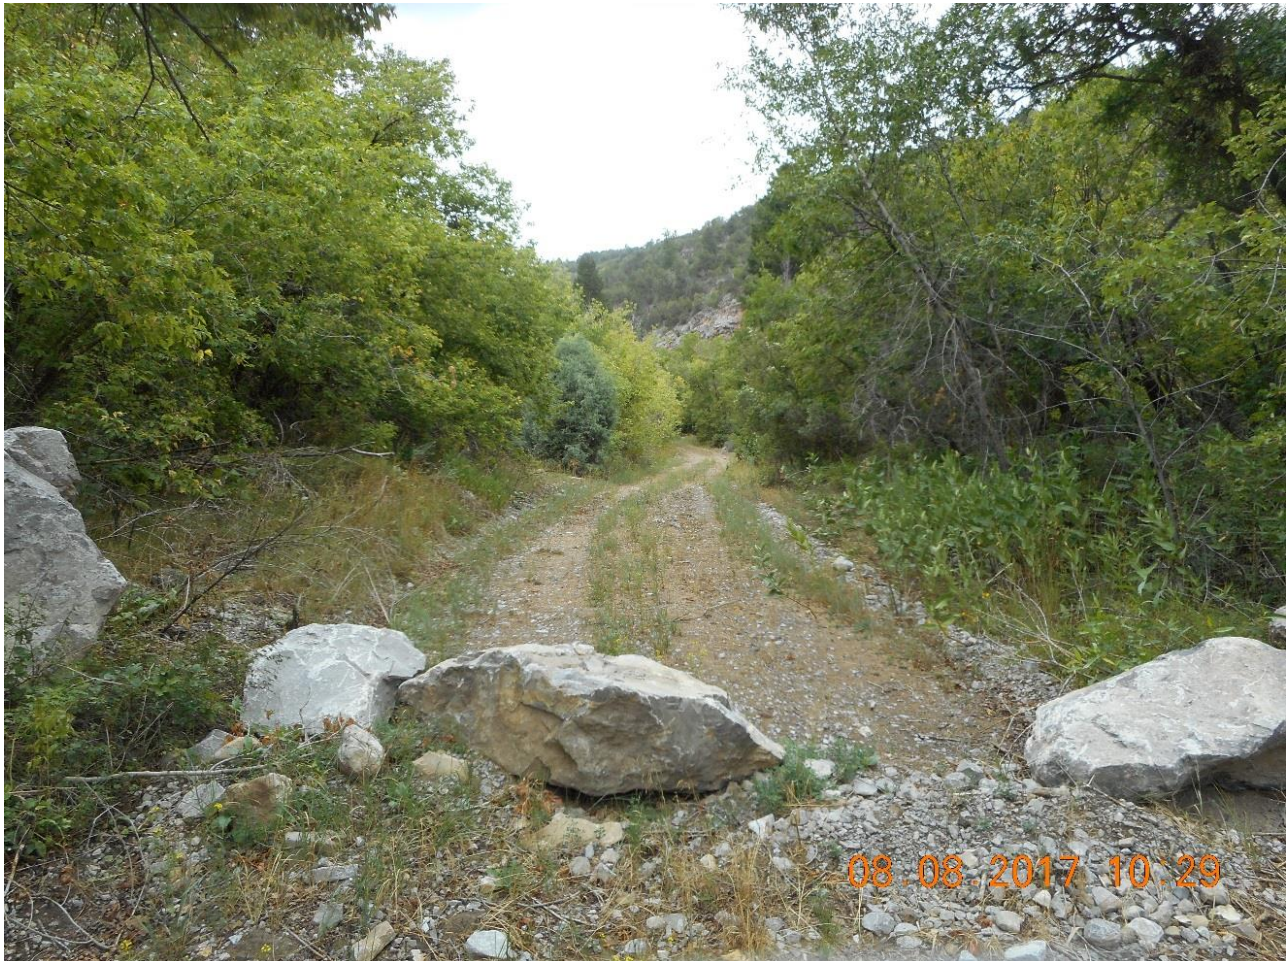
I observed the access road blocked per the Final Reclamation Plan. The surface of the road was covered in the approved alternative growth media and mulching material (a combination of fish emulsion solids, spent grain solids, spent potato mash solids, mulch, and topsoil). Grasses and forbs were growing on the road bed; there was more vegetation along the side and down the middle of the old road than in the wheel ruts. Signage was present at the southeast corner of the main quarry area.

Photo 1: Looking west at the barricaded access road. Vegetation is successfully growing in the middle and on the sides of the road.

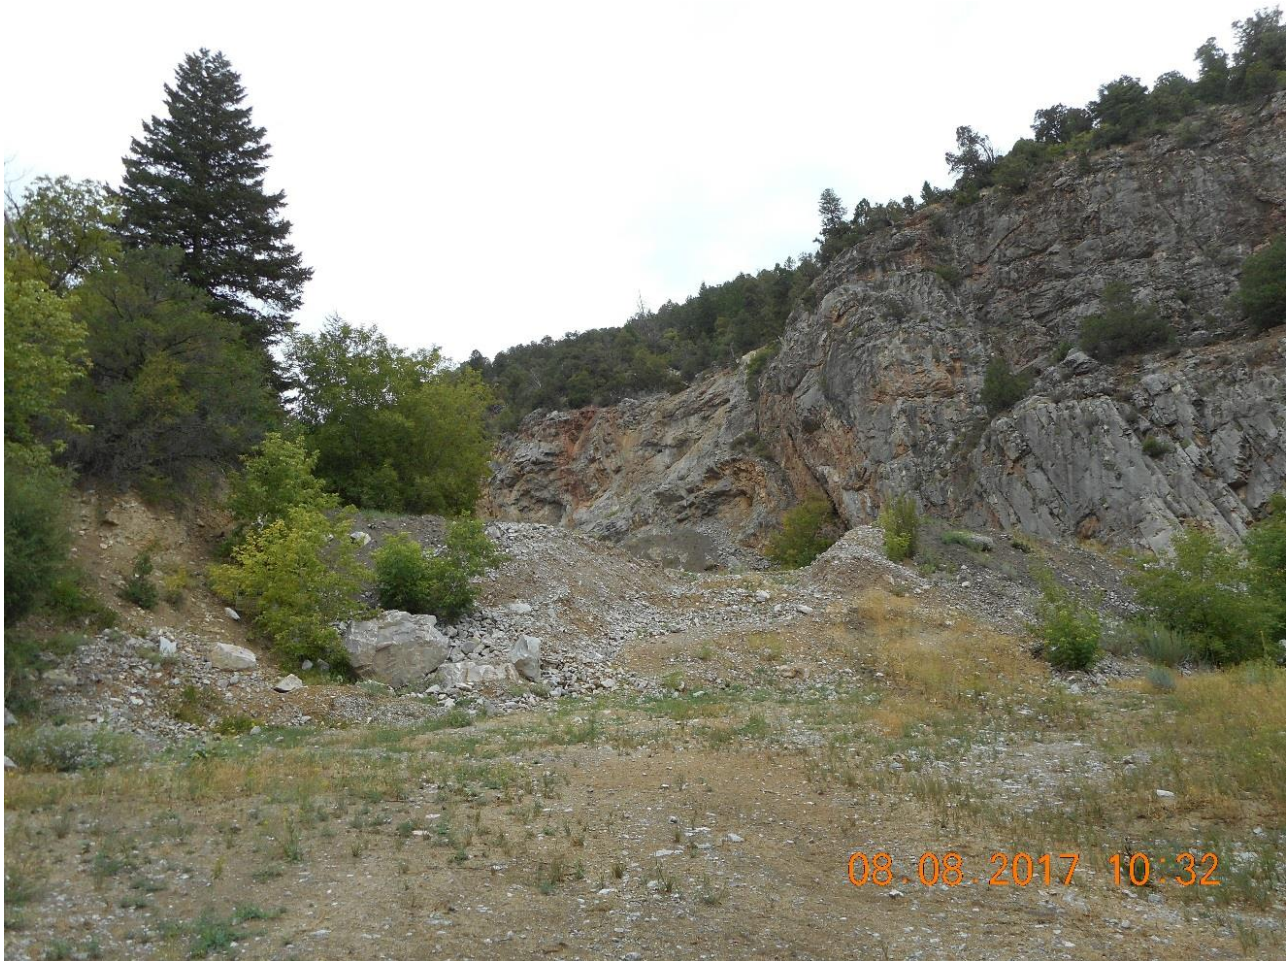
The 1.65-acre site includes a highwall on the north side and a backfilled and regraded area to the south. The backfilled quarry floor terminates to the east with an east-facing, 20-foot high, approximately 2:1 slope. There is a bermed access route up the eastern slope to the recontoured quarry floor. The eastern slope, the quarry floor, the northern upper access bench, as well as most of the remaining quarry area was covered in the alternative growth media and mulching material. Vegetation covered approximately 50% of the recontoured quarry floor. An unknown species of mustard was especially prevalent. This plant is not part of the 2016 BLM-approved seed mix. Mullein was also observed throughout the quarry. Future inspections will monitor the revegetation within the reclaimed area.

Photo 2: Looking west to the slope on the eastern side of the quarry. The eastern slide of the slope is covered in alternative growth media and mulching material.

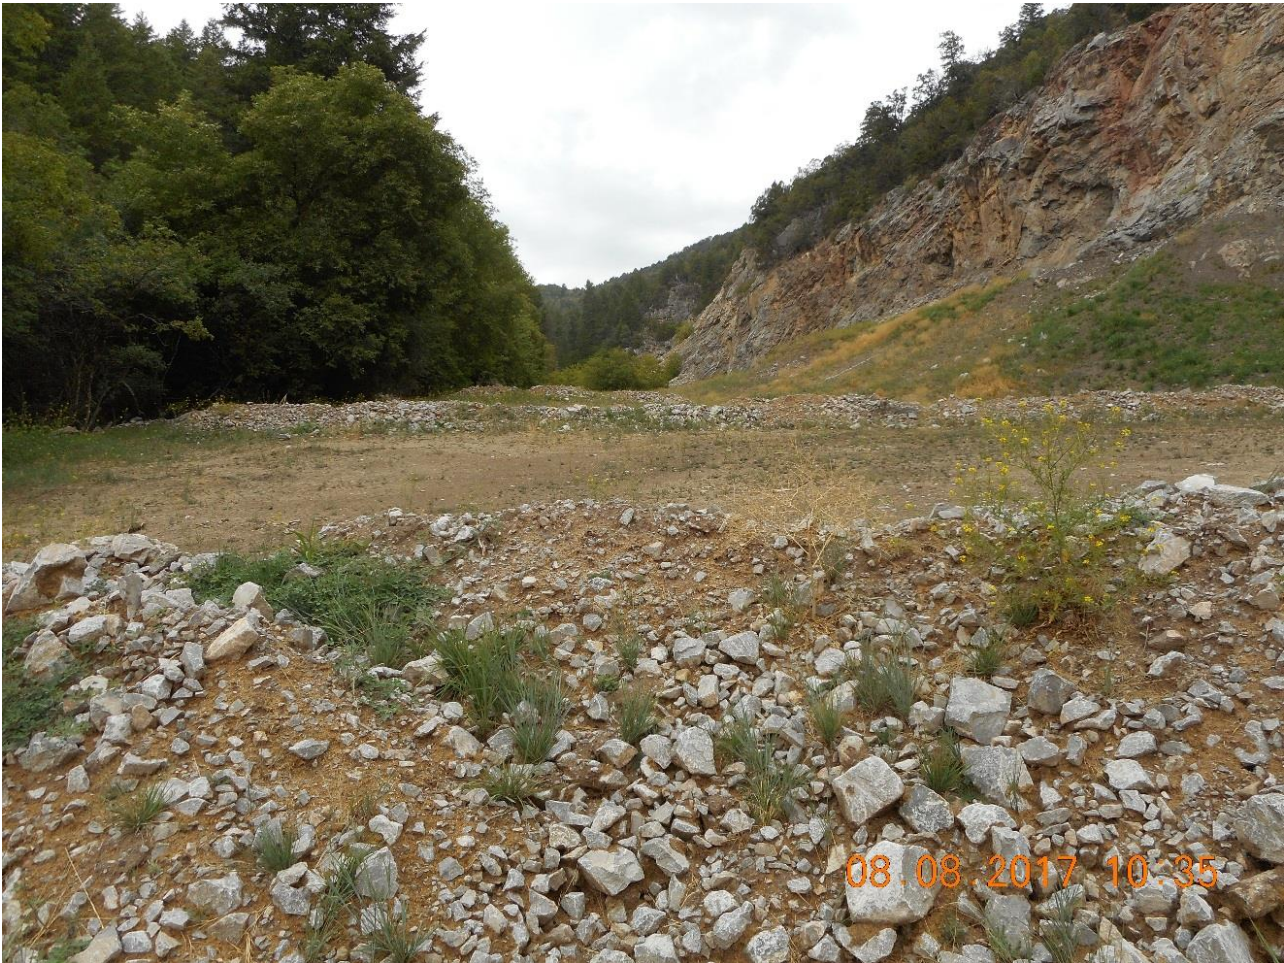
There were several 24" tall sediment control windrows running perpendicular to the west-to-east gradient on the quarry floor. These windrows were fairly effective at trapping sediment. The vegetation on the quarry also appeared to prevent erosion. There was some evidence of slight gullying/rilling and erosion of material in channels on the quarry floor. The channelization and erosion wasn't extensive, but additional erosion could occur if measures are not taken. Future inspections will continue to monitor effectiveness of sediment control.

Photo 3: Looking west at the sediment control windrows that run north-south (right to left) across the quarry floor. The unknown mustard plant species is located in the right foreground.

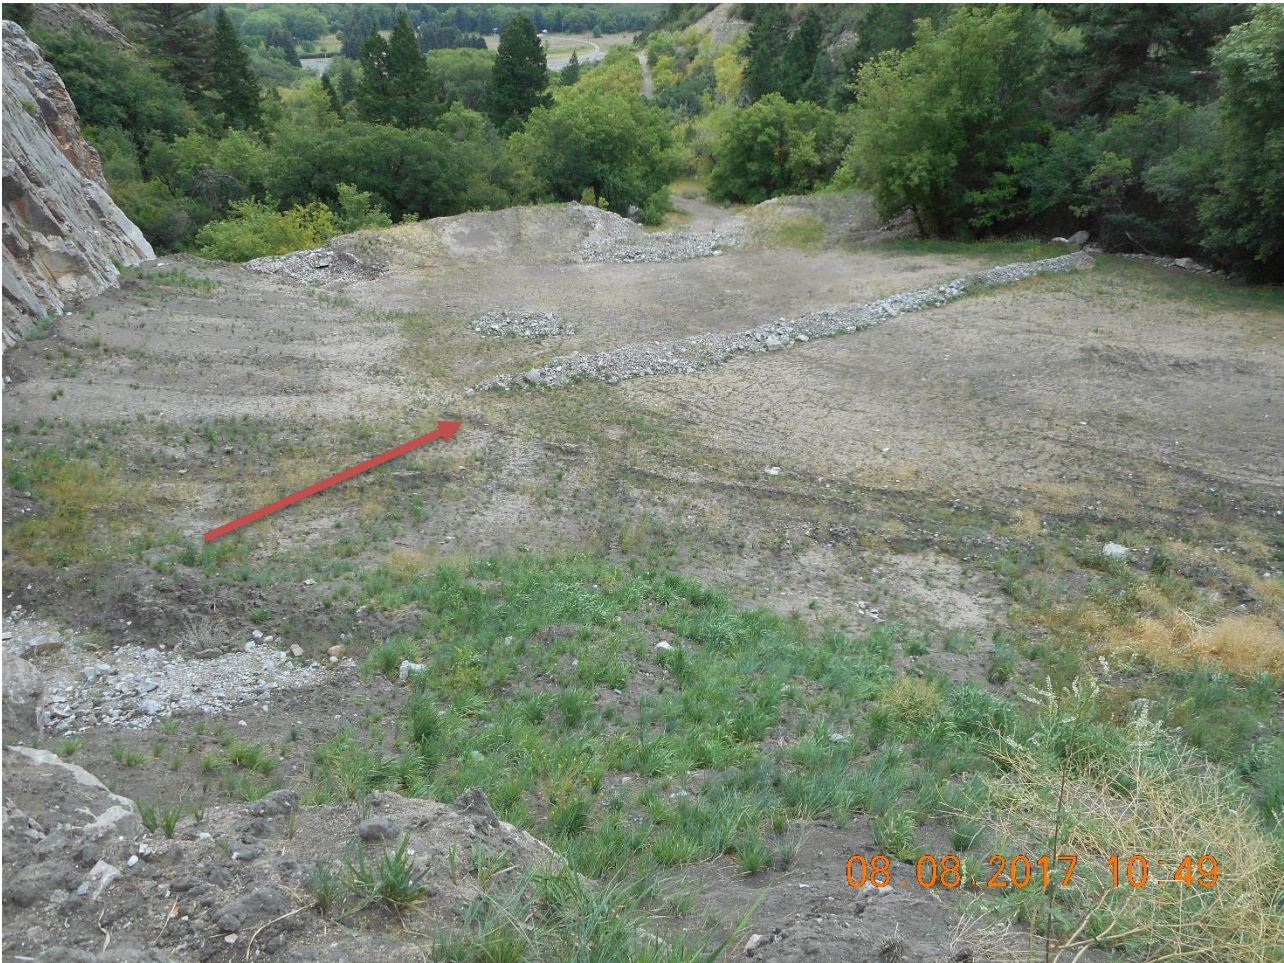
Photo 4: Looking southeast from the reclaimed upper quarry bench. Note the slight gully beginning to form around the northern (left) side of one of the windrows (red arrow).

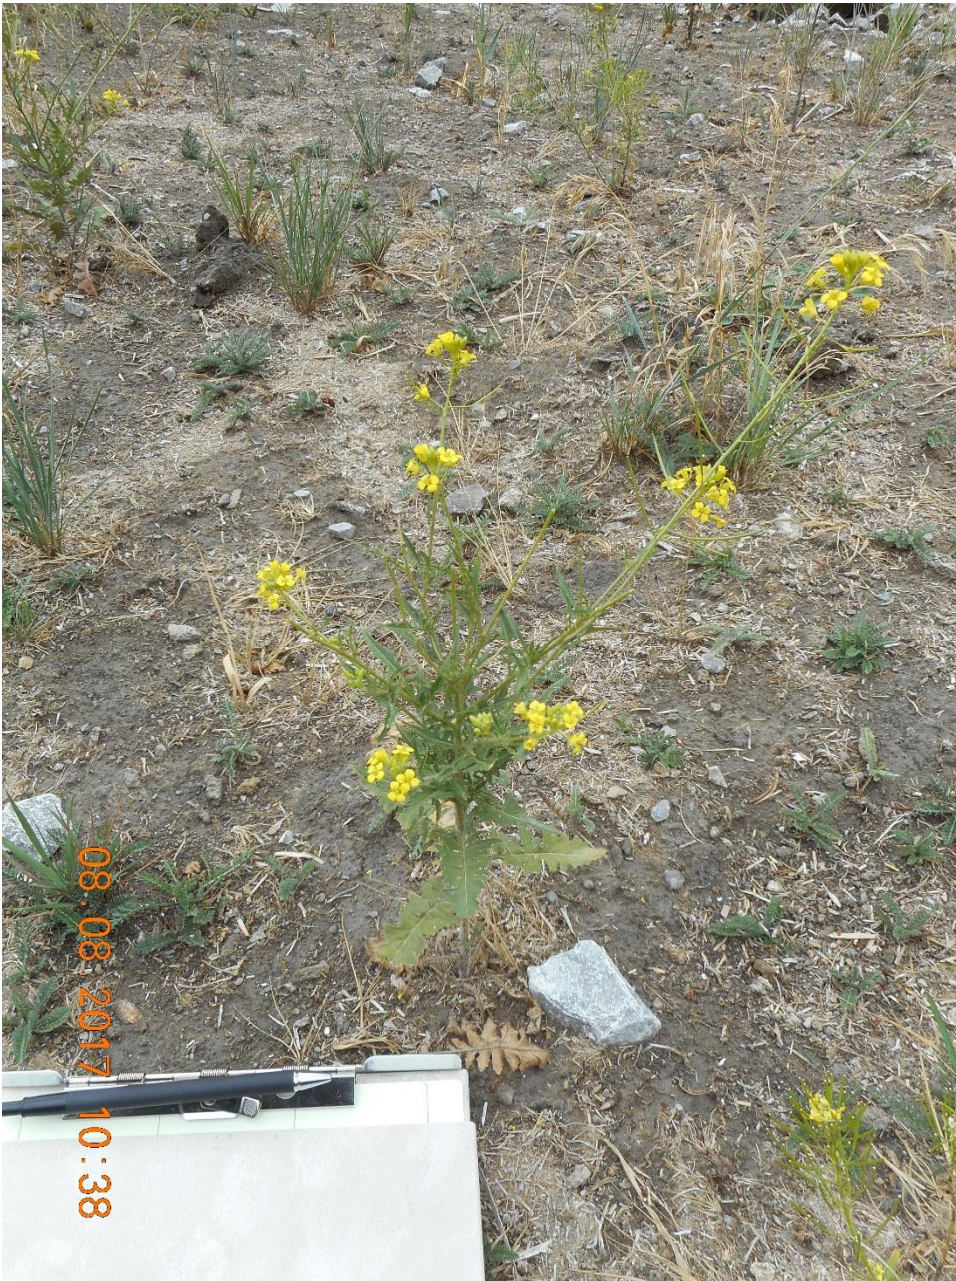
Photo 5: Close-up of unknown mustard species. Clipboard for scale.
