MINERALS PROGRAM INSPECTION REPORT
PHONE: (303) 866-3567

MINE NAME: Rifle Quarry	MINE/PROSPECTING ID#: M-1985-038	MINERAL: Limestone (general)	COUNTY: Garfield
INSPECTION TYPE: Monitoring	INSPECTOR(S): Amy C. Yeldell	INSP. DATE: November 9, 2017	INSP. TIME: 08:00
OPERATOR: Pete Lien & Sons, Inc.	OPERATOR REPRESENTATIVE: None	TYPE OF OPERATION: 112c - Construction Regular Operation	
REASON FOR INSPECTION: Normal I&E Program	BOND CALCULATION TYPE: Complete Bond	BOND AMOUNT: \$53,640.00	
DATE OF COMPLAINT: NA	POST INSP. CONTACTS: None	JOINT INSP. AGENCY: None	
WEATHER: Clear	INSPECTOR'S SIGNATURE:

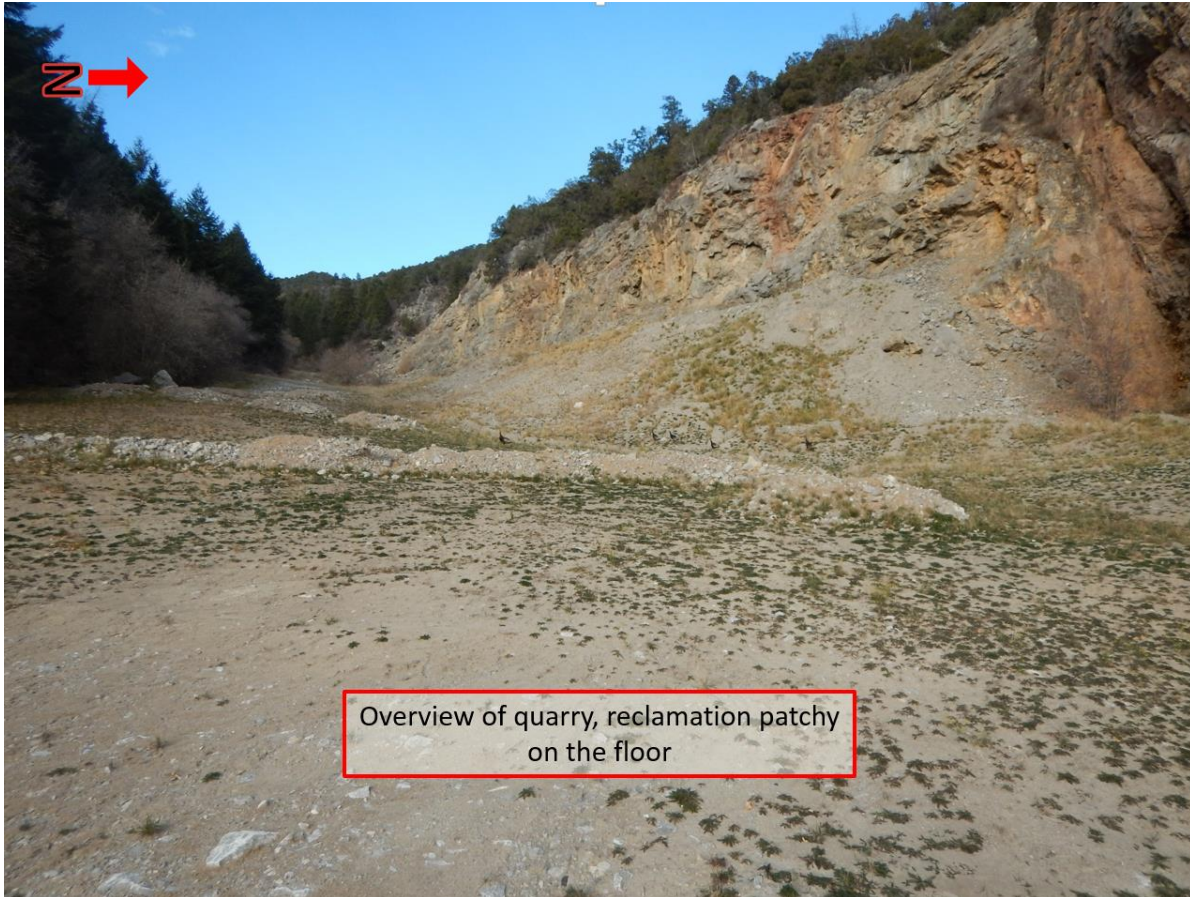
Overview of quarry, reclamation patchy
on the floor

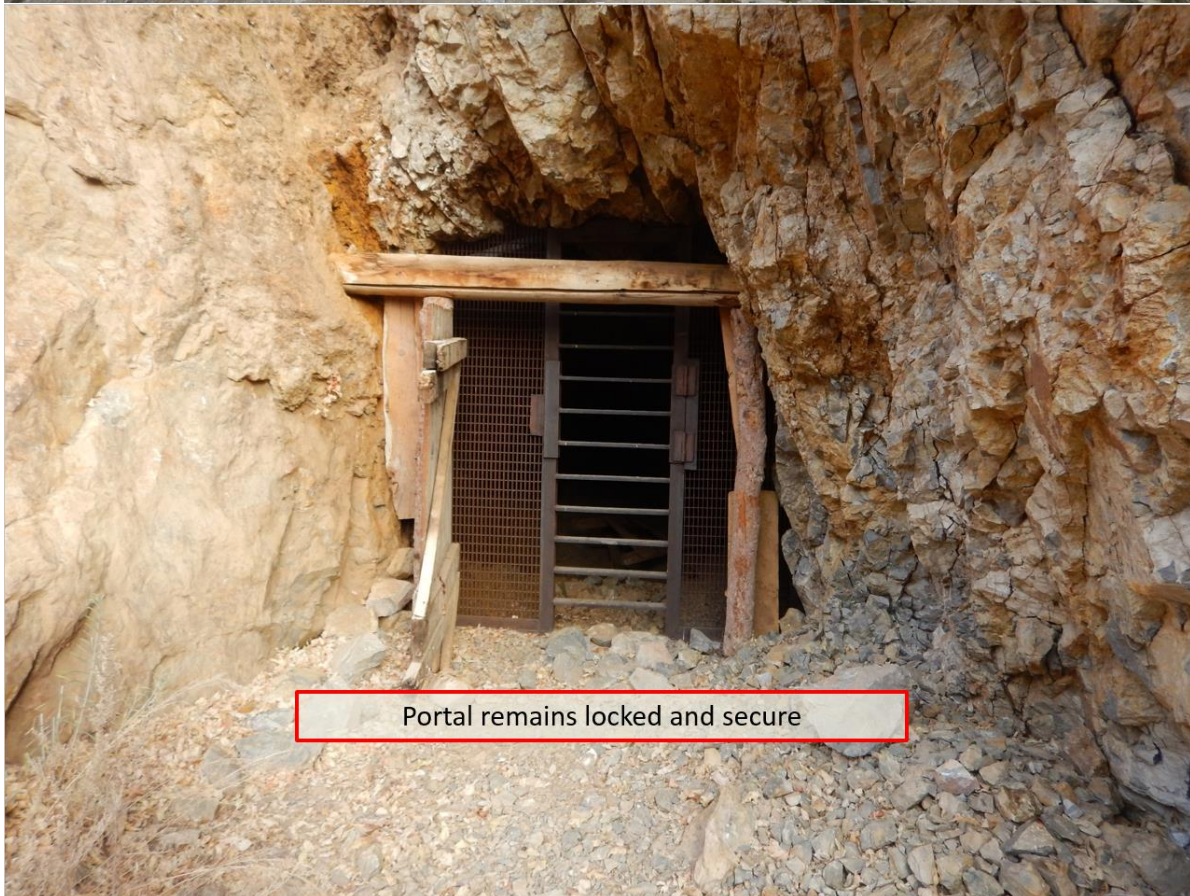
The portals on site remain secured.

Portal remains locked and secure
