## Bureau of Land Management Colorado River Valley Field Office Minerals Inspection Report

General Information	
<b>Date</b>	11/6/2017
<b>Project Name</b>	Rifle Quarry
<b>Operator</b>	Colorado Lien Company
<b>Serial Number</b>	COC-077876
<b>Project Classification</b>	Plan of Operations
<b>Project Location</b>	T4S R92W Sec15, Garfield County
<b>Inspection Purpose</b>	Reclamation site inspection
<b>Time Period Onsite</b>	1 hour
<b>Attendees</b>	Jessica Lopez Pearce, BLM Geologist

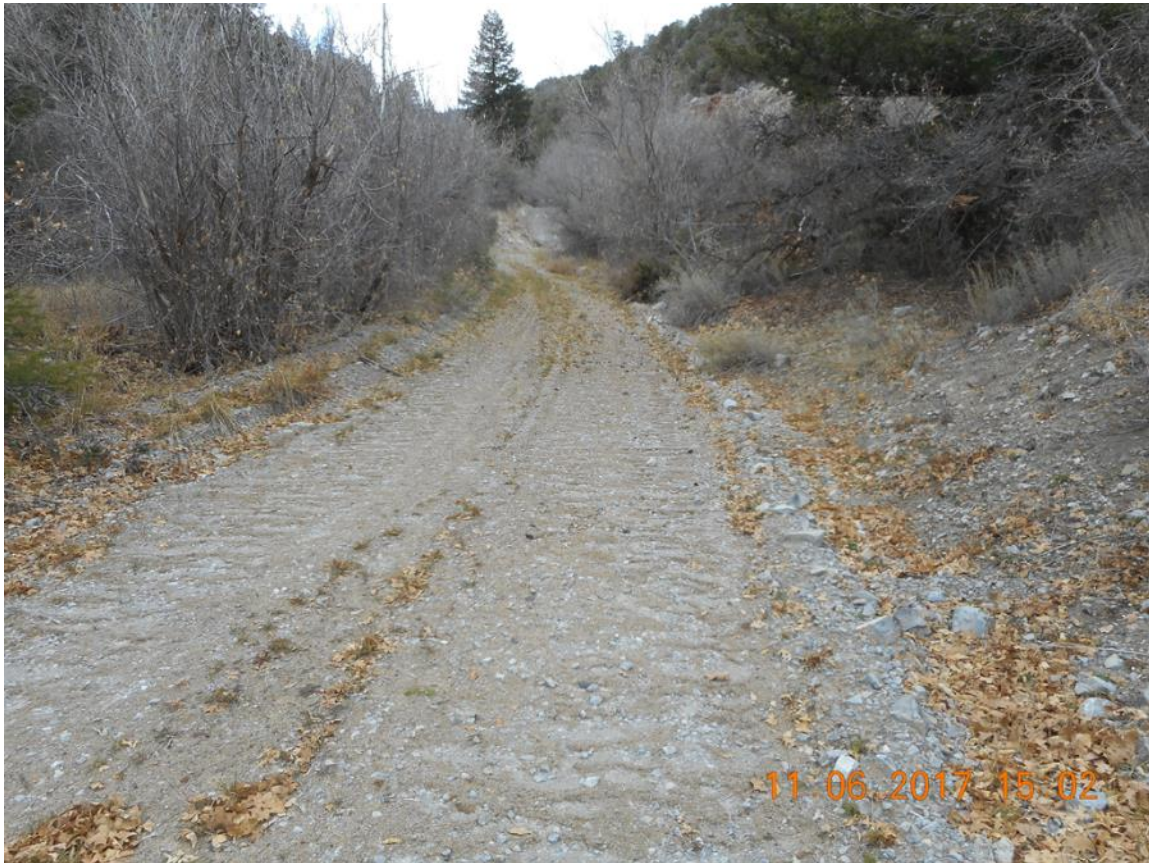
I observed the access road blocked per the Final Reclamation Plan. There was approved alternative growth media and mulching material (a combination of fish emulsion solids, spent grain solids, spent potato mash solids, mulch, and topsoil) on the surface of the road; however, it had been washed away in some areas. Grasses and forbs from the previous growing season were observed on the road bed; there was more vegetation along the side and down the middle of the old road than in the wheel ruts. Signage was present at the southeast corner of the main quarry area.

Photo 1: Looking west at the barricaded access road. There is evidence of vegetation from the last growing season in the middle and on the sides of the road.

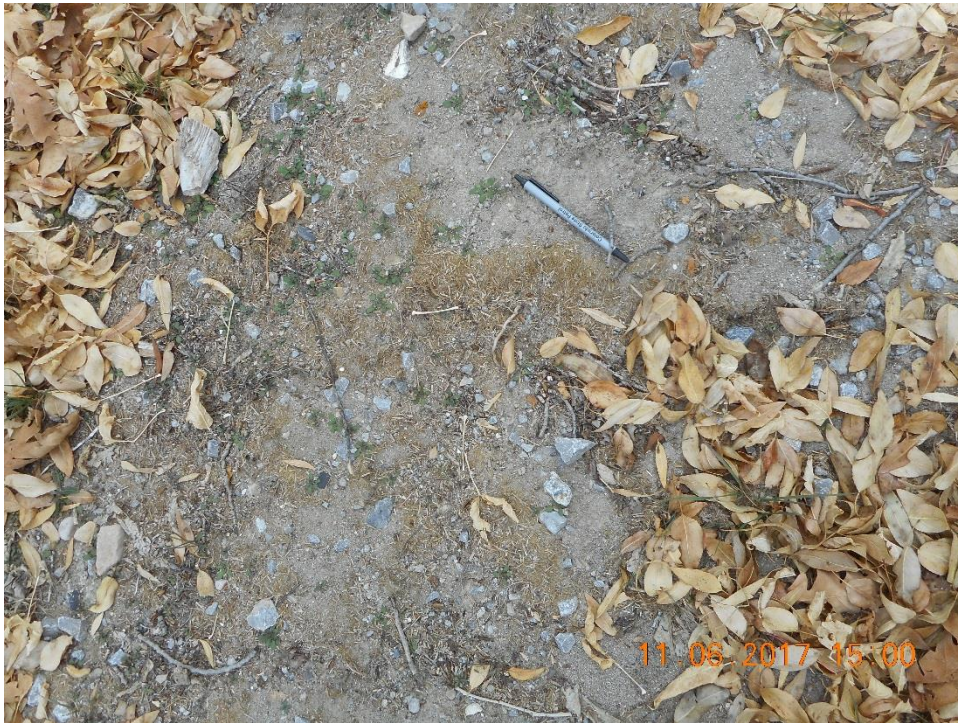
Photo 2: A close up of the alternative growth media and vegetation on the access road (pen for scale). The alternative growth media appears to be washing away.

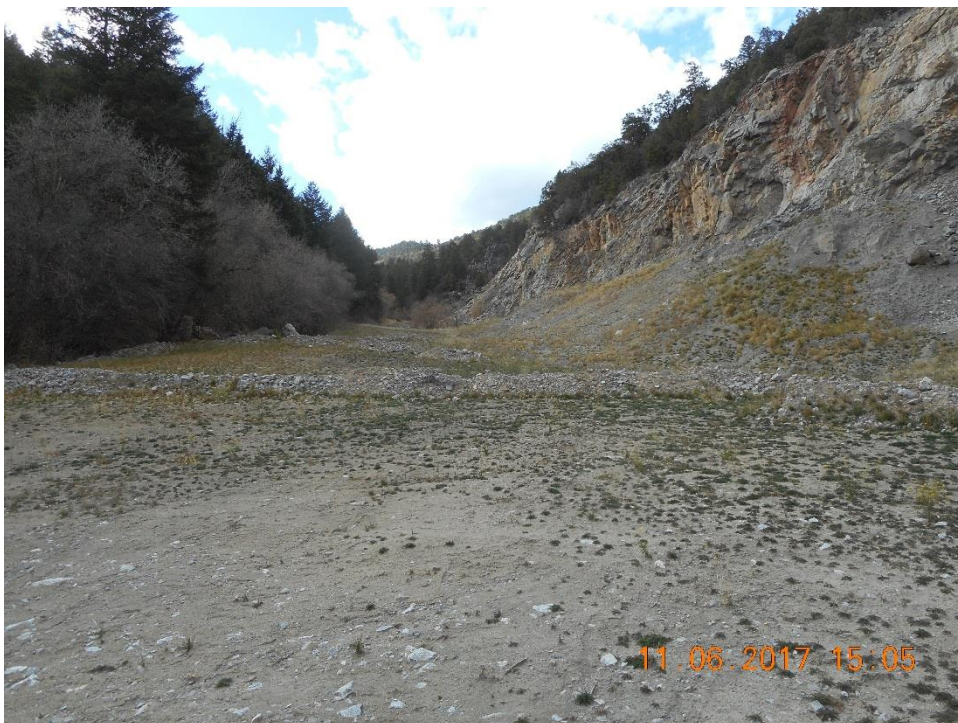
There were several 24" tall sediment control windrows running perpendicular to the west-to-east gradient on the quarry floor. These windrows were fairly effective at trapping sediment and eroded growth media. The vegetation on the quarry floor also appeared to prevent erosion. There was some evidence of slight gullying/rilling and erosion of material in channels on the quarry floor. The channelization and erosion wasn't extensive, but additional erosion could occur if measures are not taken. Future inspections will continue to monitor effectiveness of sediment control.

Photo 3: Looking west at the sediment control windrows that run north-south (right to left) across the quarry floor. Vegetation appears sparse in this area of the quarry floor.

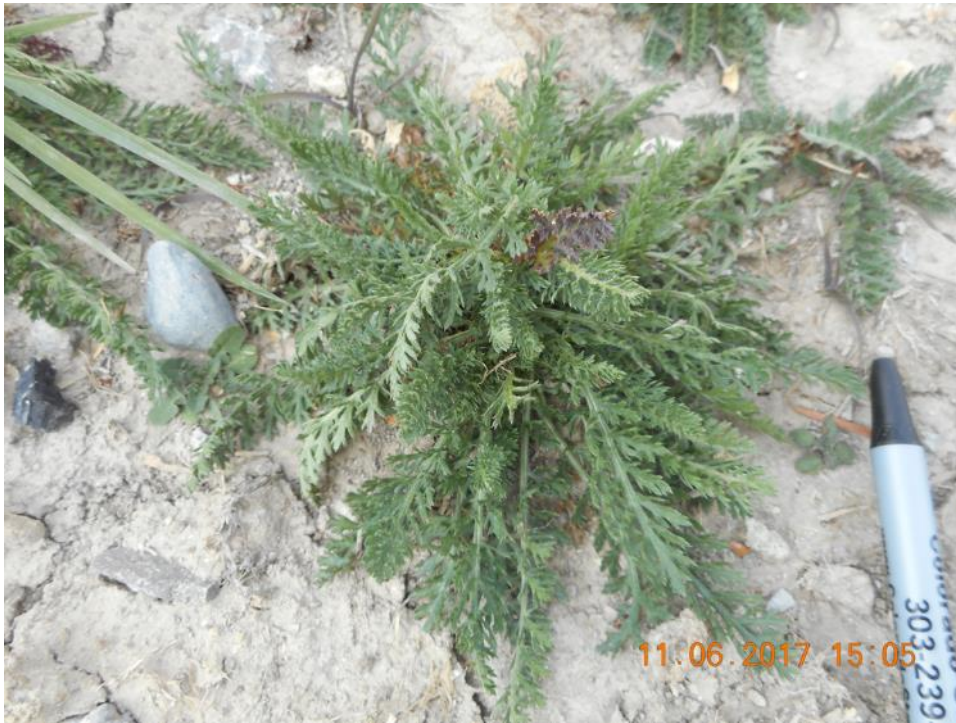
Photo 4: Close-up of unknown plant species. Pen for scale.

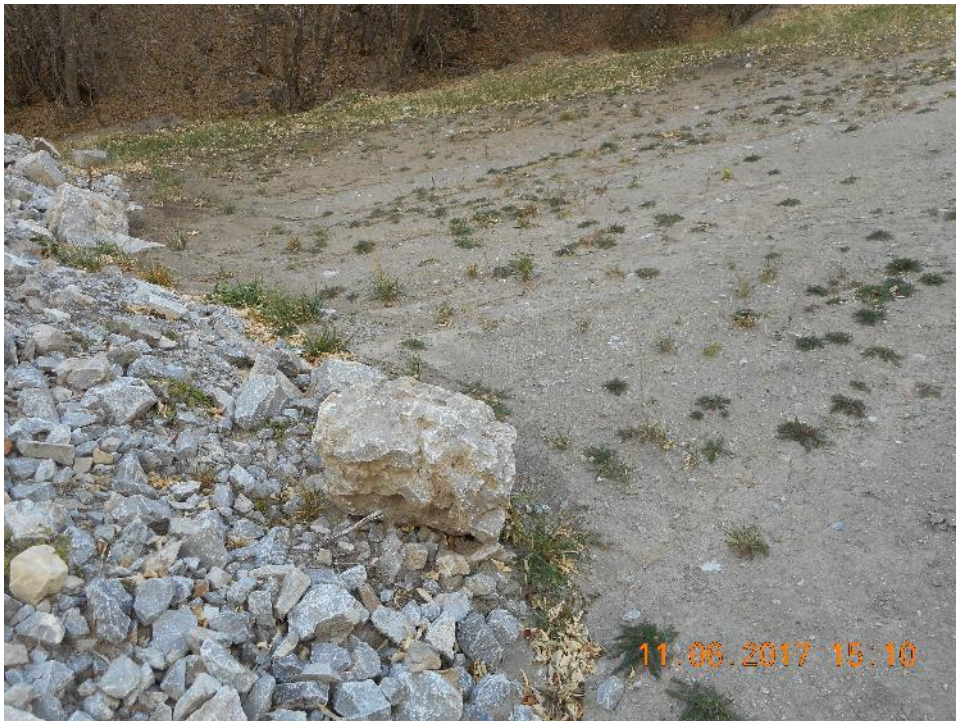
Photo 5: Looking southeast from the reclaimed upper quarry bench. Note the slight gully beginning to form around the northern (left) side of one of the windrows. The accumulated material appears to consist of sediment and eroded alternative growth media.

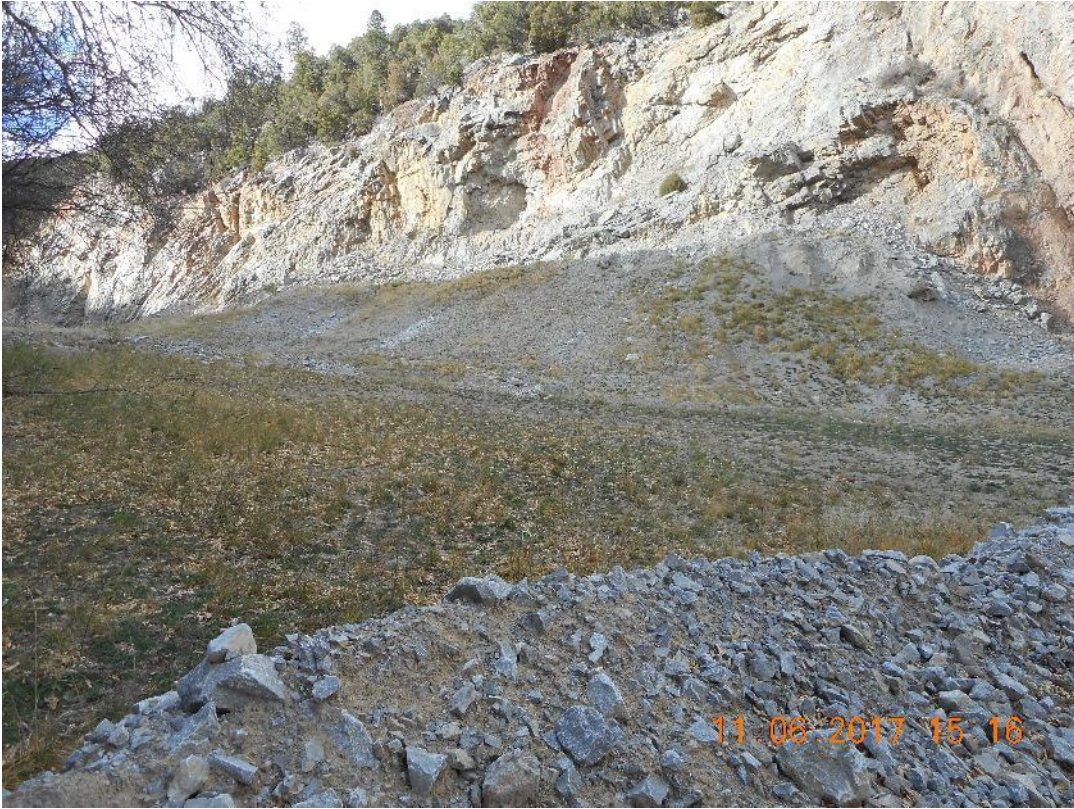
Photo 6: Looking north from the south side of the quarry floor to the upper quarry bench and highwall.
