**MINERALS PROGRAM INSPECTION REPORT**  
**PHONE: (303) 866-3567**

<b>MINE NAME:</b> Line Camp Pit	<b>MINE/PROSPECTING ID#:</b> M-2001-001	<b>MINERAL:</b> Sand and gravel	<b>COUNTY:</b> Montezuma
<b>INSPECTION TYPE:</b> Surety-Related Inspection	<b>INSPECTOR(S):</b> Lucas J. West	<b>INSP. DATE:</b> November 9, 2017	<b>INSP. TIME:</b> 13:00
<b>OPERATOR:</b> Stone Sand & Gravel, LLC	<b>OPERATOR REPRESENTATIVE:</b> Daren Stone	<b>TYPE OF OPERATION:</b> 112c - Construction Regular Operation	
<b>REASON FOR INSPECTION:</b> Surety Related	<b>BOND CALCULATION TYPE:</b> Complete Bond	<b>BOND AMOUNT:</b> \$91,917.00	
<b>DATE OF COMPLAINT:</b> NA	<b>POST INSP. CONTACTS:</b> None	<b>JOINT INSP. AGENCY:</b> None	
<b>WEATHER:</b> Clear	<b>INSPECTOR'S SIGNATURE:</b>

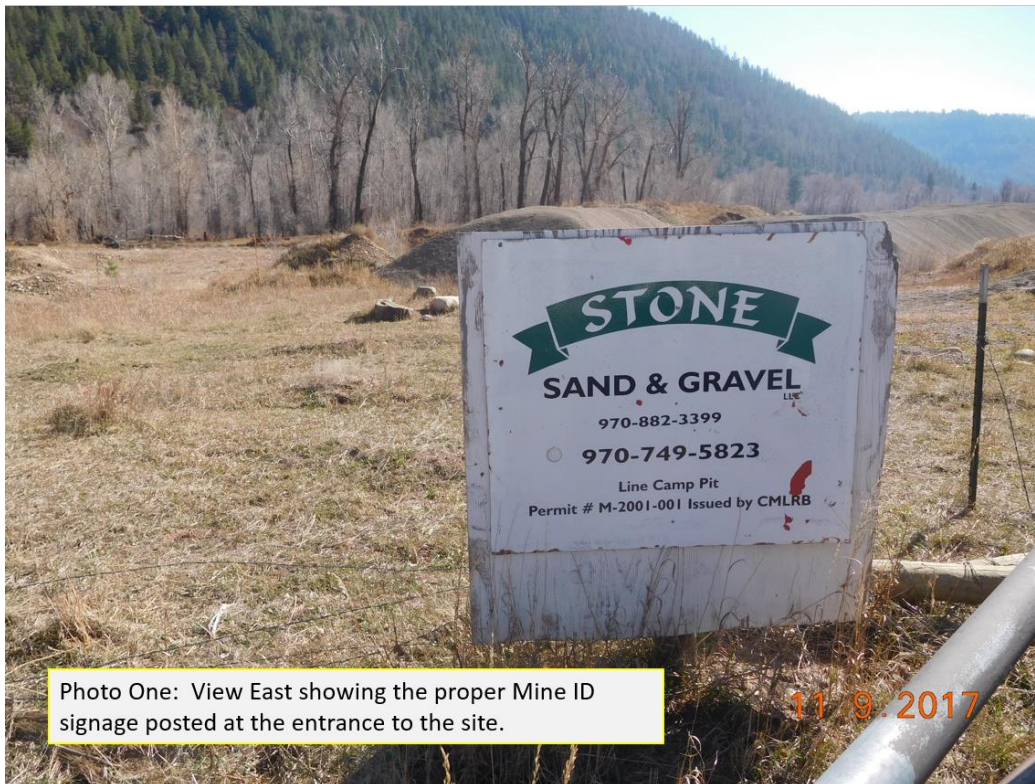
Photo One: View East showing the proper Mine ID signage posted at the entrance to the site.

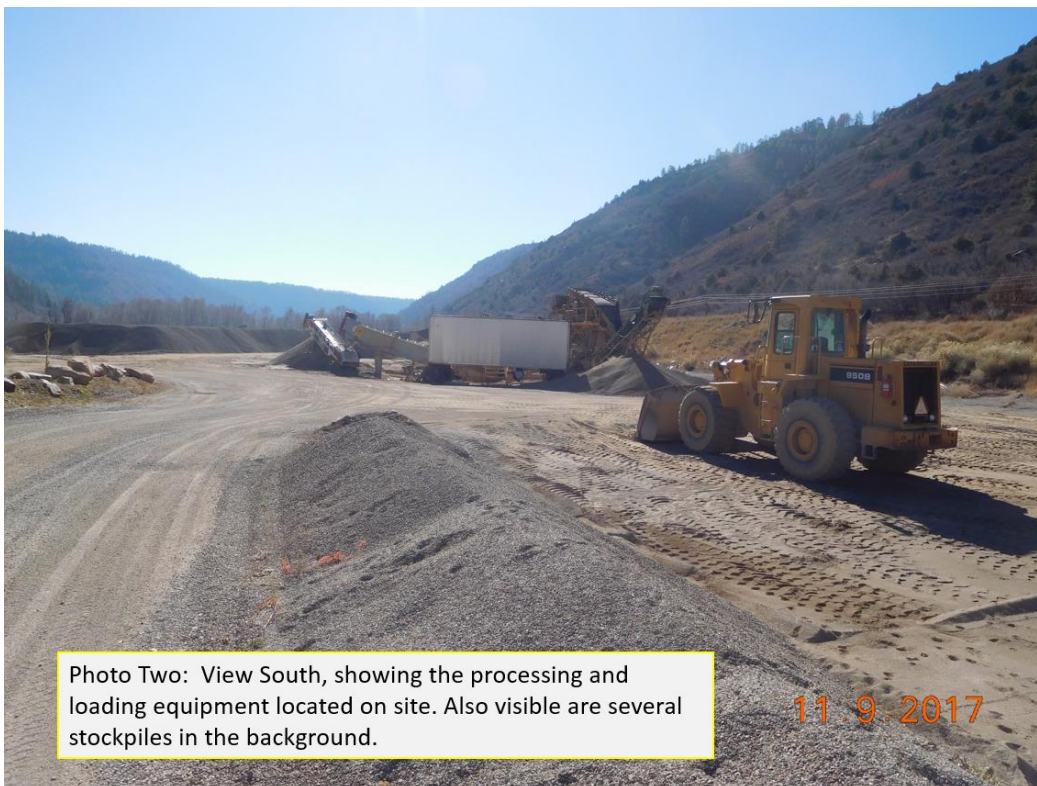
Photo Two: View South, showing the processing and loading equipment located on site. Also visible are several stockpiles in the background.

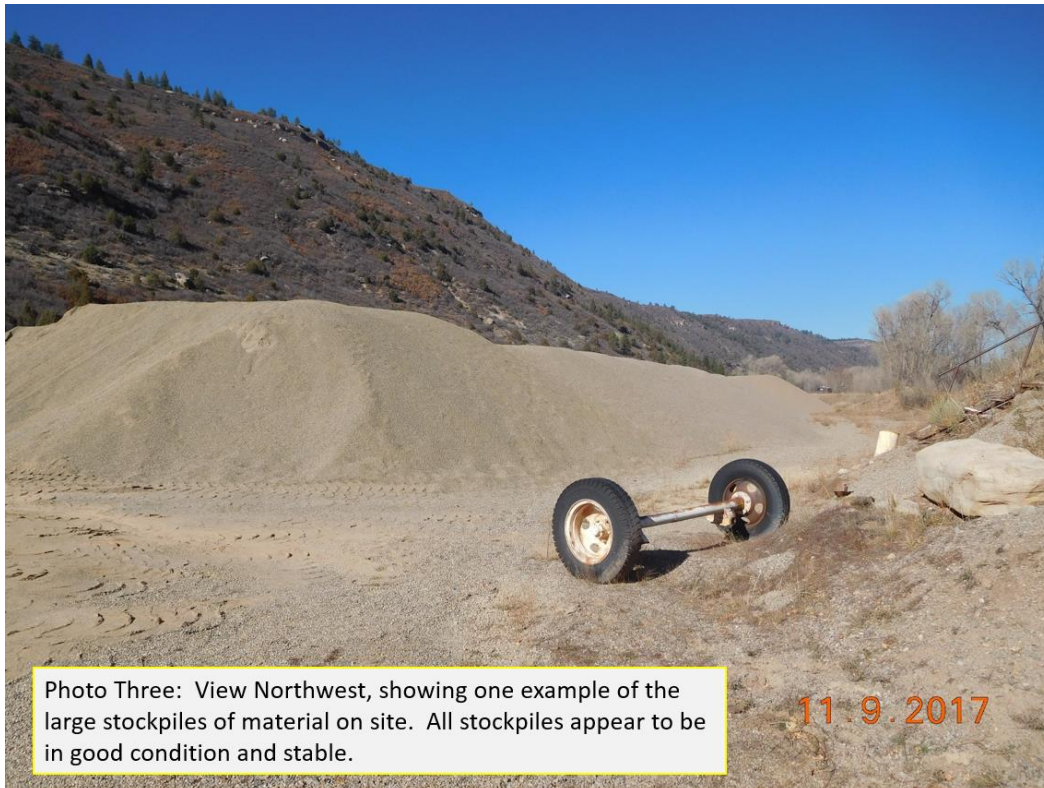
Photo Three: View Northwest, showing one example of the large stockpiles of material on site. All stockpiles appear to be in good condition and stable.

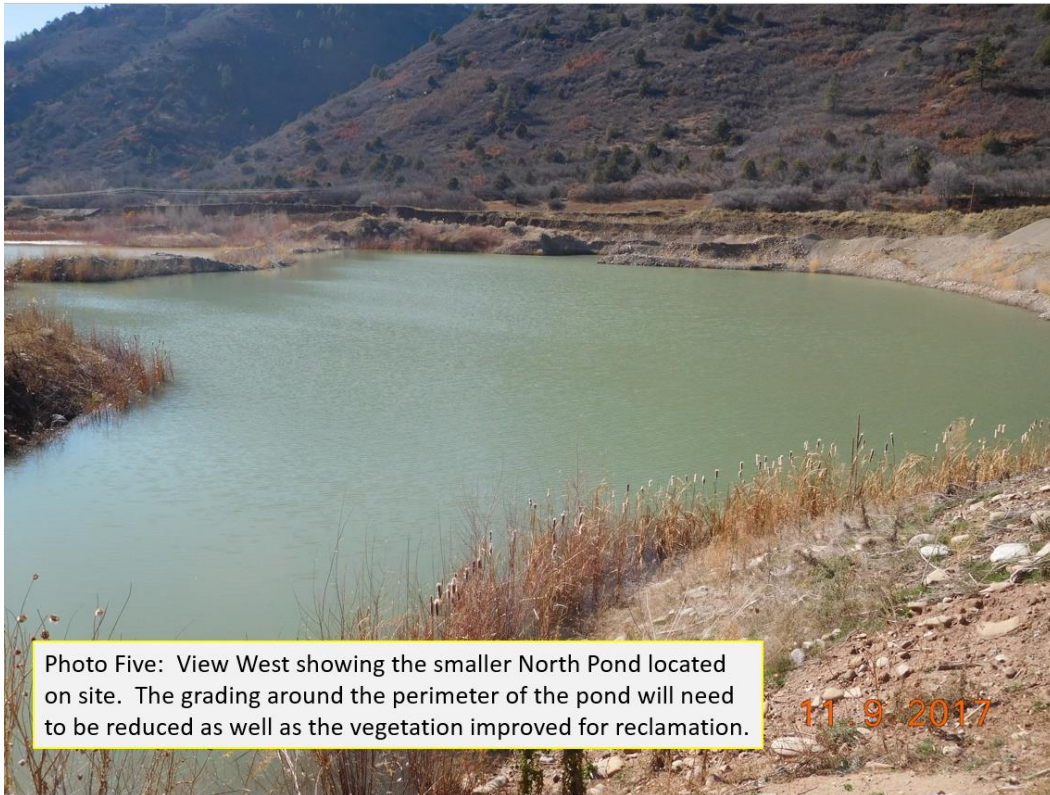
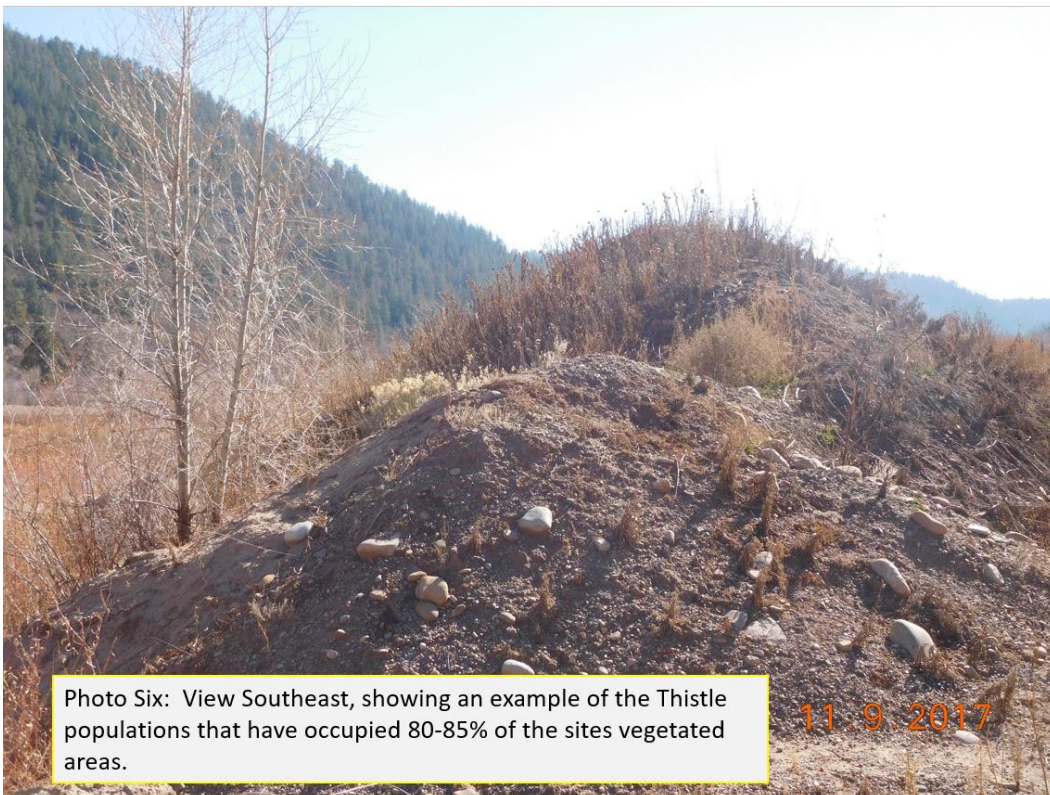
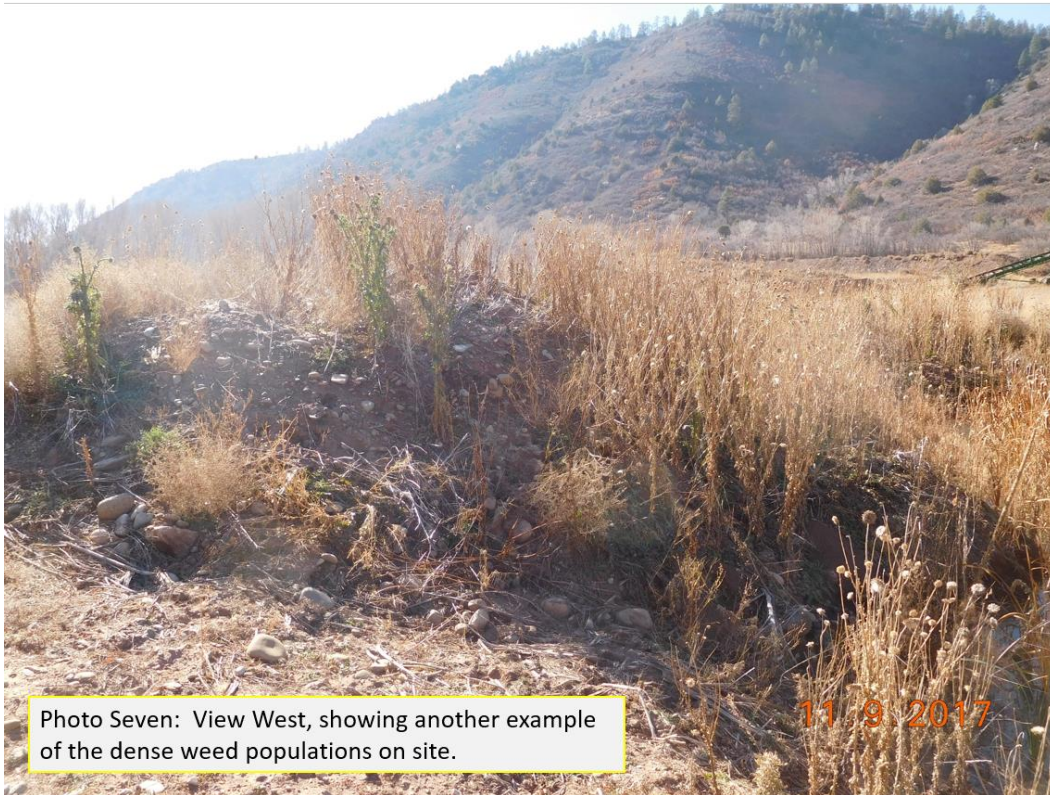
Similar to the grading, there are areas around the largest pond that have excellent wetland and riparian vegetation. The majority of the vegetation around the ponds, as well as the stockpiles and throughout the entire site consists of State Listed Noxious Weeds. The species of concern are Bull, Canada and Musk thistle as well as Common mullein. The weeds have occupied approximately 80-85% of the vegetated areas. This is not being cited as a problem at this time due to seasonal treatment restrictions. Examples of the populations can be seen in Photos Six and Seven. Discussions with the Operator indicate that some weed treatment had taken place on site. The Operator does have an approved weed management plan but it is proving ineffective. The Operator should coordinate with the Montezuma County weed management department to develop a targeted robust plan to combat these populations.

Due to the overwhelming weed populations on site and need for major site cleanup, Division Staff is denying the Operators request for a financial warranty reduction. Once the Operator has coordinated with the County Weed Program and gained control over these populations as well as performed an extensive site cleanup a follow up Financial Warranty Reduction may be submitted. Please see the attached SR-02 Denial Letter for details. All responses to this report should be directed to Lucas West at the Colorado Division of Reclamation Mining and Safety at 1313 Sherman Street, Room 215, Denver, CO 80203, by phone at (970)-243-6368 or by email at lucas.west@state.co.us.
