MINERALS PROGRAM INSPECTION REPORT

MINE NAME: Emma Lode MS#7261	MINE/PROSPECTING ID#: M-2008-037	MINERAL: Silver, gold, copper,	COUNTY: Clear Creek
INSPECTION TYPE: Monitoring	INSPECTOR(S): Michael A. Cunningham	INSP. DATE: October 26, 2017	INSP. TIME: 11:00
OPERATOR: Venture Resources, Inc.	OPERATOR REPRESENTATIVE: Patrick Maher, Mason Drake	TYPE OF OPERATION: 110(2) - Hard Rock Limited Impact

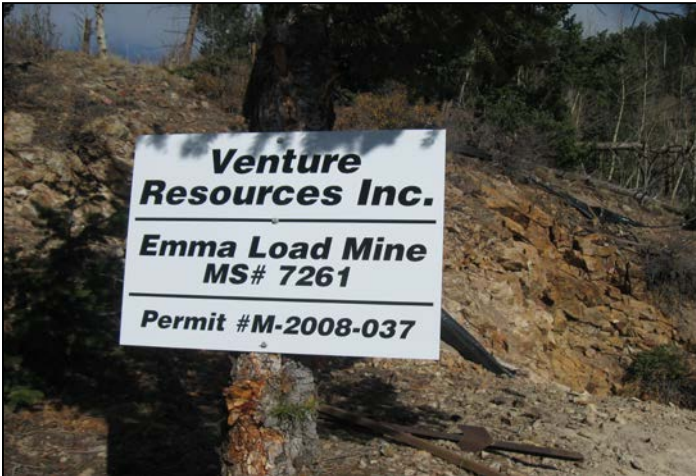
The inspection was conducted as part of the Division's regular monitoring program; the site was last inspected in 2013. Conditions at the Emma Lode remain unchanged since the last inspection; no mining activity has occurred. The mine identification sign was posted at the site as required by Rule 3.1.12.

1. Permit sign at site entrance.

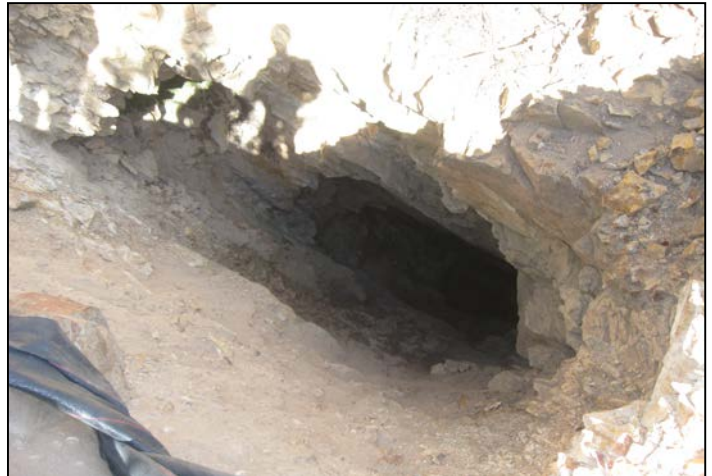
PROBLEM/POSSIBLE VIOLATION: Problem: The Garland Shaft is not safeguarded from unauthorized entry into the mine. This is a problem pursuant to Rule 3.1.5(6) for failure to close or safeguard the shaft.

The existing disturbance at the Emma Lode consists of a shaft without a collar or an enclosure. The shaft is approximately 240' in length and connects to the 2nd underground level of the Dove's Nest Mine. The unsecured shaft opening is large enough for someone to fall into. According to the approved Mining Plan, a shaft collar/enclosure would be constructed immediately upon the commencement of mining. Pursuant to Rule 3.1.5(6), adits and shafts should be closed, and where practicable, backfilled and graded in a manner consistent with the post-mining land use. The Division is concerned the shaft, in its current state, is an attractive nuisance which poses a risk to public health and safety. This matter has been cited as a problem and will require corrective action by the Operator. Please see the first page of this report for additional information.

2. Unsecured mine shaft.

CORRECTIVE ACTIONS: The Operator shall submit a Technical Revision which addresses how the Garland Shaft will be safeguarded from unauthorized entry until such time as mining commences and a shaft collar/enclosure is constructed. The Technical Revision application shall be submitted to the Division on or before the corrective action date.

CORRECTIVE ACTION DUE DATE: 1/19/18
