**MINERALS PROGRAM INSPECTION REPORT**  
**PHONE: (303) 866-3567**

<b>MINE NAME:</b> Schwartzwalder Mine	<b>MINE/PROSPECTING ID#:</b> M-1977-300	<b>MINERAL:</b> Uranium	<b>COUNTY:</b> Jefferson
<b>INSPECTION TYPE:</b> Monitoring	<b>INSPECTOR(S):</b> Michael A. Cunningham	<b>INSP. DATE:</b> October 5, 2017	<b>INSP. TIME:</b> 09:30
<b>OPERATOR:</b> Cotter Corporation	<b>OPERATOR REPRESENTATIVE:</b> Steve Cohen, Bruce Nordquist	<b>TYPE OF OPERATION:</b> 112d-2 - Designated Mining Operation	
<b>REASON FOR INSPECTION:</b> Normal I&E Program	<b>BOND CALCULATION TYPE:</b> None	<b>BOND AMOUNT:</b> \$4,339,003.39	
<b>DATE OF COMPLAINT:</b> NA	<b>POST INSP. CONTACTS:</b> None	<b>JOINT INSP. AGENCY:</b> None	
<b>WEATHER:</b> Clear	<b>INSPECTOR'S SIGNATURE:</b>

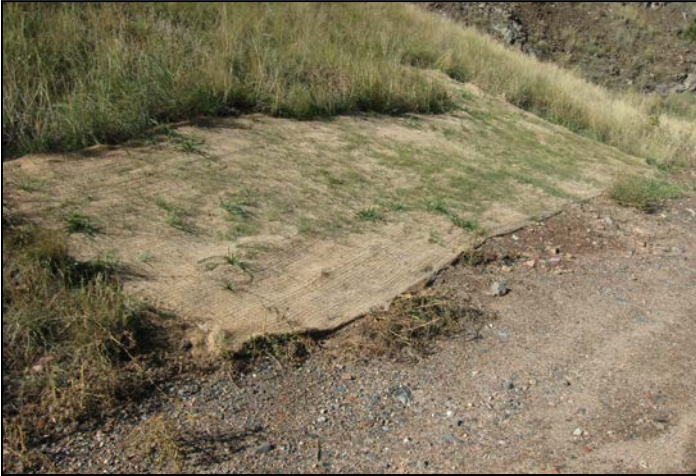
The Division inspected the North and South Waste Rock Piles. The Division noted several areas of erosion along the toe of both the Waste Rock Piles. The Operator laid down erosion control blanket over the eroded areas and reseeded the areas. The Division observed initial germination of the planted grasses and found the repaired areas had been adequately stable. The Operator should continue to monitor these areas to ensure an adequate cover of vegetation is established.

1. Erosion repair to South Waste Rock Pile.

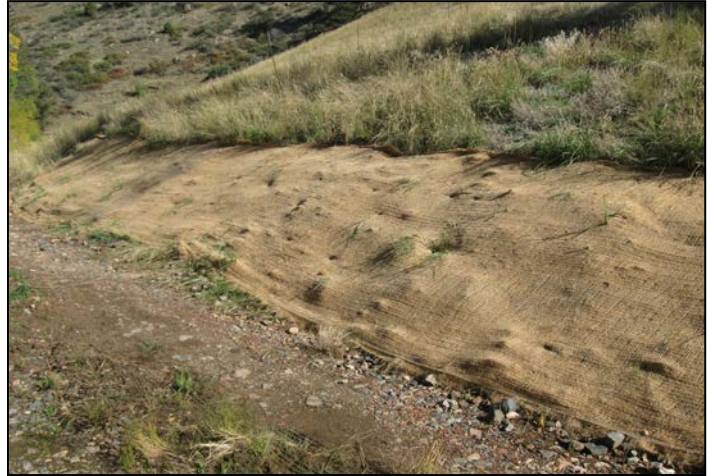
2. Erosion repair to North Waste Rock Pile.

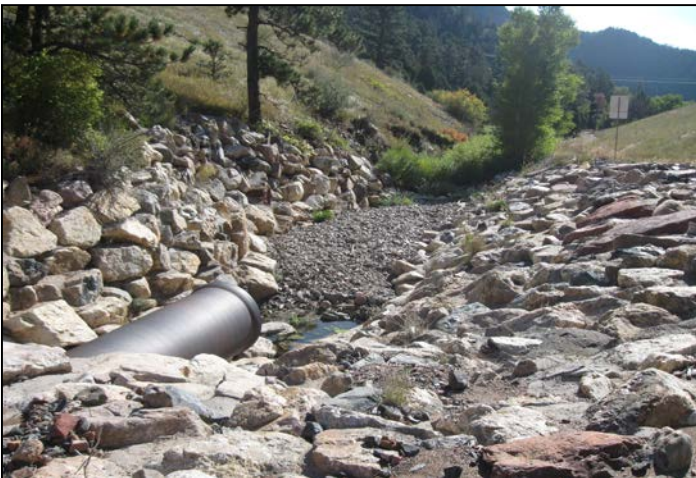
The water in Ralston Creek was being diverted through the bypass pipeline at the time of the inspection. The creek bed was dry down gradient of the cut-off wall.

3. Ralston creek, below cut-off wall.
